**Final Monitoring Report for
Marlette Creek Dam Removal and
Restoration Project,
Period of Record 2002 to 2008**

USDA Forest Service

Lake Tahoe Basin Management Unit

March 2009

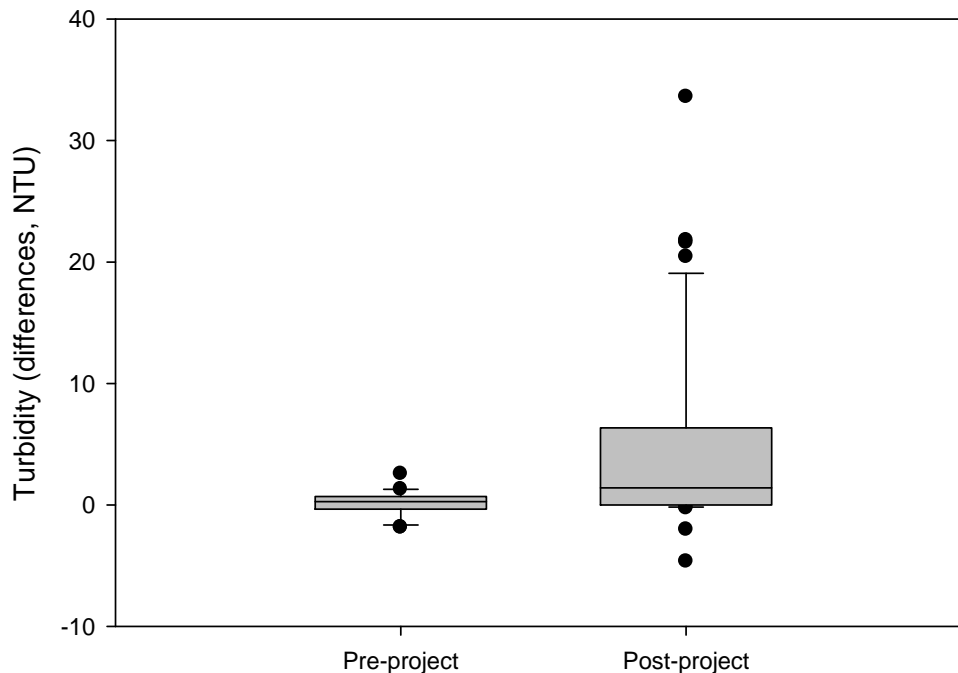
Figure 2: Pre and Post Project Median Turbidity Differences at Marlette Creek

The differences in turbidity values upstream versus downstream of the project were calculated for each sampling event, and compared between pre- and post-project data sets. Prior to project implementation, the median of the differences in turbidity values between the upstream and downstream monitoring locations was 0.27 NTU compared to 1.3 NTU after the project. Thus, the median difference between the upstream and downstream turbidity values increased by 1.03 NTU after project implementation. Executing a Mann-Whitney Rank Sum Test on the pre- and post-project differences indicated that the difference between median turbidity values was greater than would be expected by chance, and is statistically significant ($P = 0.005$). Therefore, the differences between turbidity values from upstream and downstream samples increased after project implementation, and this increase is statistically significant. This data is graphically displayed in the box and whisker plots in Figure 2. The line in the middle of the box displays the median value, the boxes above and below the line represent the 25th and 75th percentile of the data, and the “whisker” displays the full range of the data, excluding outliers. Figure C1 in Appendix C illustrates the turbidity and flow data collected upstream and downstream of the project area.

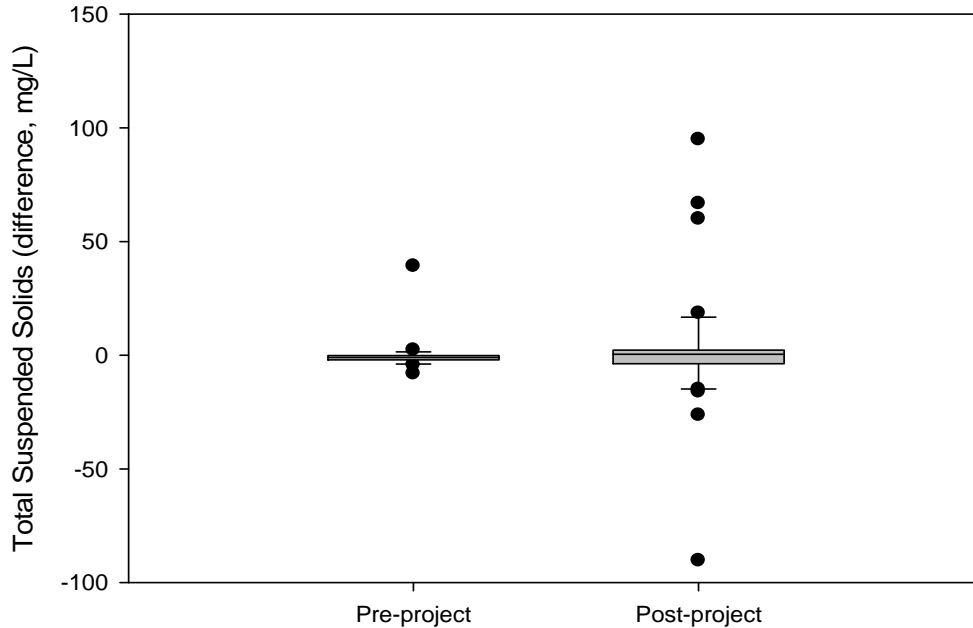
Figure 3: Pre and Post Project Median TSS Differences at Marlette Creek

The differences in TSS values between measurements taken upstream of the project site and those taken downstream were also calculated, and are displayed graphically in Figure 3. Prior to implementation of the project, the median difference between the upstream and downstream values was -1.02 mg/L (i.e. TSS downstream of the project area was less than TSS upstream of the project). After the project, the median difference between the upstream and downstream values was 0.40 mg/L. Thus the difference in the median TSS values between upstream and downstream of the project site increased by 1.42 mg/L after the project. Executing a Mann-Whitney Rank Sum Test on the pre- and post-project differences indicated that the difference between median TSS values was greater than would be expected by chance, thus the difference is statistically significant ($P = 0.060$). Therefore, the differences between upstream and downstream samples TSS values

increased after project implementation, and this increase is statistically significant.

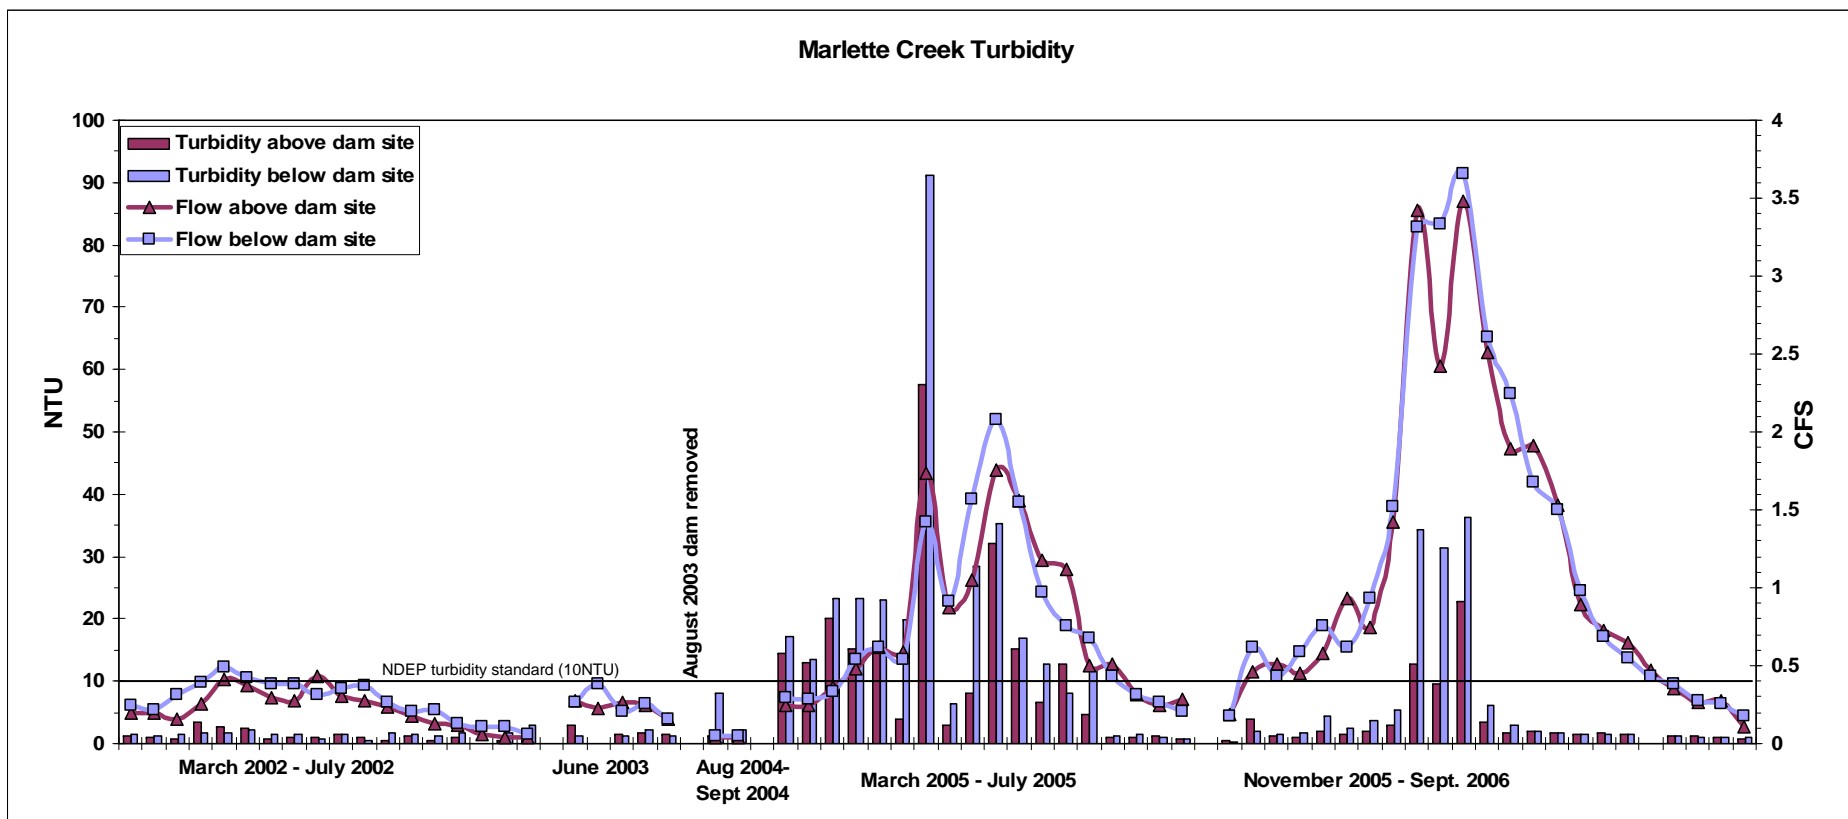
Figure C1. Turbidity above and below dam site with stream flow rate.

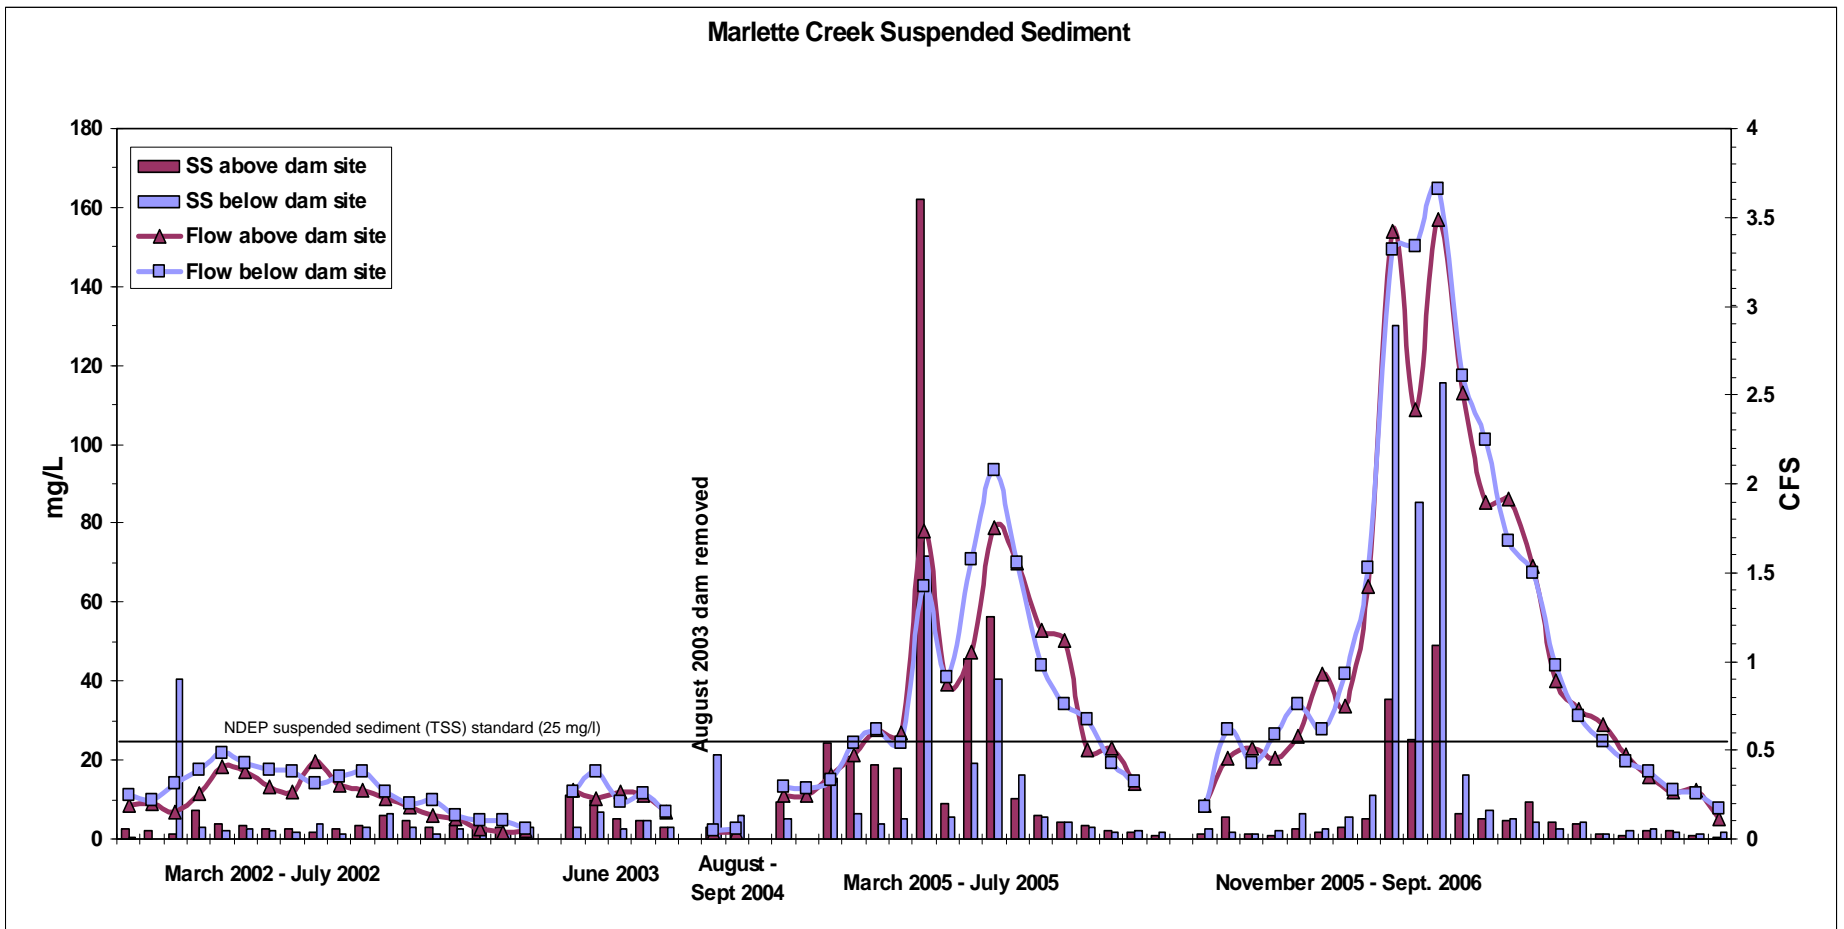
Figure C2. Total suspended solids (TSS) above and below dam site with stream flow rate.
