Executive Summary

Fiscal Year 2001 Accidents

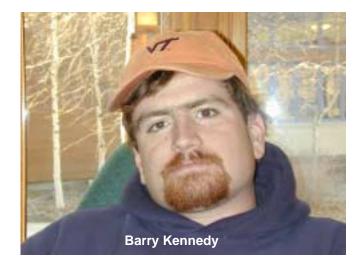
Barry Kennedy, from Chena Lakes Helibase, Alaska, had a feeling that something was wrong while observing a recent pilot qualification flight conducting water bucket operations. Barry checked the bucket and found it was unserviceable. The bucket didn't have a model number or capacity markings nor did it have "cinch rings, markings or loops in the bucket" needed to adjust its capacity. Being concerned for the crew's safety, Barry approached the pilot with this information. The pilot confirmed the problem and the bucket was removed from service. Great job, Barry! <u>OAS SafeCom 01-90</u>

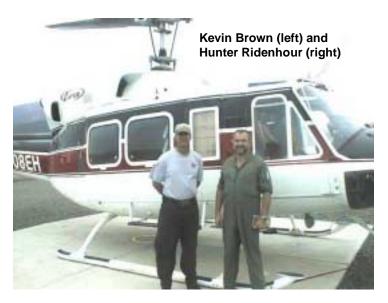
Home Run

During rappel proficiency training at the John Day Oregon Base, the helicopter experienced mechanical failure during flight. Kevin Brown, spotter, had begun rappel training when he heard a noise that led him to believe it was a lost hydraulic pump. Hunter Ridenhour, pilot, decided to make the play of the day by stealing a base and sliding into home plate. He quickly turned the aircraft back to the airport while Brown prepared the crew for a hardball landing. The helicopter slid to a stop on the taxiway and the crew departed. Brown observed smoke from a grass fire that this incident

may have caused, notified Ridenhour and he contacted the base manager for initial attack action on the fire. Nice slide, guys! <u>USFS SafeCom 01-373</u>
