Executive Summary Systems Safety – Re-defining a Core Value

We invite you to study the FY 2004 Accident Review and to benefit from the lessons learned. For more about the USDA Forest Service Aviation Safety program, visit the NASC website at <u>www.fs.fed.us/fire/aviation_safety</u>.

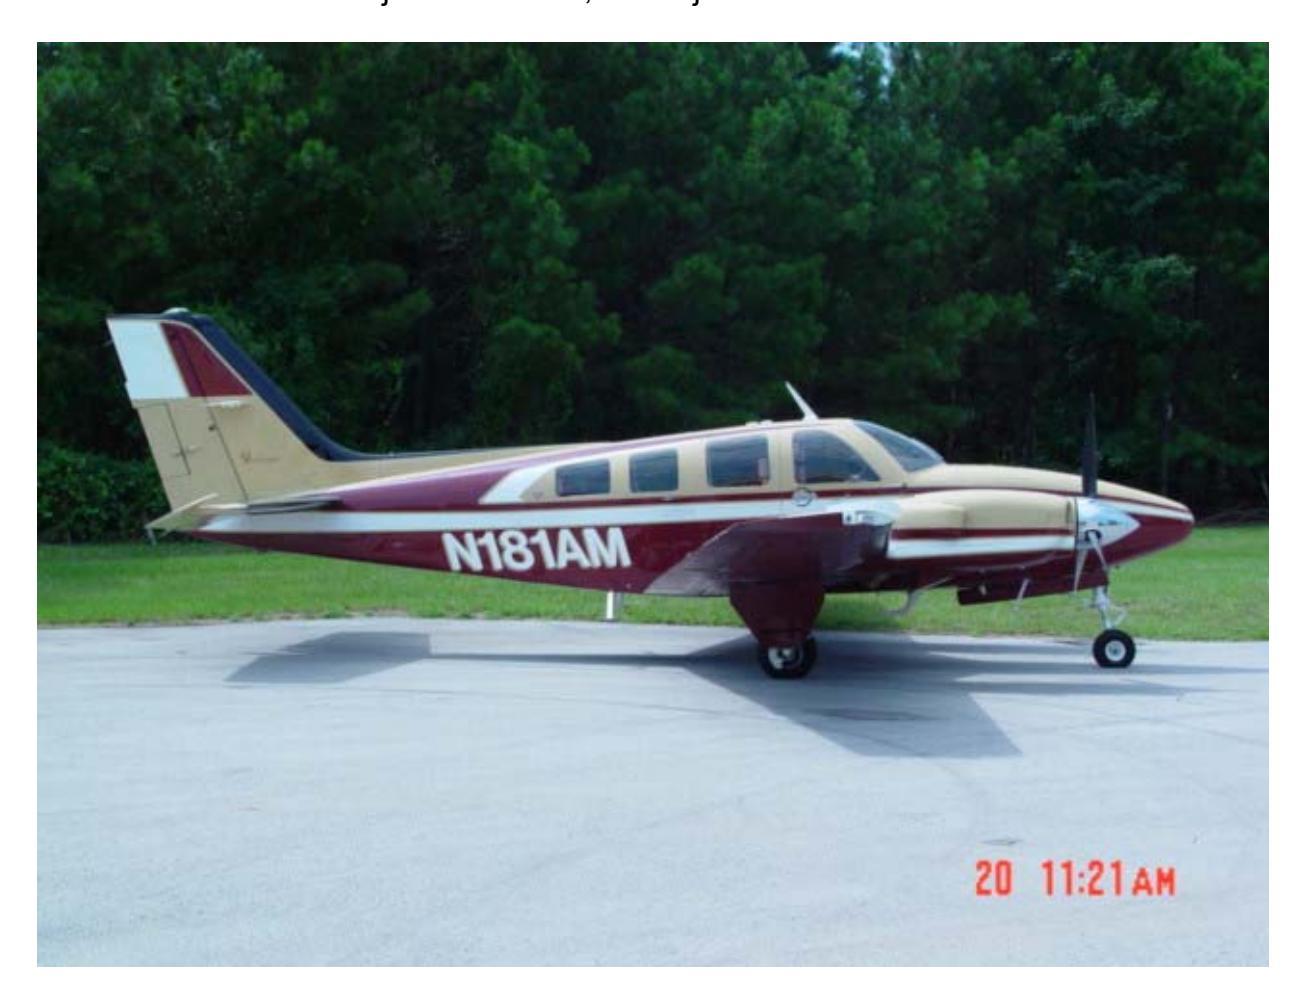
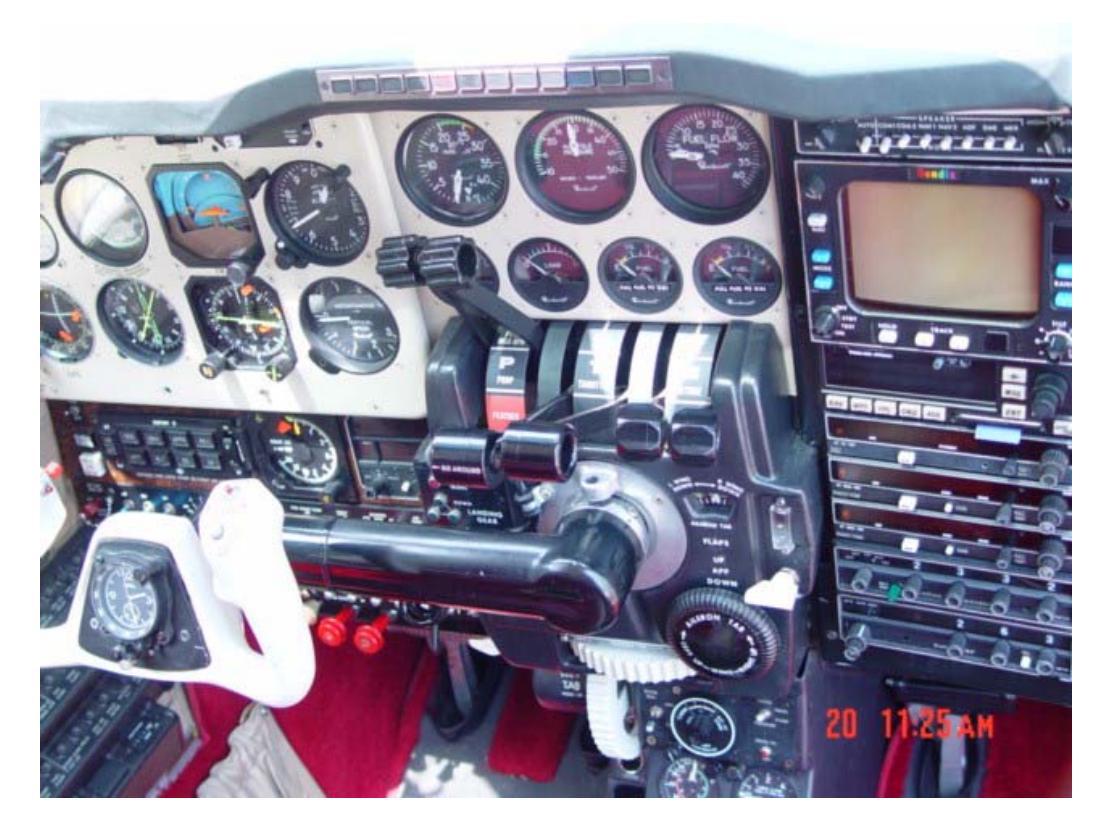
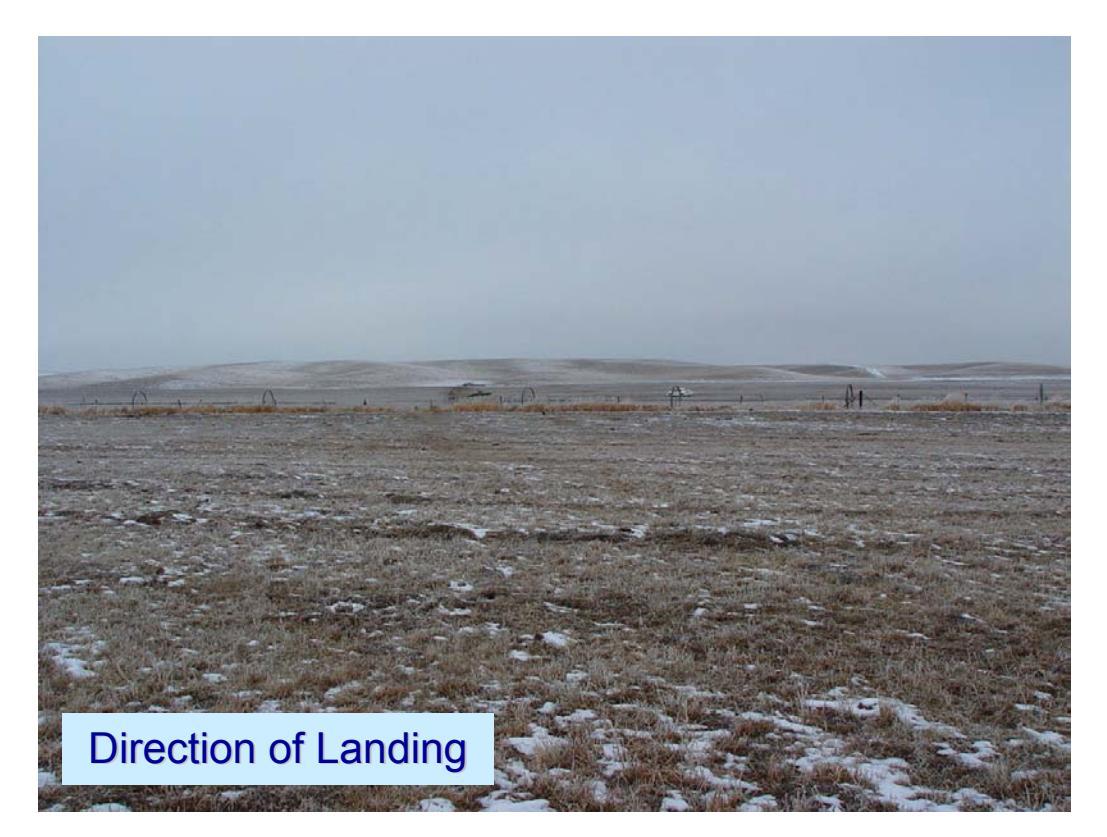
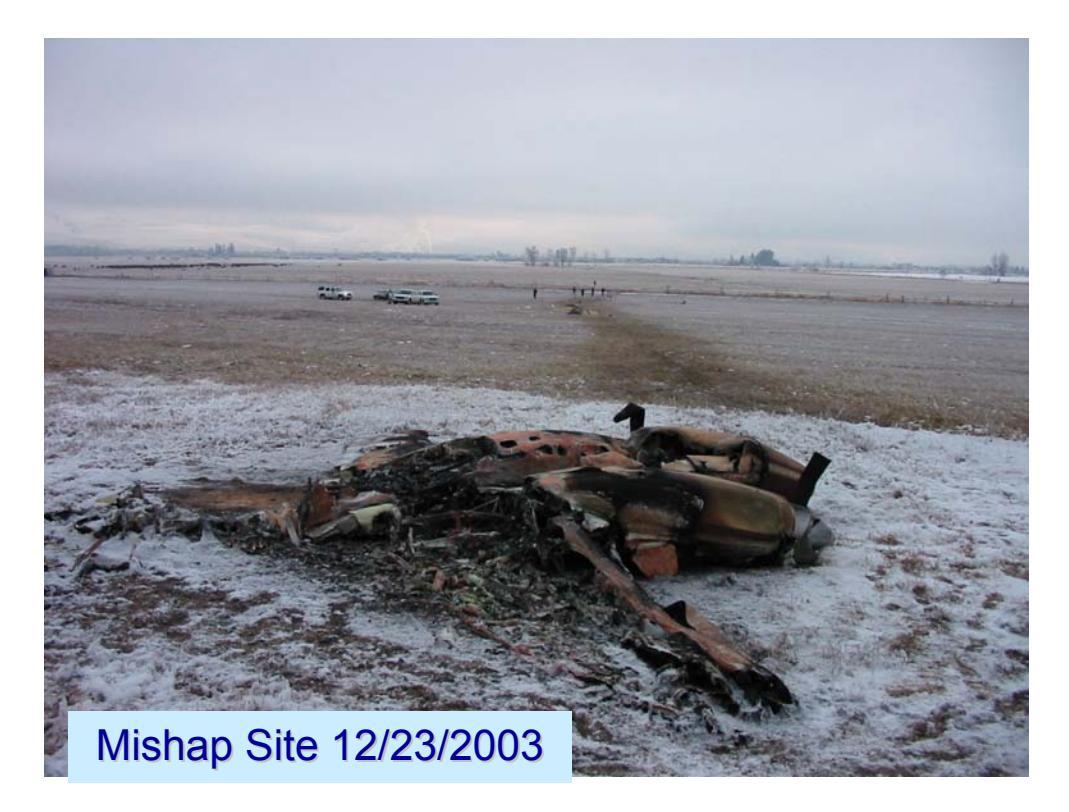
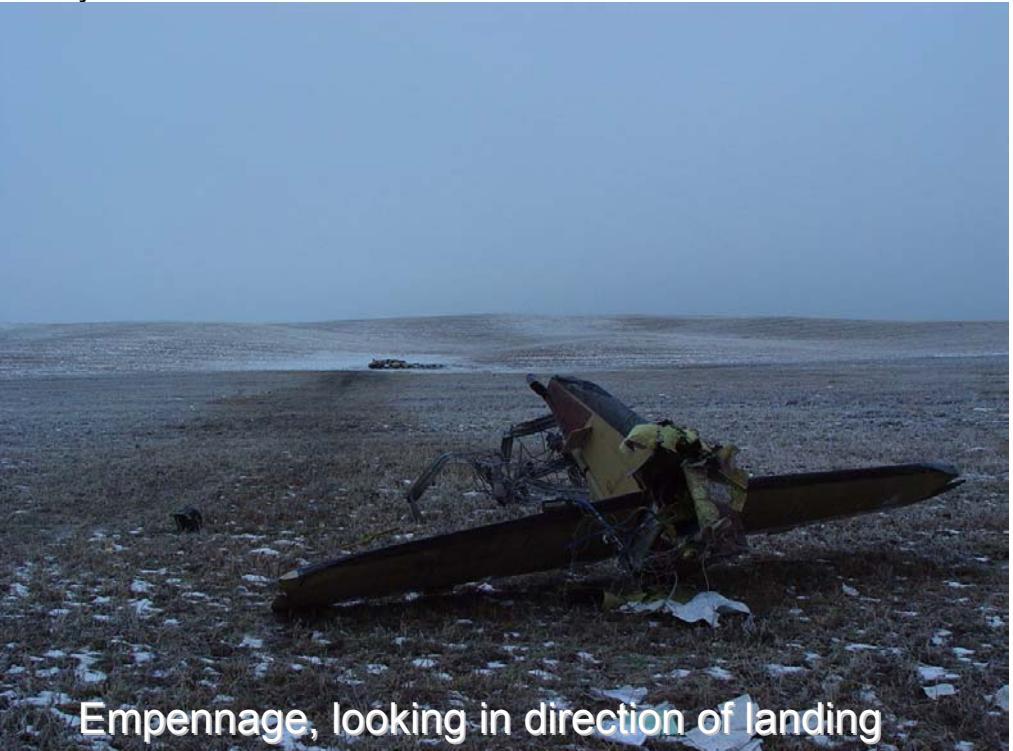
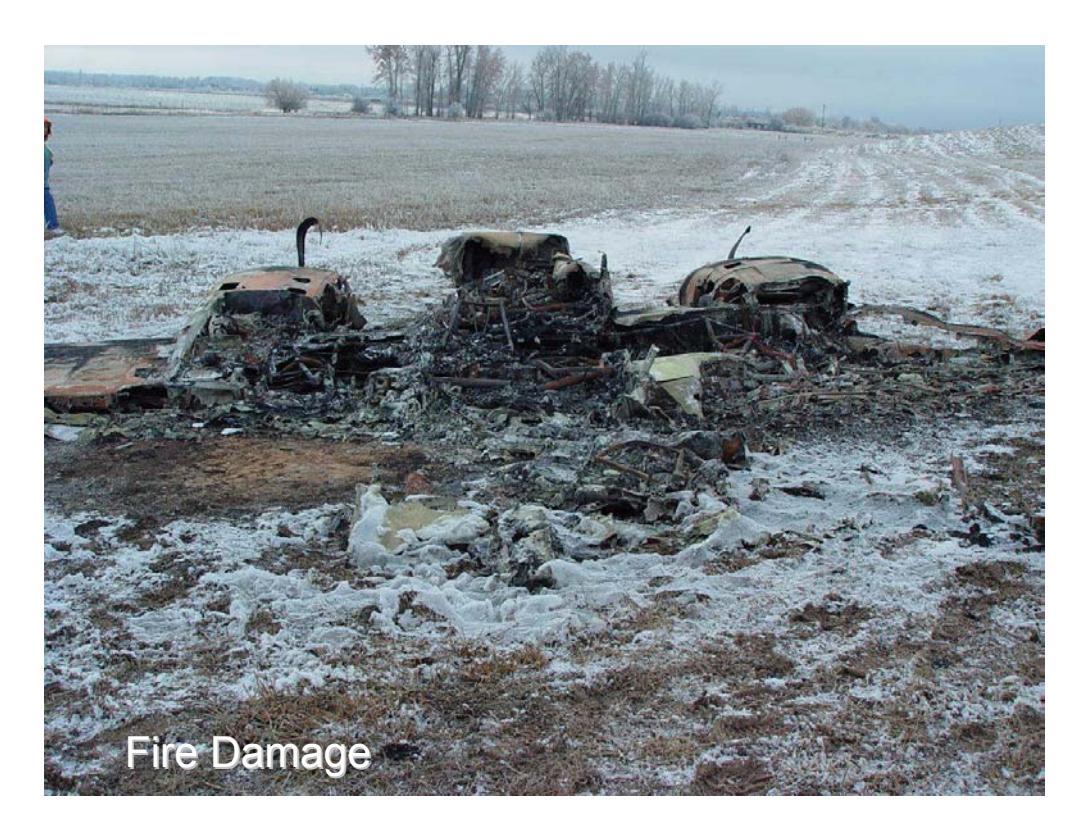
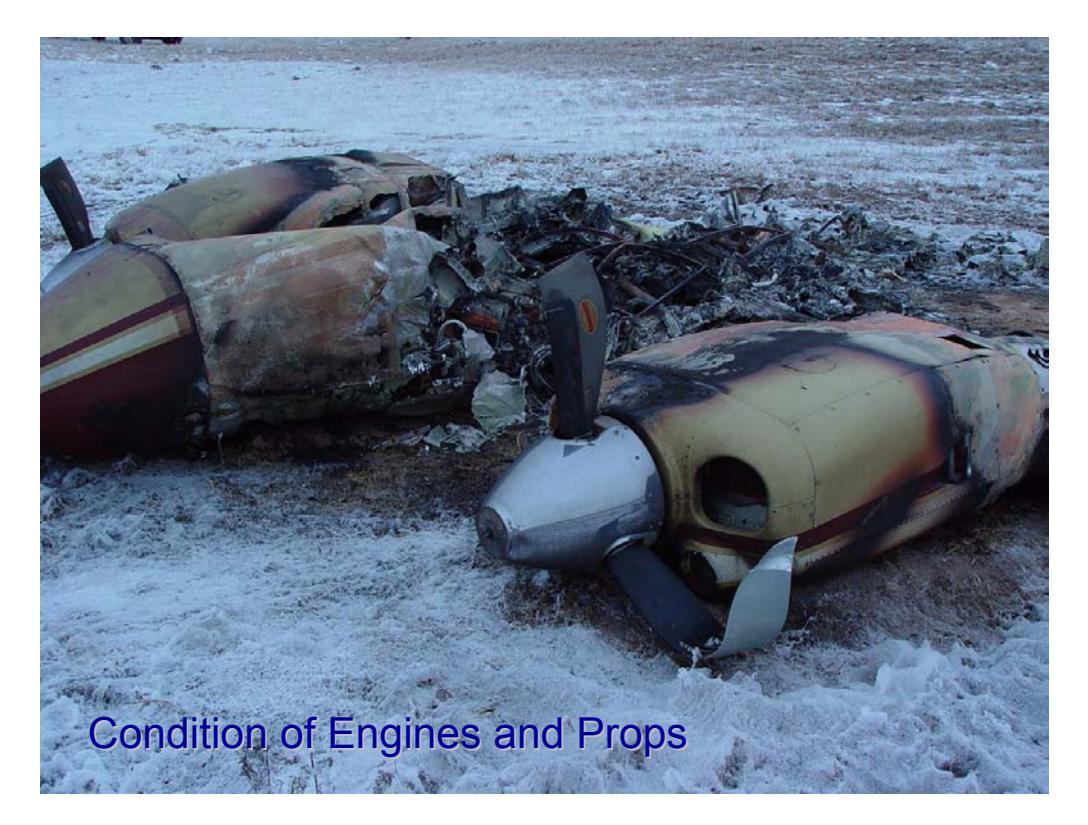
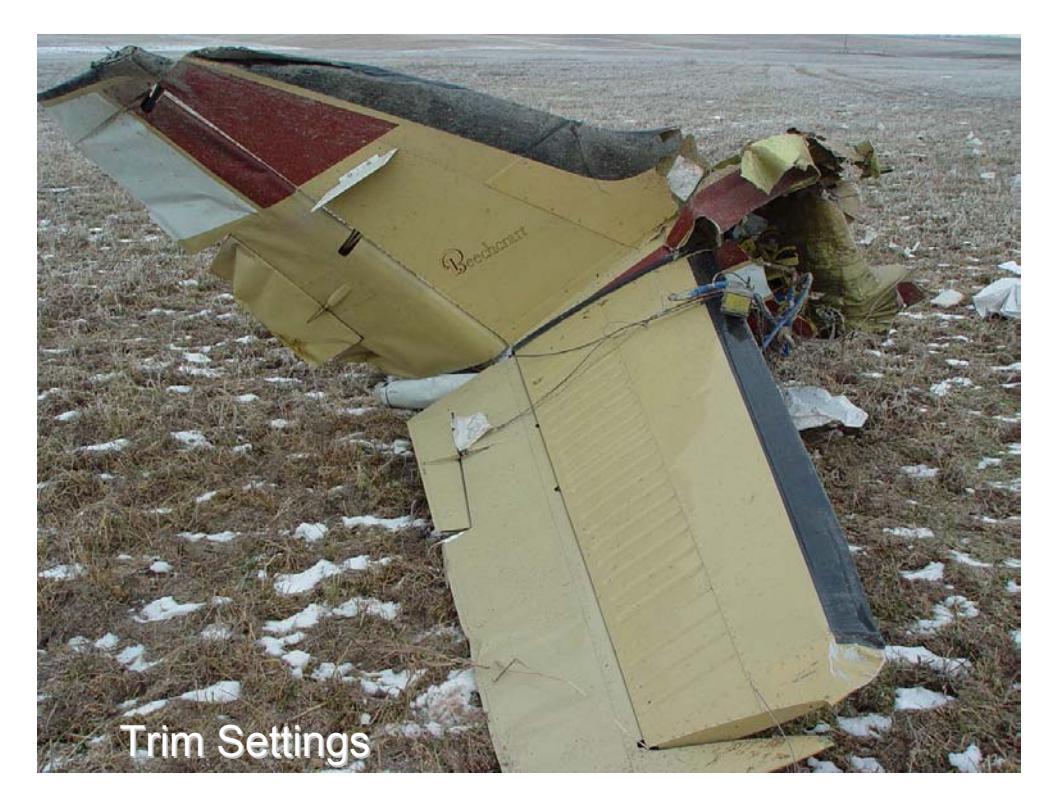
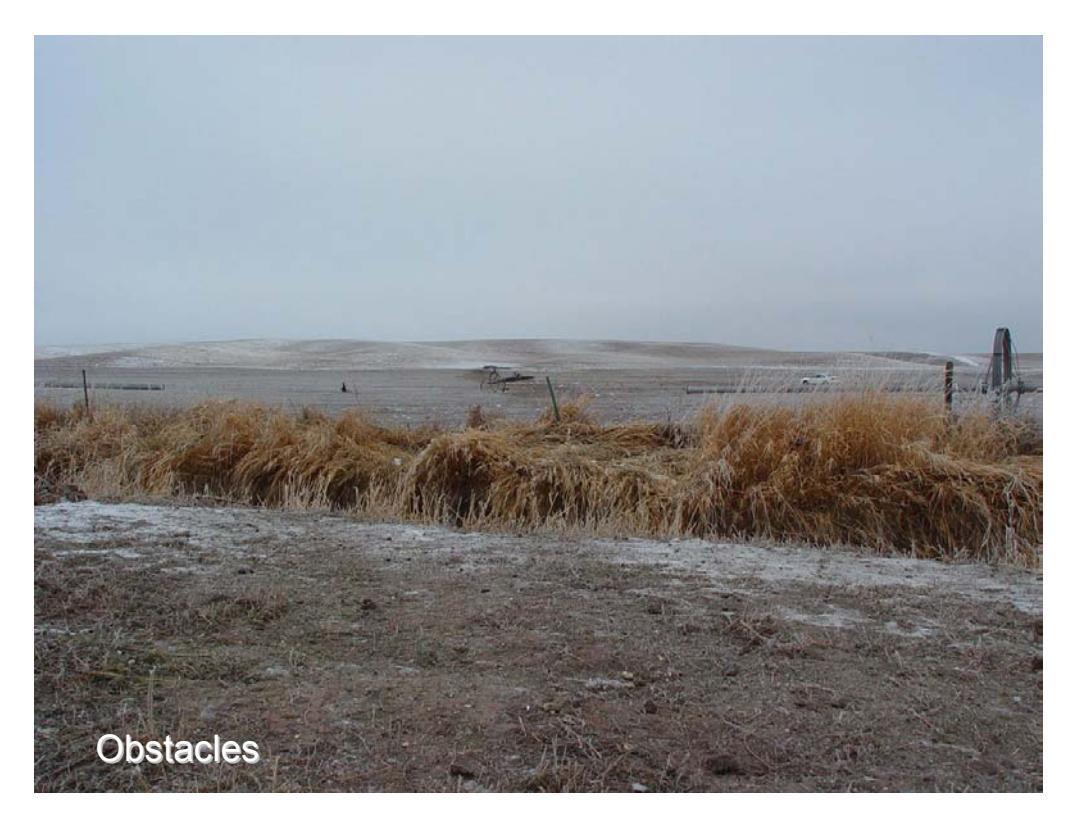
Region 6, Regional Air Group NTSB Identification: <u>SEA04LA029</u>. Accident occurred Monday, December 22, 2003 in Missoula, MT Aircraft: Beech 58P, registration: N181AM Injuries: 1 Minor, 1 Uninjured.

During the turn, a "thump" was felt and the right bank angle increased from about 25 degrees to 45 degrees. While the second pilot was attempting to correct from the increased bank angle, the aircraft at some point, entered a descent.

Just before ground impact to open terrain about one mile south of the runway, the pilot-in-command took control of the aircraft to level the wings.

The aircraft skipped across the open terrain for several hundred yards before coming to rest on its belly. The aircraft was consumed by fire shortly thereafter.

Neither pilot could explain the loss of altitude as both believed they were in a continuous climb during the event as airspeed and pitch attitude remained constant. Neither pilot could recall if they scanned the vertical speed indicator or altimeter to verify if they were indicating a climb or descent.

During the post accident inspection of the aircraft, no evidence of a mechanical failure or malfunction was found and no evidence of an in flight collision with an object was noted. At the time of the accident, low freezing fog and visibility was reported.

NTSB Probable Cause: The second pilot's failure to maintain terrain clearance while maneuvering after takeoff. Proper climb rate not verified by the flight crew, fog, freezing fog, dark night conditions and inadequate supervision by the pilot-in-command were factors.

- Perform a review of R6 standards and practices for pilot training to ensure adequacy, compliance with national standards (where applicable), and implementation. Correct identified deficiencies.

- Rewrite policy in FSH 5709.16 to establish IFR takeoff minimums for visibility, ceiling, icing conditions, and safe return to the airport of departure in case of emergency.

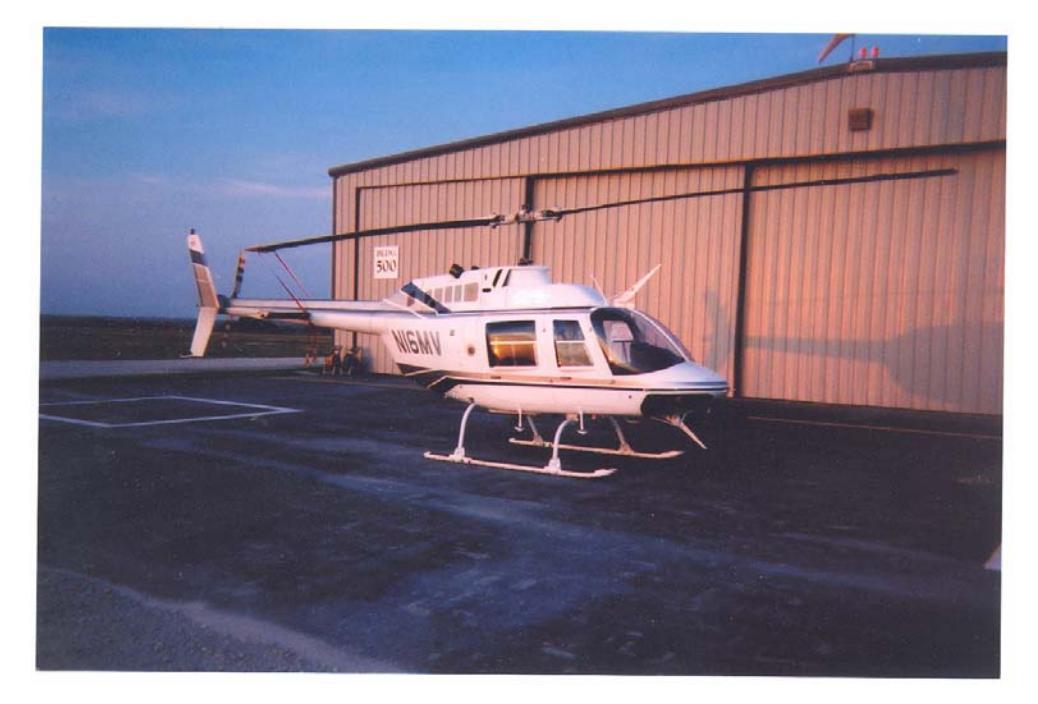
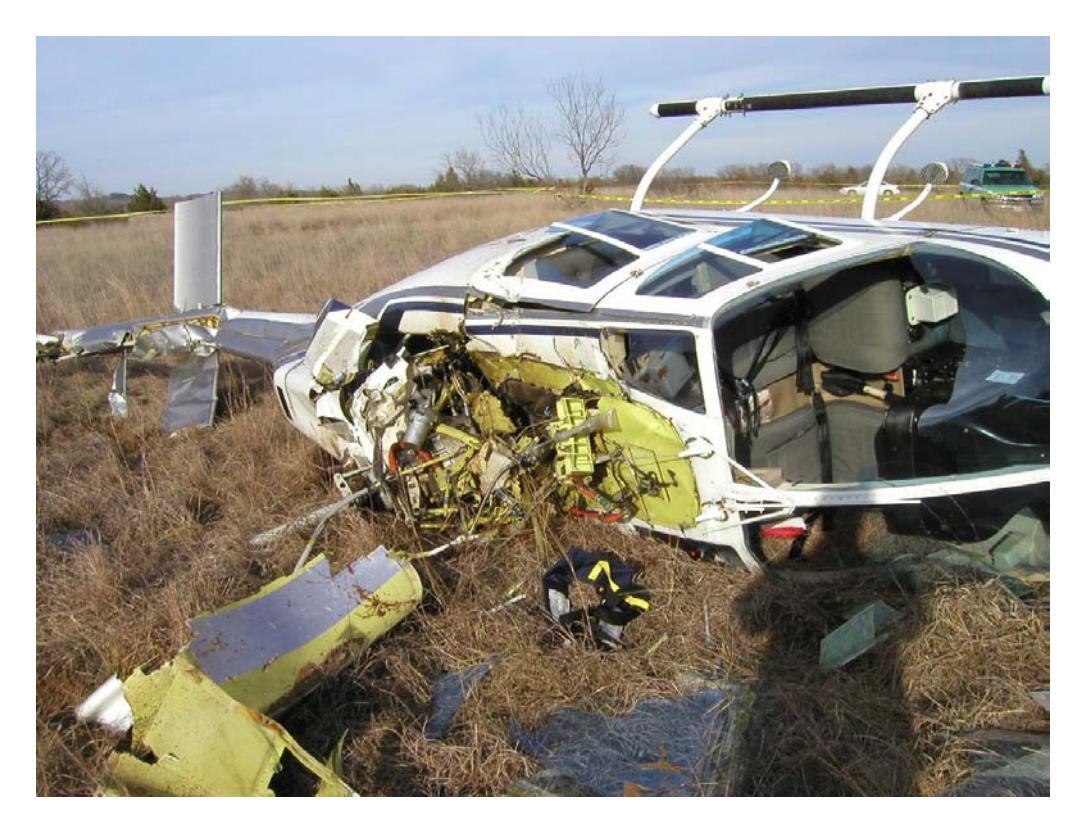
Region 8, LBJ National Grasslands NTSB Identification: <u>FTW04TA075</u>. Accident occurred Wednesday, February 18, 2004 in Decatur, TX Aircraft: Bell 206B, registration: N16MV Injuries: 1 Minor.

During lift off from soft uneven terrain, the rear portion of the helicopter's right main skid came in contact with the ground resulting in a dynamic rollover. The pilot reported that the terrain he departed from was "clumpy and lumpy with ruts of grass approximately 1 to 2 feet in height."

As he started to lift the helicopter off the ground, he made a slow ascent rate. When the skids were about 1 foot above the ground, he said, "the helicopter stopped for a split second as if something had caught some portion of the right side of the helicopter and the helicopter began a slight lateral roll to the right."

The pilot further reported that he recognized the problem too late as he applied full left cyclic and lowered the collective after the helicopter exceeded the critical angle of bank into the low skid to a point where the situation was unrecoverable, and it rolled 90 degrees to the right.

No mechanical deficiencies with the engine or airframe were noted

NTSB Probable Cause: The pilot's failure to maintain control of the helicopter during liftoff after encountering dynamic rollover. A contributing factor was the rough and uneven terrain.

- The agency should establish minimum Training, evaluation and certification for entry-level helicopter pilots performing aviation natural resource missions including external load missions
- The agency should re-assess the role of and need for a Marshaller/Parking Tender under the various missions. (This recommendation is currently being addressed by the agency, and is expected to be finalized in 2005)
- With a significant number of dynamic rollover events occurring on flatland terrain, we recommend the Agency review the data for dynamic rollover events, determine if there is a cause and effect situation, and recommend actions be taken as needed.

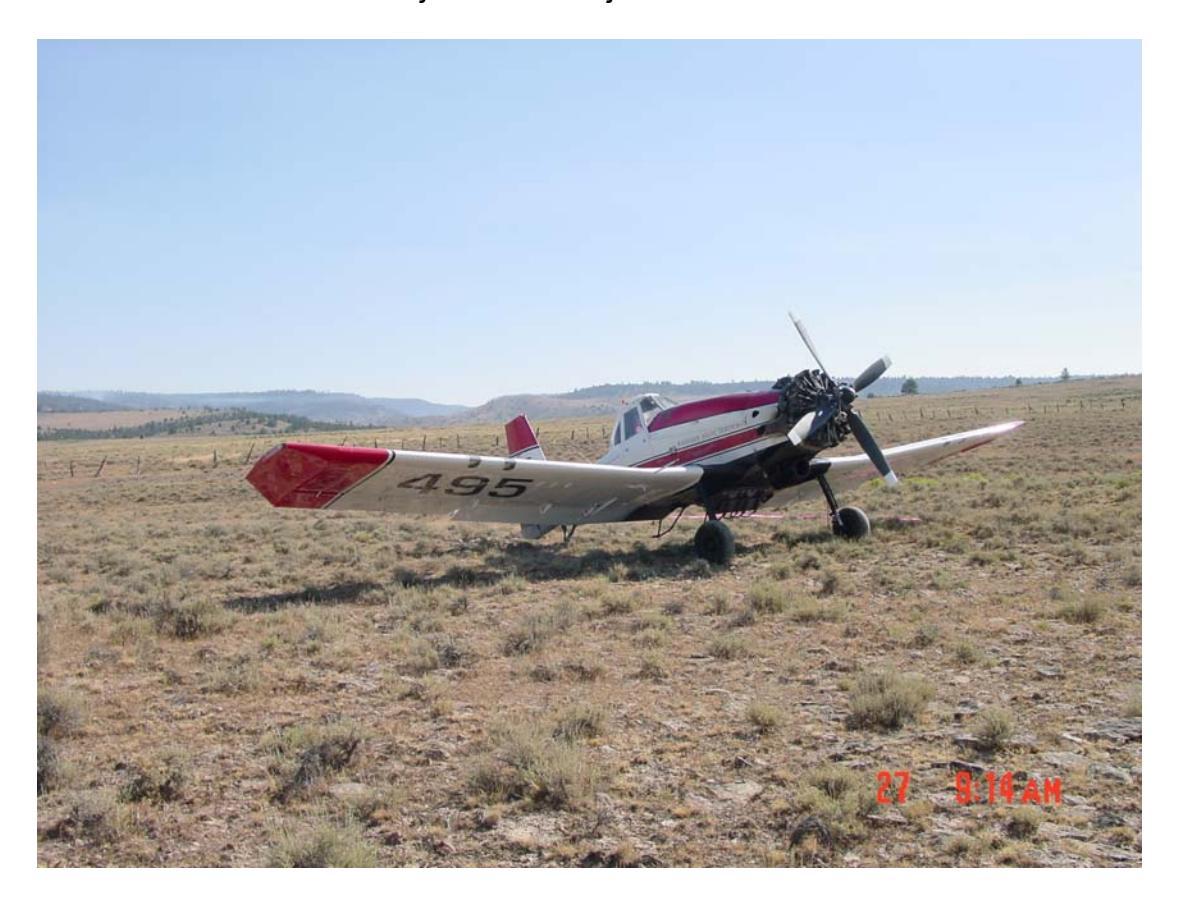
Region 6, Malheur National Forest NTSB Identification: <u>SEA04TA147</u>. Accident occurred Monday, July 26, 2004 in Burns, OR Aircraft: WSK PZL Mielec M-18A, registration: N495WP Injuries: 1 Uninjured.

The pilot was attempting to climb following a fire retardant drop. When he moved the throttle forward, the engine did not respond. The airplane started loosing altitude, and the pilot performed a forced landing to an open plateau. During the landing, the throttle would not retard all the way.

In order to land the airplane, the pilot turned the fuel selector to the off position. During the landing roll, the left wing impacted a fence pole bending ribs and wrinkling the aileron. Post accident examination revealed that the bolt normally connecting the throttle linkage clevis to the throttle arm was missing.

- > Re-inspect aircraft operated by vendor.
- Establish contractual requirements for maintenance of SEAT aircraft equivalent to other interagency fire aircraft.
- Conduct a risk analysis and develop mitigation measures for Forest Service use of SEAT's.
- Establish an interagency working group to conduct an operational analysis of SEAT's and develop use standards.
- Establish policy based on the risk and operational uses analyses.

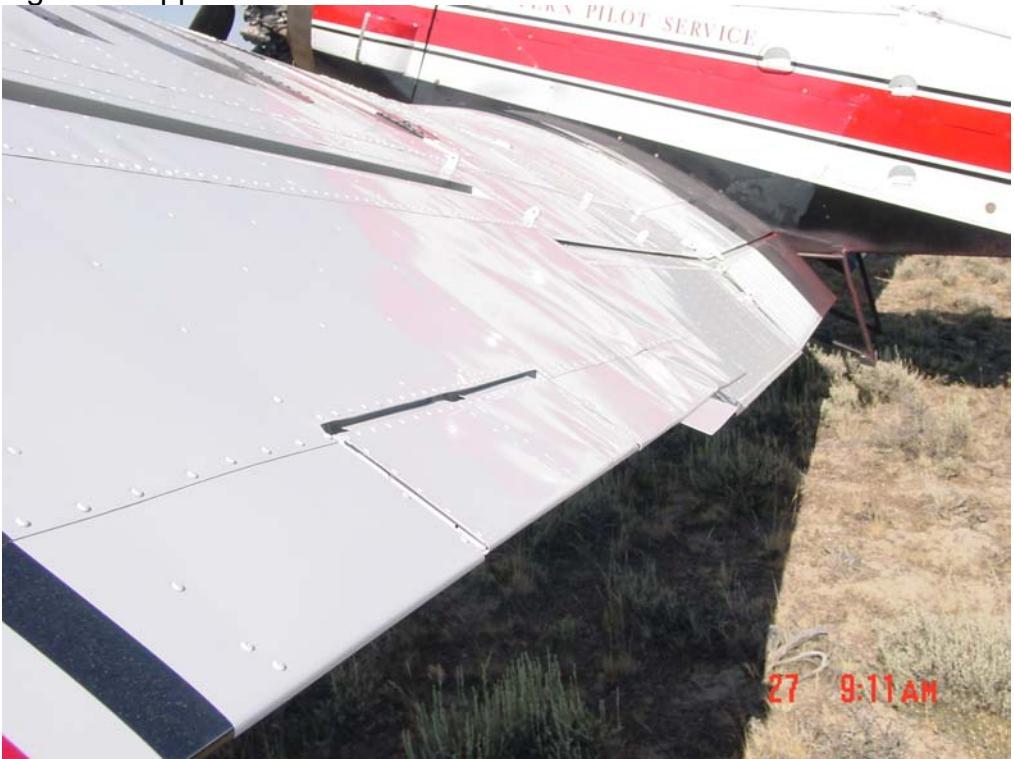
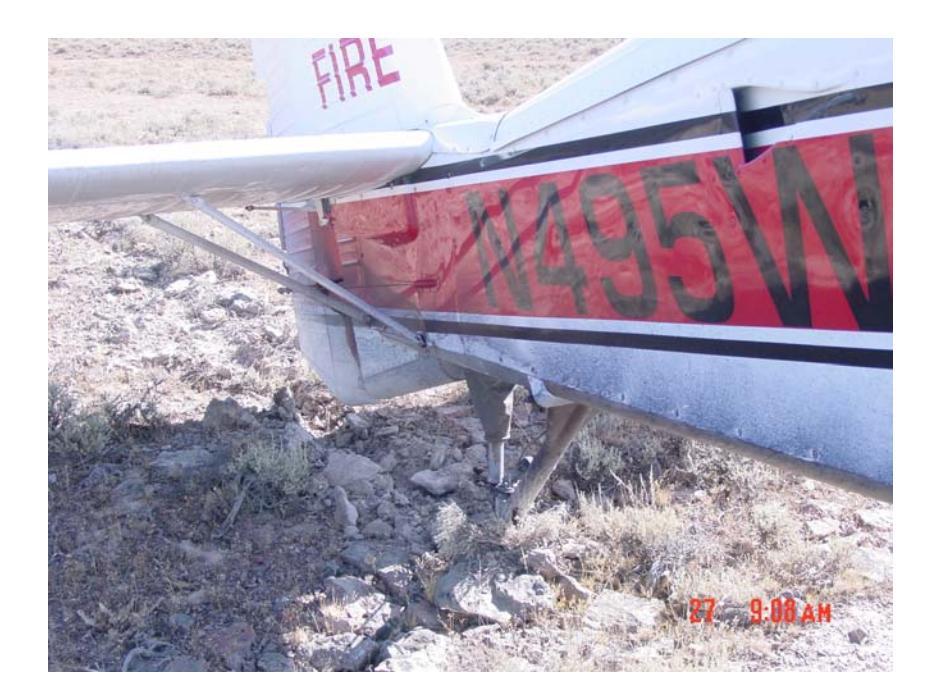
The industry standard, found in FAA Advisory Circular AC43.13-1B, chapter 7, section 4, paragraph 7-64, states that nylon locking nuts should not be used with rotating components or assemblies. It further states that nylon and/or fiber nuts are highly susceptible to wear from repetitive use and from high heat applications.

NTSB Probable Cause: The improper installation of the throttle linkage clevis to the throttle control arm by unknown maintenance personnel. Contributing factors were the nylon lock nut separating from its' bolt, which permitted the throttle cable to disconnect from the throttle control arm, and the fence post.

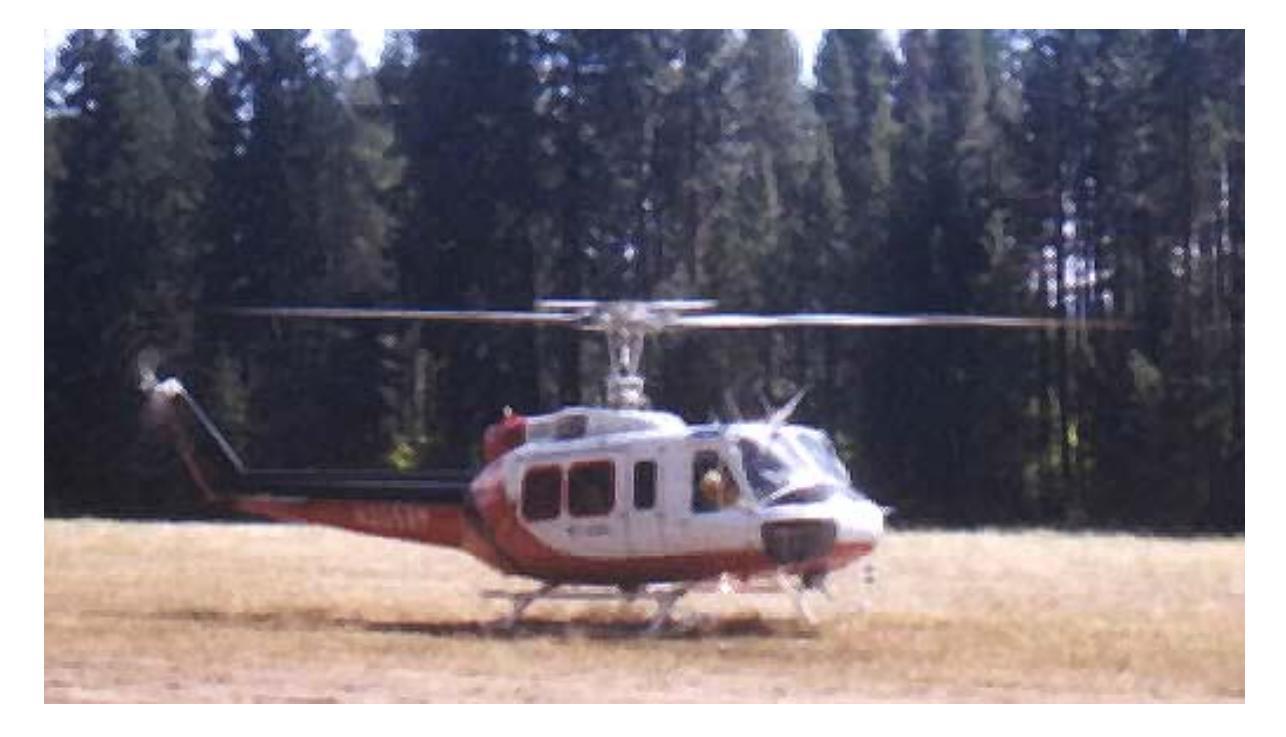
Region 6, Okanogan & Wenatchee National Forests NTSB Identification: <u>SEA04TA158</u> Accident occurred Wednesday, August 11, 2004 in Leavenworth, WA Aircraft: Bell 205A1, registration: N205XP Injuries: 1 Fatal.

The helicopter was destroyed and the pilot was fatally injured when it impacted heavily wooded, mountainous terrain. Prior to the impact, the helicopter's tail rotor struck a tree and aircraft control was lost while maneuvering to deliver an external load.

- Revise the IHOG Longline Procedures and Forest Service Operations and Safety Procedures Guide for Helicopter Pilots to state: In areas of sloping terrain or with obstacles rising to one or more sides of the cargo pickup/delivery area, or dip site, pilot shall maintain rotor clearance from all obstacles equivalent to the IHOG Chart 8-1 landing area safety circle requirements. When specified clearance cannot be maintained, the mission shall be declined by the pilot until hazards are removed, additional line can be added or a better location can be identified.

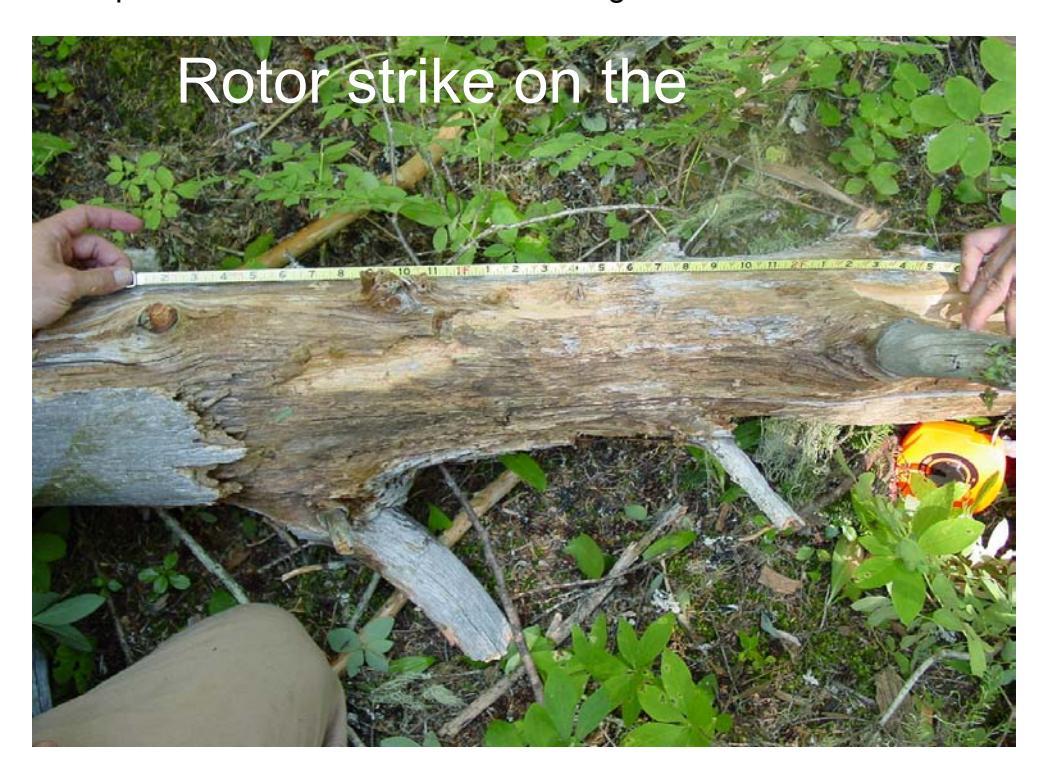
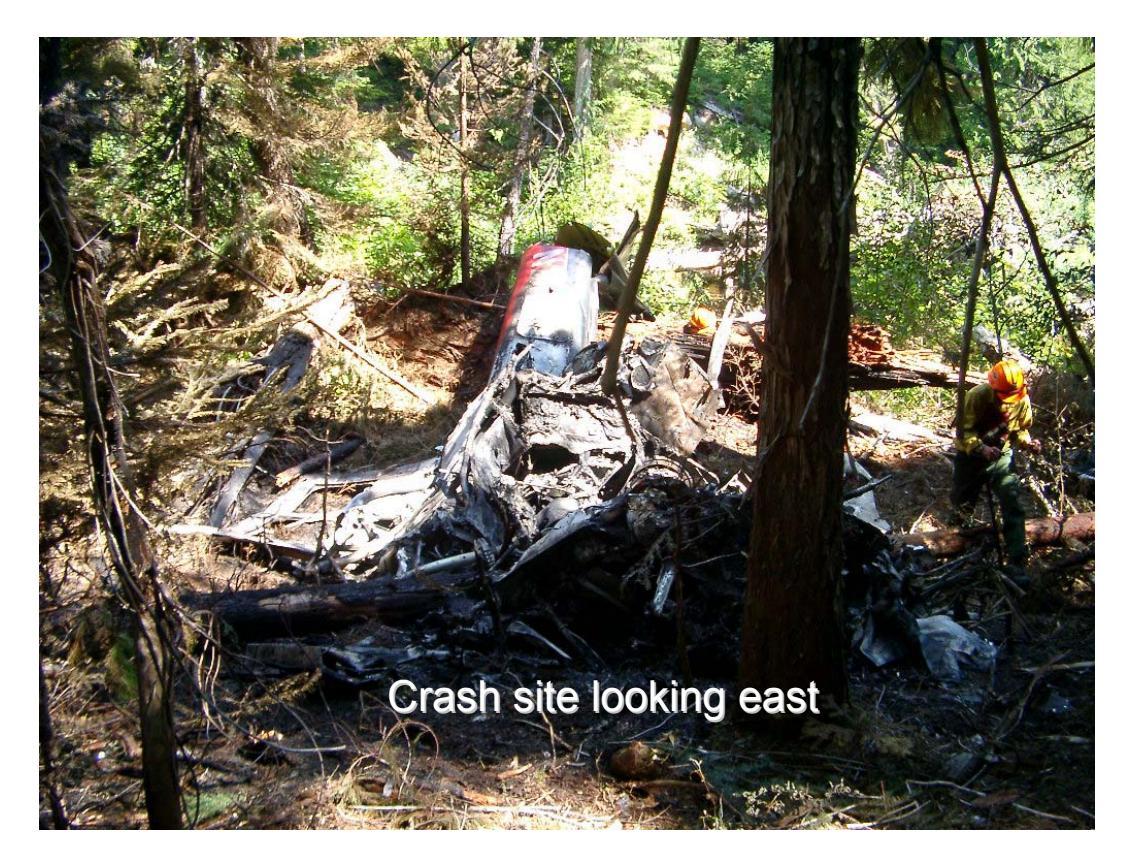
The helicopter then started to ascend, and at that time, the helicopter's tail rotor contacted a dead snag. When the tail rotor contacted the snag, the helicopter was about 150 feet above the ground.

The helicopter began to spin, the main rotor blades struck other trees, and the helicopter fell to the ground.

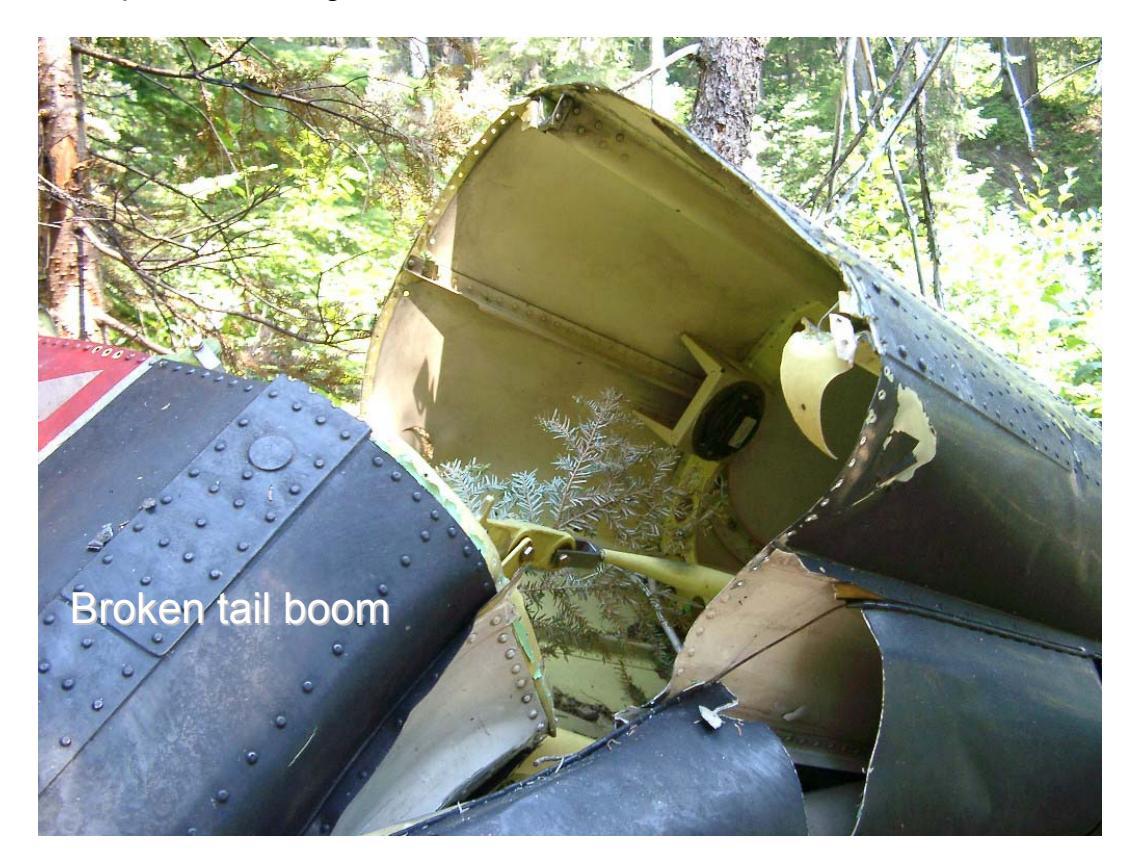
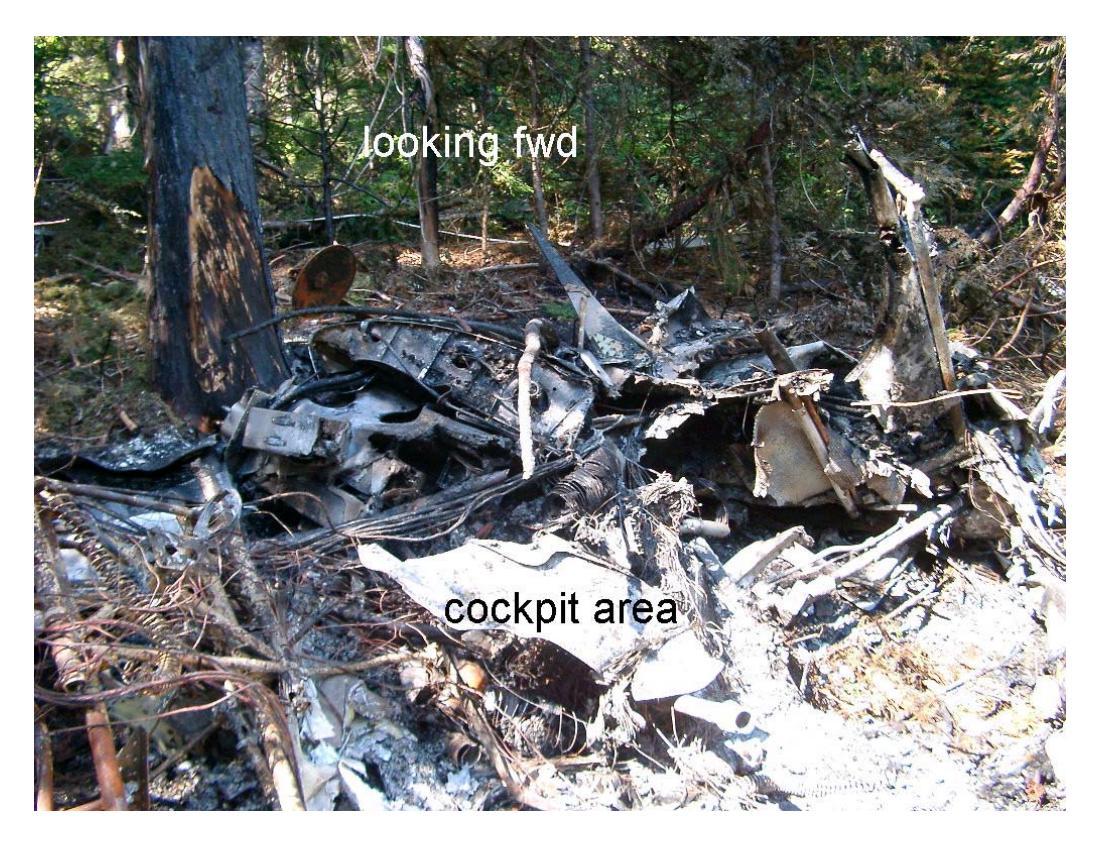
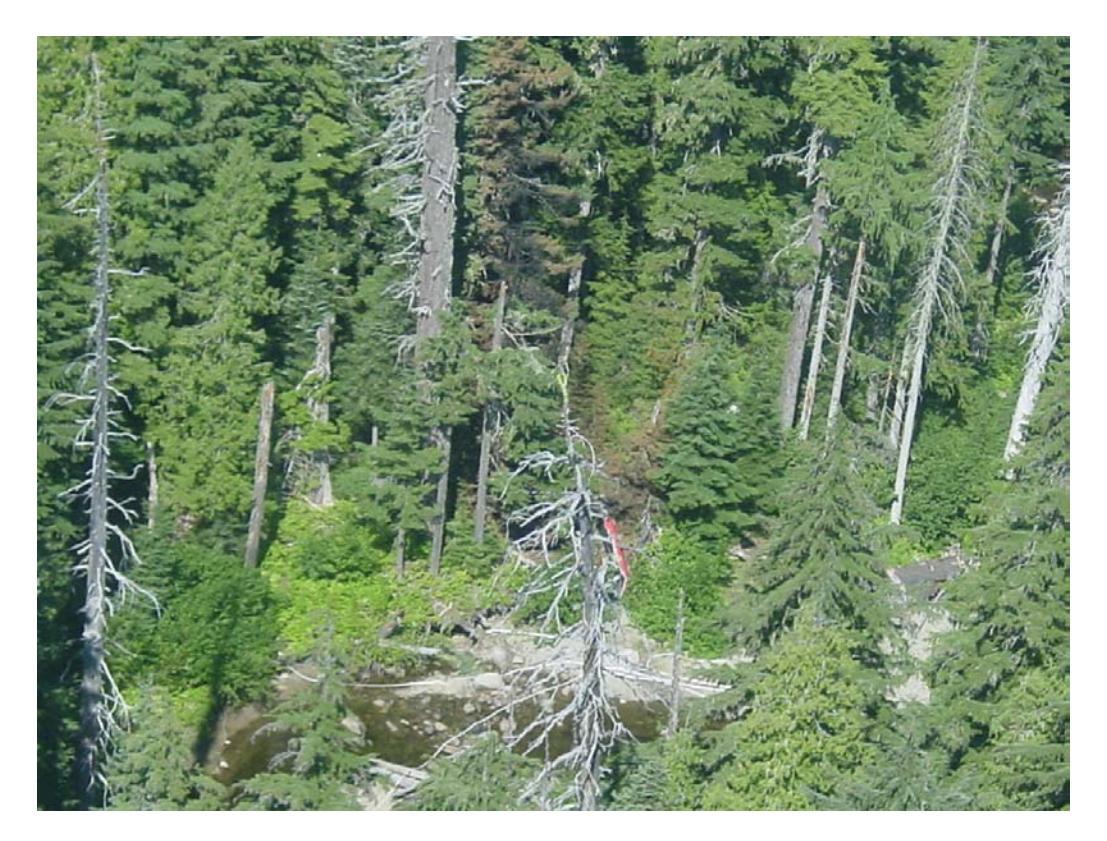
A post-crash fire erupted, which consumed the fuselage of the helicopter.

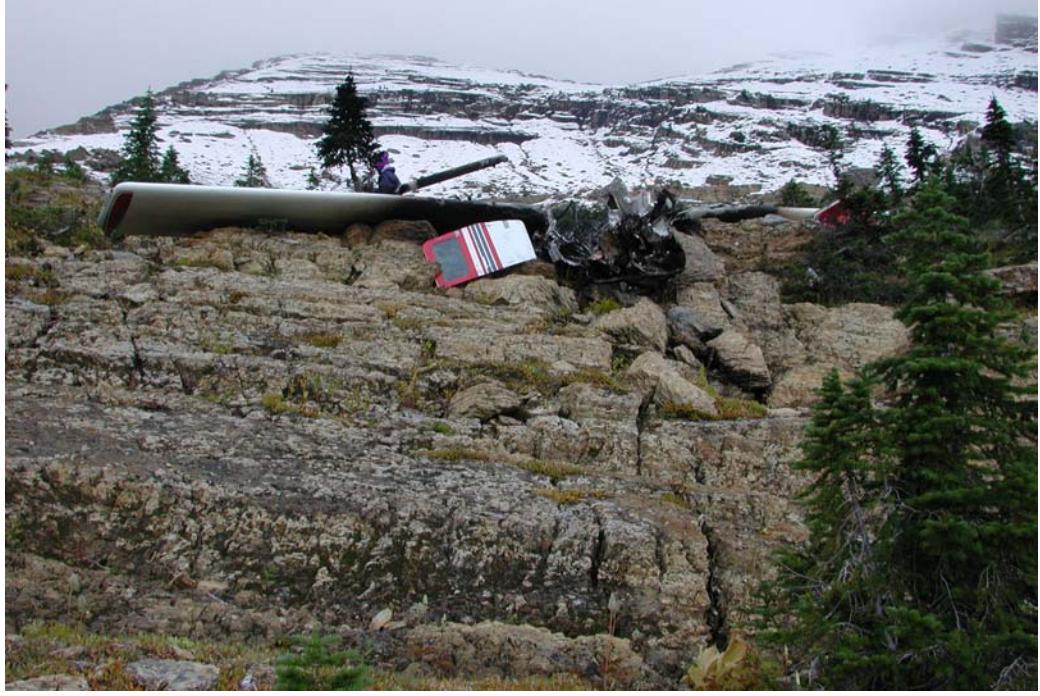
The right cargo door located on left side of wreckage

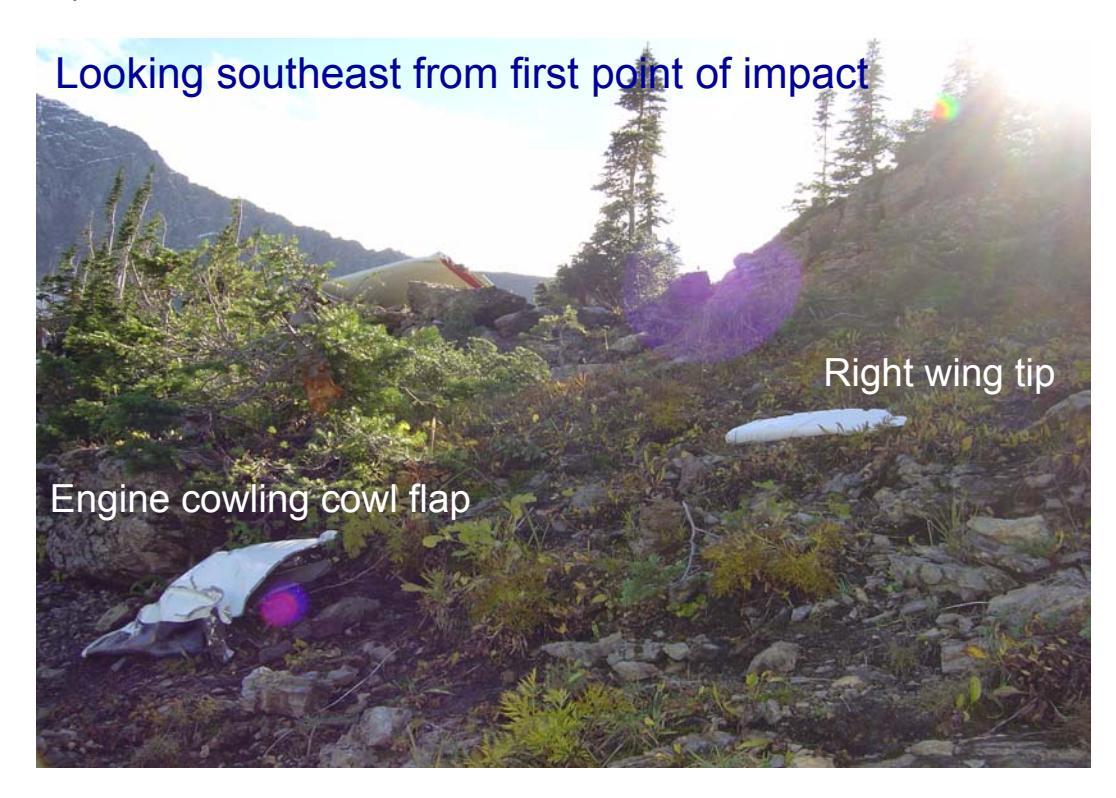
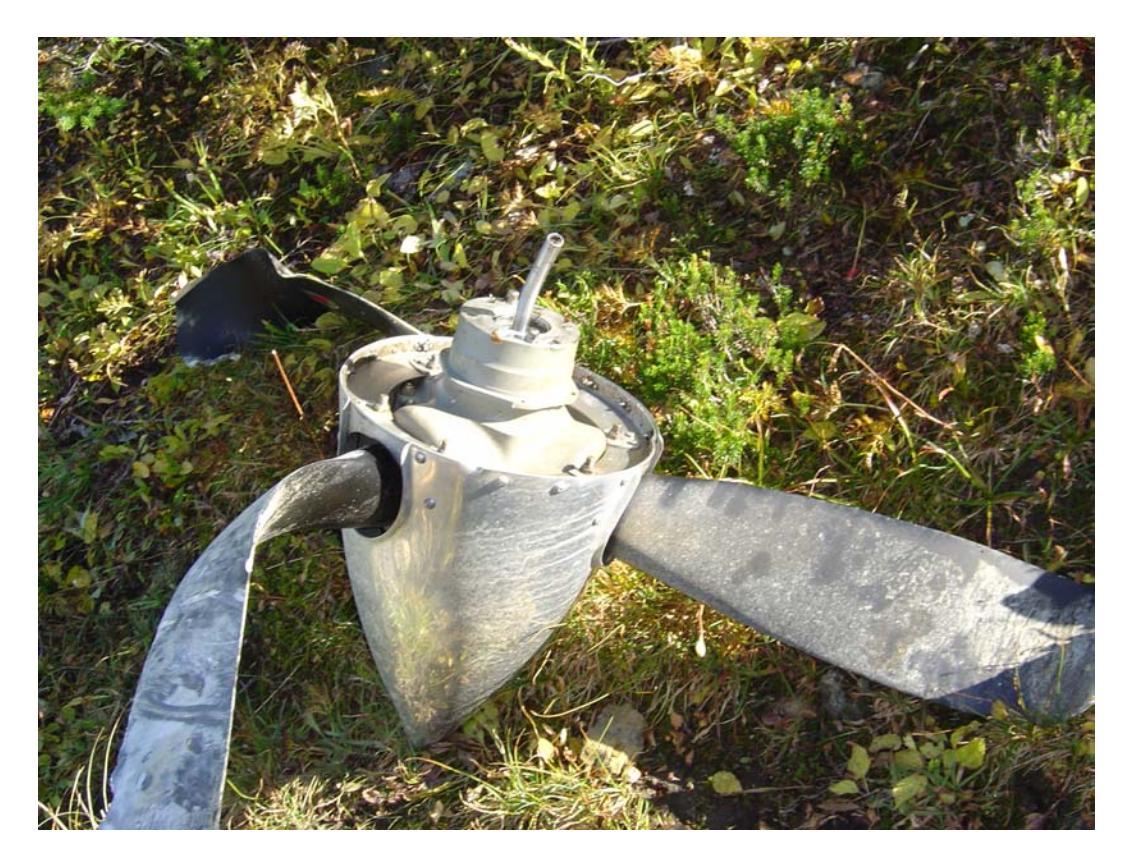
The airplane impacted rugged mountainous terrain near the head of the Tunnel Creek drainage of the Flathead Range at a Global Positioning System (GPS) location of 48 degrees 19.011 minutes North, 113 degrees 44.166 minutes West, and an elevation of 6,604 feet. The airplane came to rest in a sparsely wooded, rocky area on an upslope of 30 to 45 degrees. All major components of the airplane were accounted for in the main wreckage area. The debris path measured approximately 80 feet in length along a magnetic bearing of 165 degrees.

The fuselage with both wings attached came to rest inverted, and the empennage, which remained attached to the fuselage by control cables came to rest upright. The engine had separated from the firewall, and the propeller had separated from the engine crankshaft. All flight controls remained attached to their respective attach points, and control continuity was verified from the control surfaces to the cockpit controls. The cockpit, cabin and the inboard sections of both wings were destroyed by fire. All three propeller blades were bent and twisted, the blade tips were broken off, and the blade leading edges were gouged and scraped.
