# Guidelines for Detection, Analysis, and Treatment of Materials-Related Distress in Concrete Pavements Volume 3: Case Studies Using the Guidelines

PUBLICATION NO. FHWA-RD-01-165

AUGUST 2002

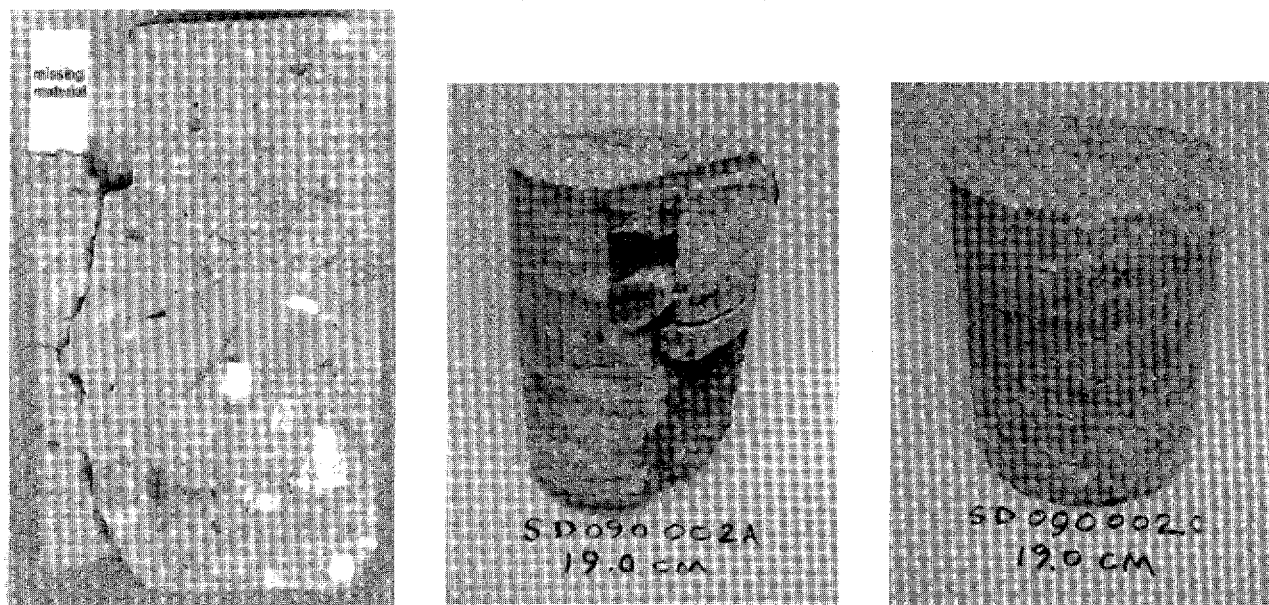
Figure 3-5. Core specimens from SD-090-019.

Based upon the field survey, distress was detected at joints and near slab corners. Photos of typical distresses are shown in figure 3-5. To look at concrete from more than one slab, Cores B and D were selected from Section 001 and Cores A, B, and C were selected from Section 002. All cores were cut to produce slabs for examination with stains.

(a) Section 001, Core B

(b) Section 002, Core A

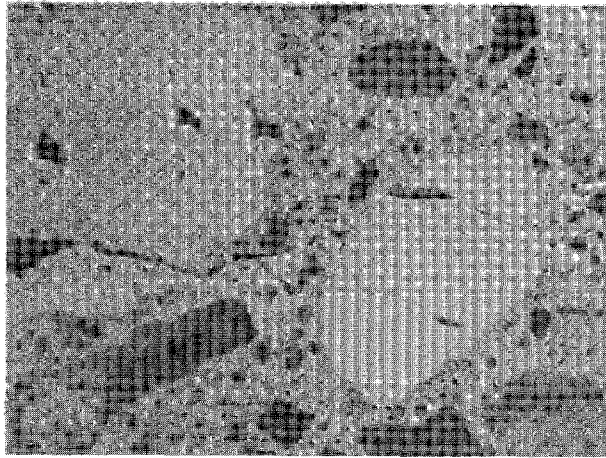
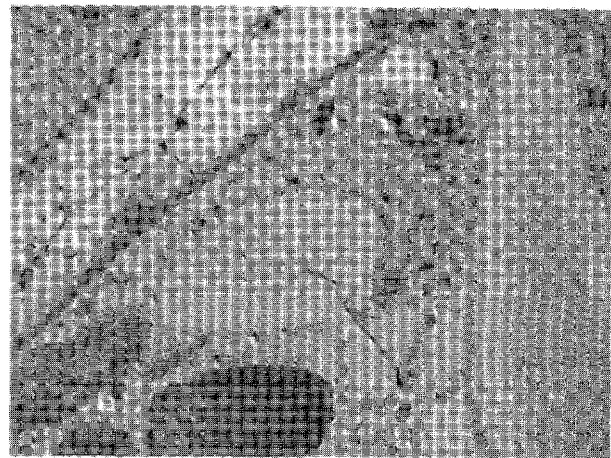
Figure 3-6. Stereo optical micrographs of typical cracking pattern associated with porous siltstone aggregate SD-090-019.

The stereo optical microscope was used to first examine polished slabs cut from each core to assess the general condition of the concrete. Typical micrographs of interesting features are presented in figures 3-6 and 3-7. The aggregate type was determined to be a natural gravel with a varied lithology including limestone, siltstone, dolomite, and rhyolite as the main rock types for the coarse aggregate. Many of the rhyolite particles had small feldspar inclusions. The fine aggregates contained the same rock types seen in the coarse aggregate in addition to shale, sandstone quartzite, and granite. Cracks passing through the paste also passed through aggregates. Reaction rims were visible along with secondary infilling in cracks and air voids. A yellow to white “soft” crumbly siltstone constituent of the coarse aggregate natural gravel is frequently cracked, with the cracks extending into the surrounding cement paste, and occasional white deposits in cracks. Aggregate particles that were volcanics or rhyolites appear to be reactive.

(a) Siltstone aggregate

(b) Siltstone and rhyolite aggregate

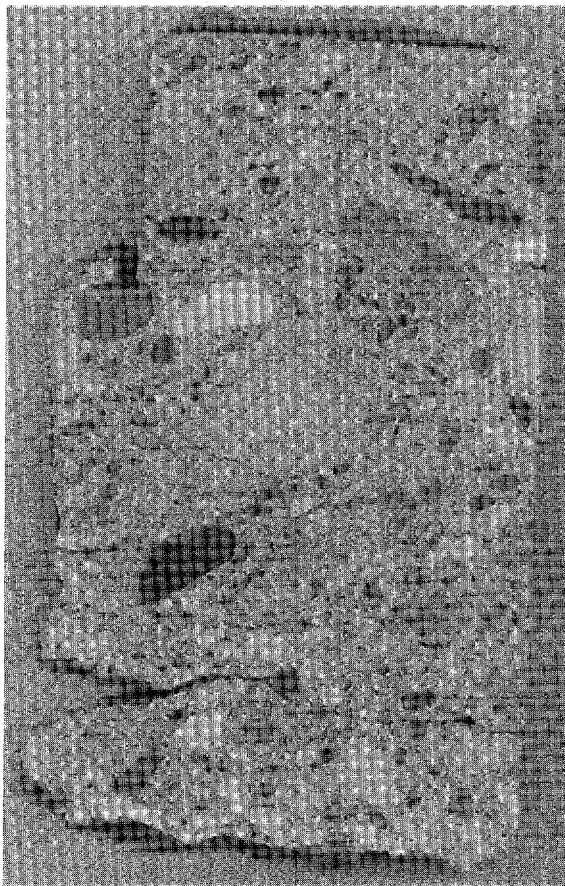
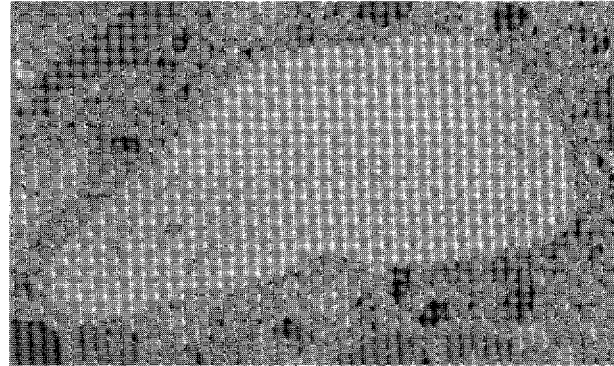
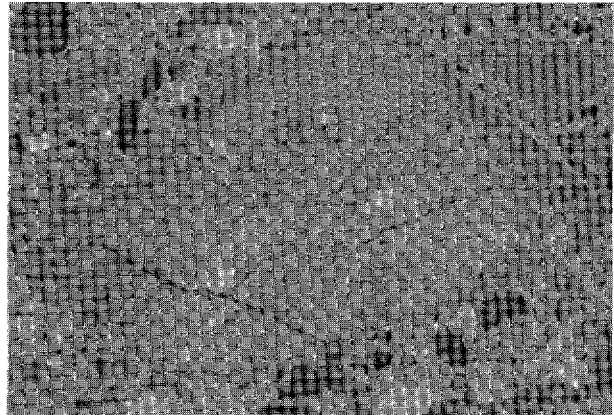
Figure 3-8. Slab 1B stained with sodium cobaltinitrite/rhodamine B from SD-090-019-001.

(a) Stained slab

(b) Stereo optical micrograph of reactive porous siltstone particle

(c) Stereo optical micrograph of reactive volcanic particle

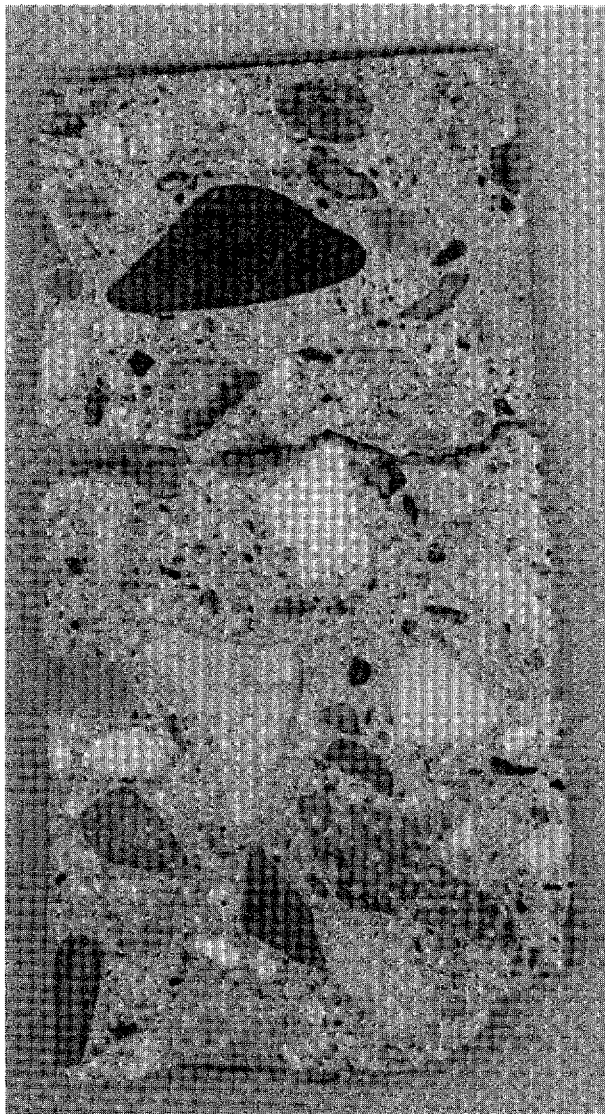
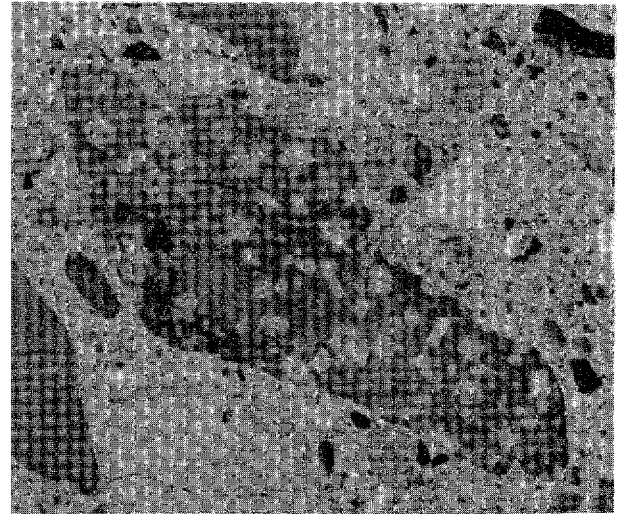
Figure 3-9. Slab 1B stained with sodium cobaltinitrite/rhodamine B from SD-090-019-001.

(a) Stained slab

(b) Stereo optical micrograph of reactive rhyolite particle

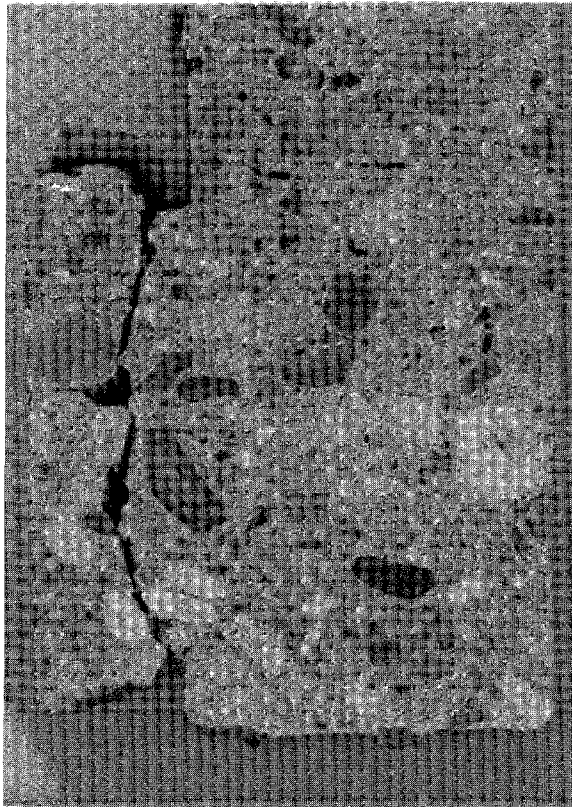
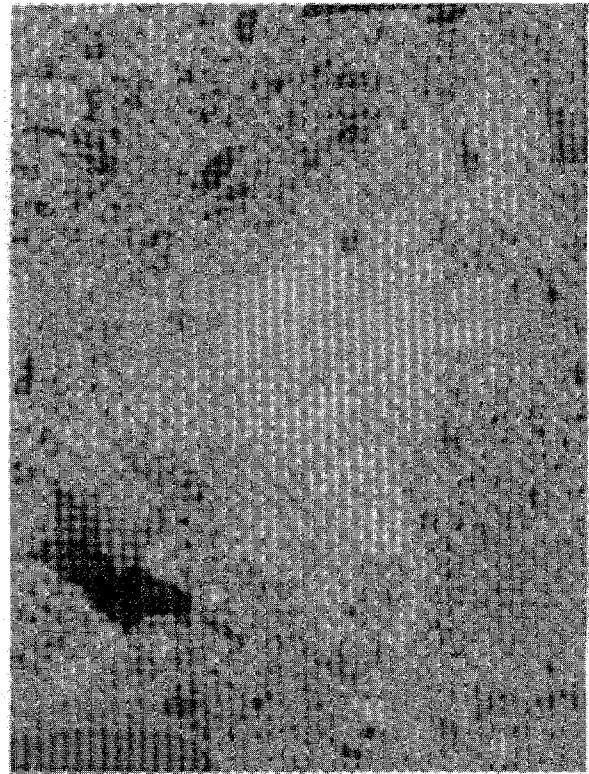
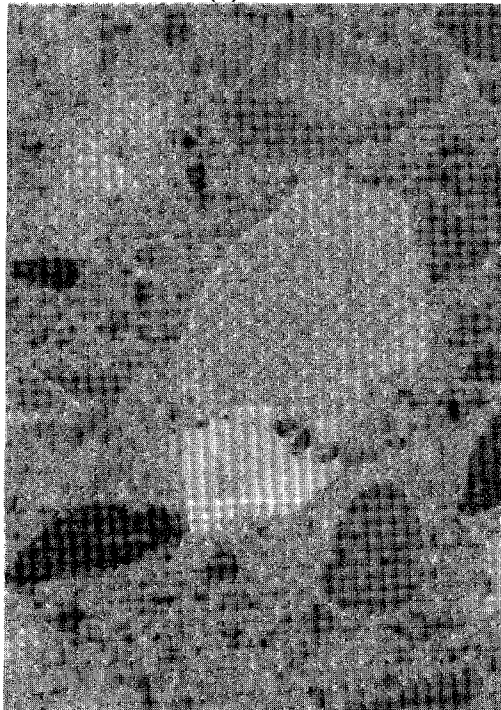
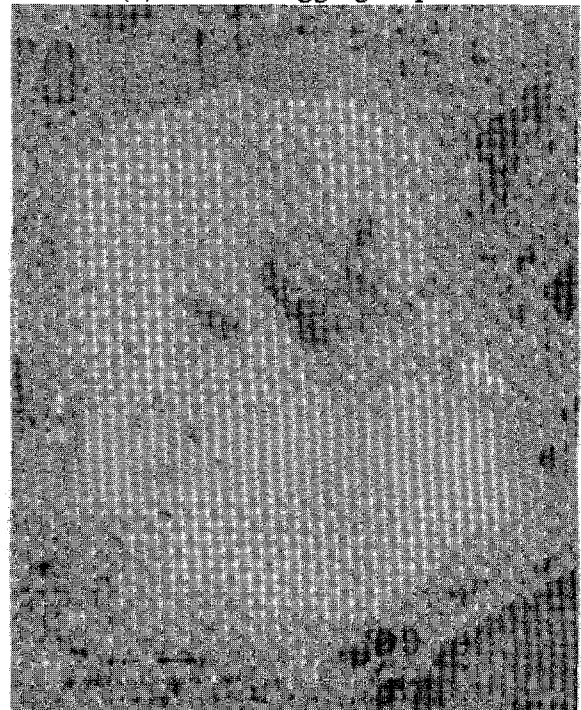
Figure 3-10. Slab 2B stained with sodium cobaltinitrite/rhodamine B from SD-090-019-002.

(a) Stained slab

(b) Reactive aggregate particle

(c) ASR gel filled void

(d) Reactive aggregate particle

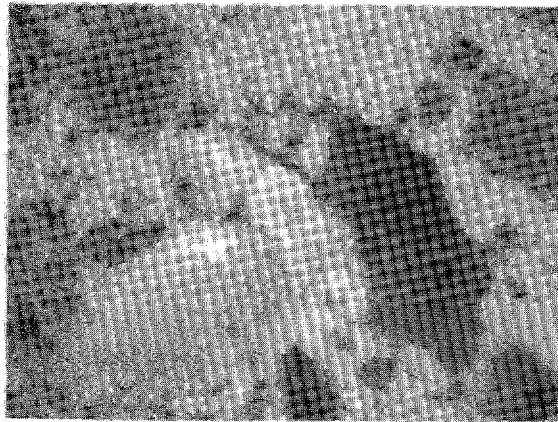
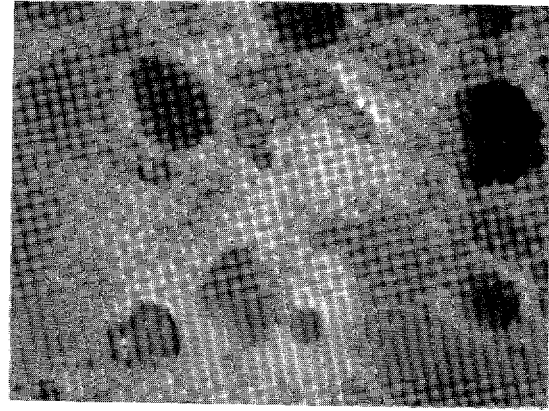
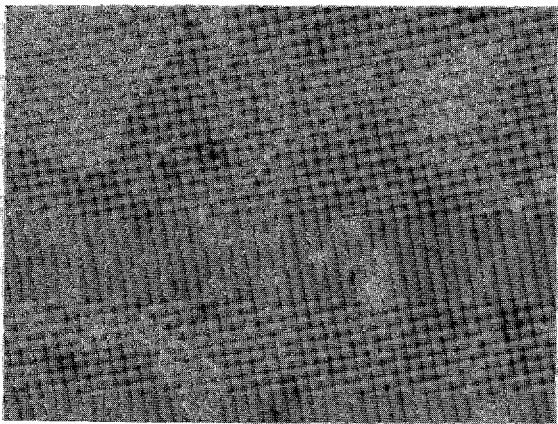
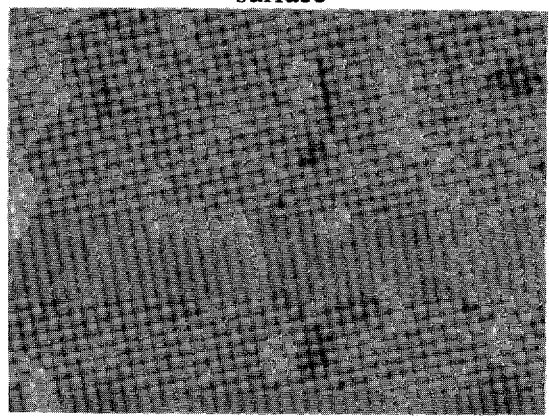
(a) Ettringite filled voids on polished surface

(b) Ettringite filled voids on polished surface

(c) Ettringite filled voids on unpolished surface

(d) Ettringite filled voids on unpolished surface

Figure 3-11. Stereo optical micrographs of air voids filled with sulfate minerals stained with potassium permanganate (note differences due to polishing).

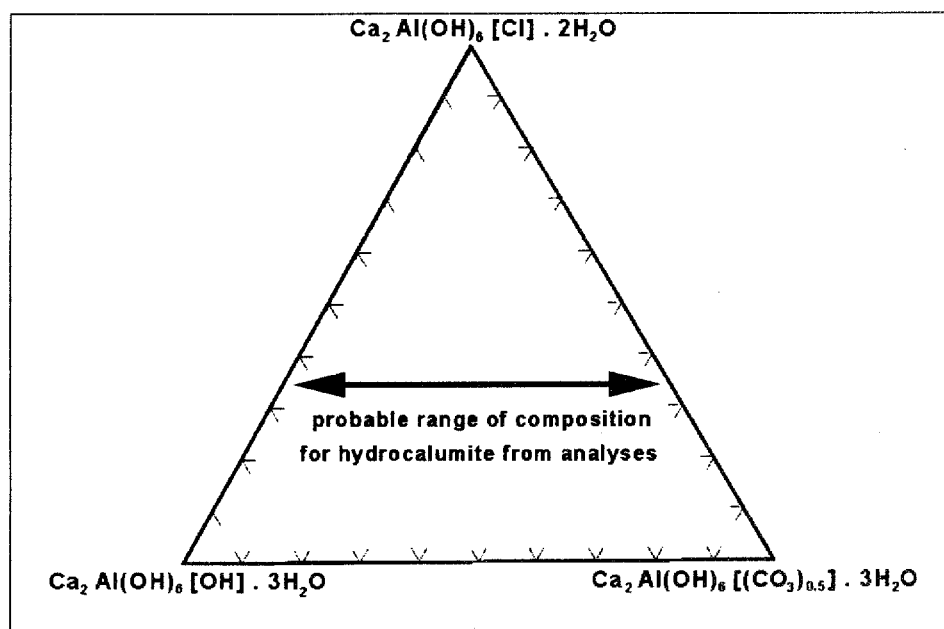
Figure 3-15. Ternary diagram showing the probable range of composition for the hydrocalumite deposits analyzed from SD-090-019.

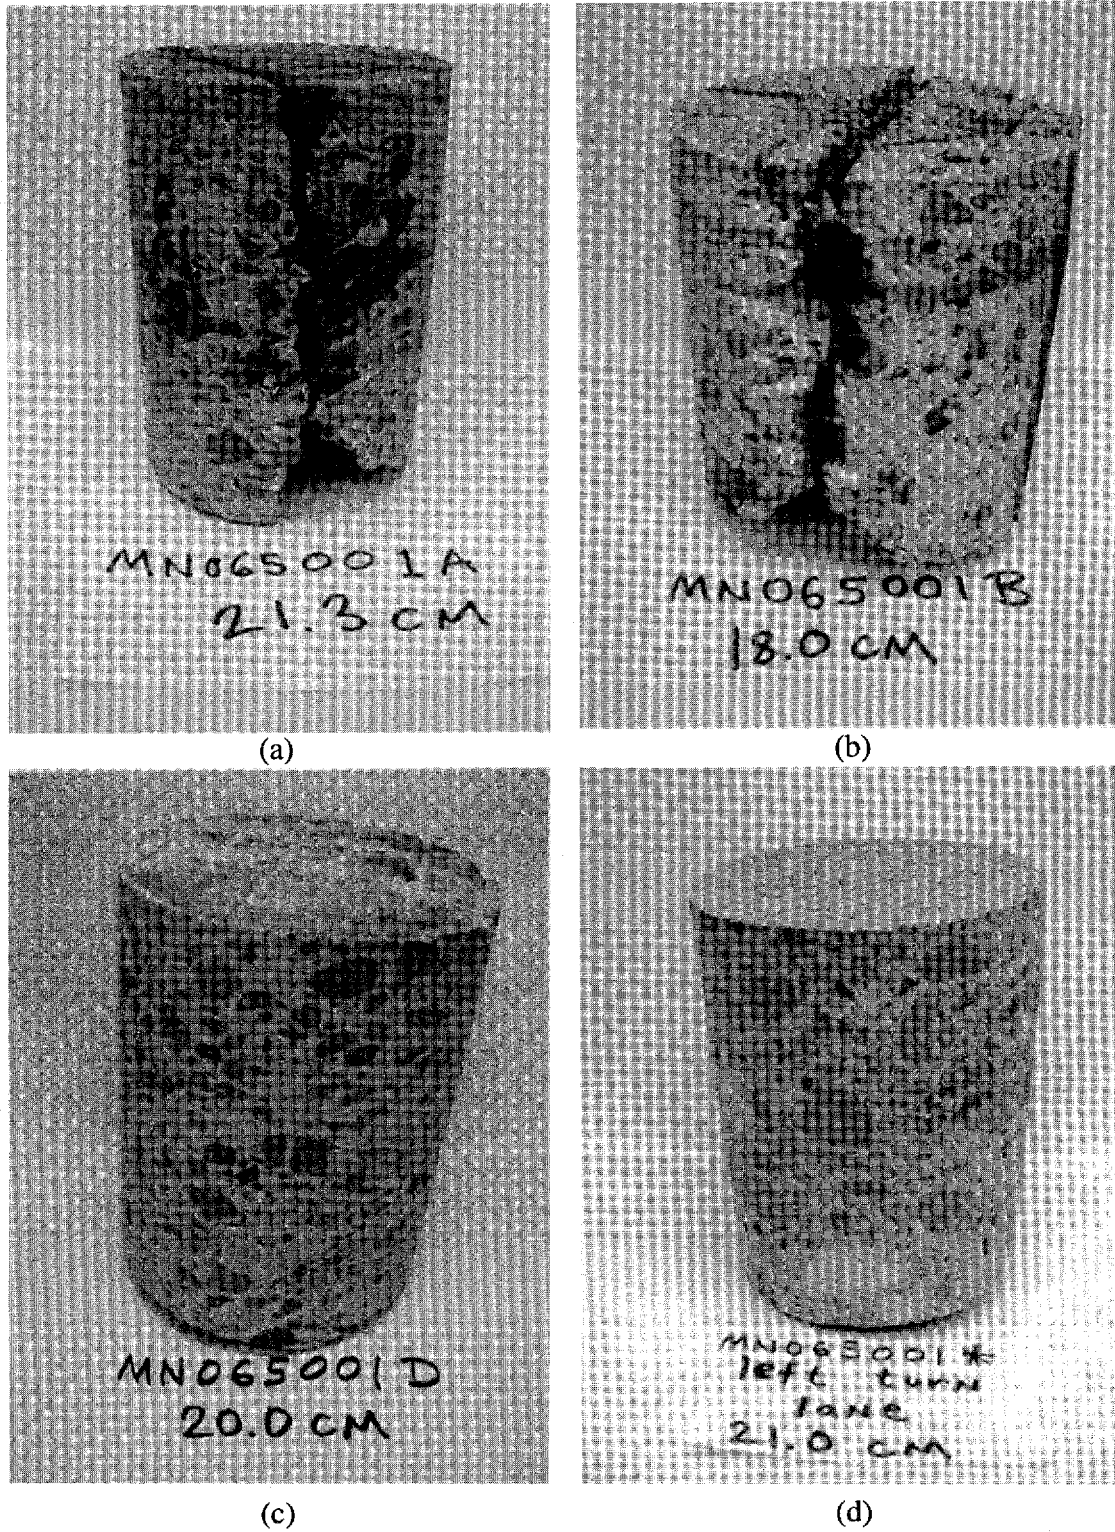
Figure 3-22. Cores evaluated for MN-065-064.

Based on the field survey and site inspection by researchers, the distress was determined to be concentrated at the transverse joints. In addition, the northbound turning lane was recognized as being in good condition even though it was approximately 40 years older than the badly distressed northbound Section 001. The guidelines for sampling were applied and four cores were retrieved from each section. Also, one mid-panel core (core D in standard pattern) was retrieved from the northbound (Section 001) left-turn lane. The cores selected for laboratory analysis were A from Section 002, cores B and D from Section 001, and core D from the left-turn lane. Pictures of these cores are shown in figure 3-22.

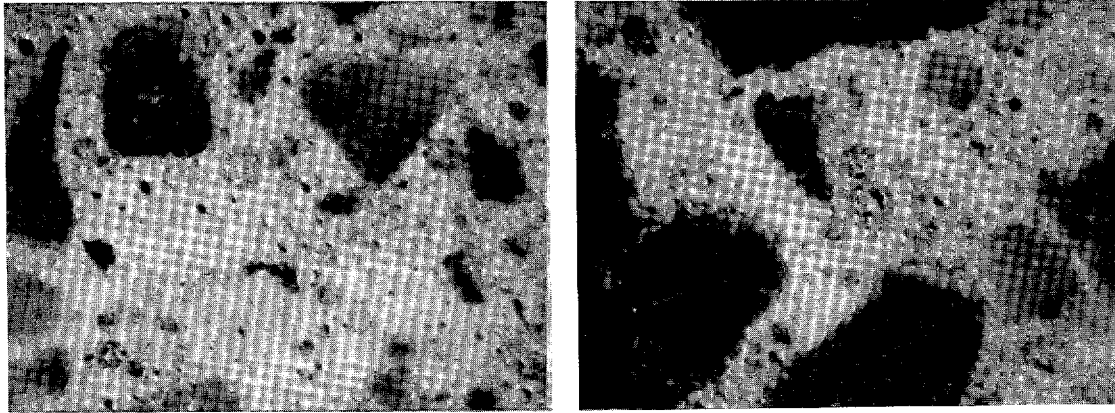
The rock type for the coarse aggregate was characterized as varying, but was dominantly mafic rock types typical of the Superior Lobe. The fine aggregate was the same, but with more quartz. No unusual alteration of the aggregate was observed. For this study, the most useful role for the stereo microscope was for observing stained specimens and determination of the hardened air content. The barium chloride/potassium permanganate stain described in Guideline II colors sulfate minerals a brilliant pink to purple hue as shown in figure 3-23.

Figure 3-23. Stereo optical micrographs showing sulfate minerals filling air voids.

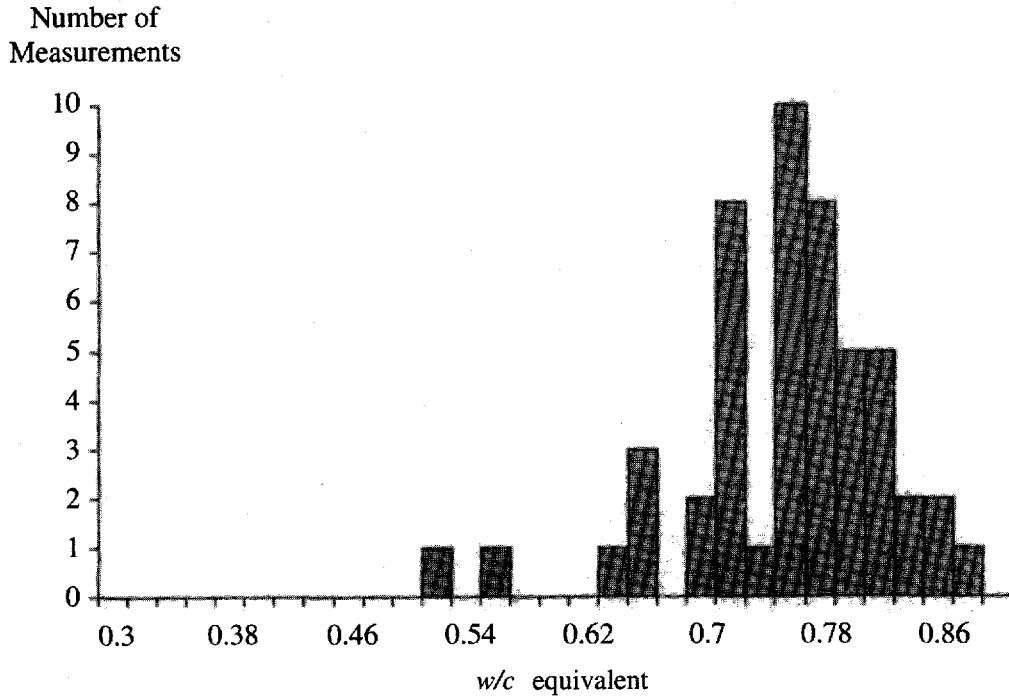
Figure 3-36. Distribution of the w/c values from the 1990 concrete from mid-panel of the traffic lane of site MN-065-064-001.

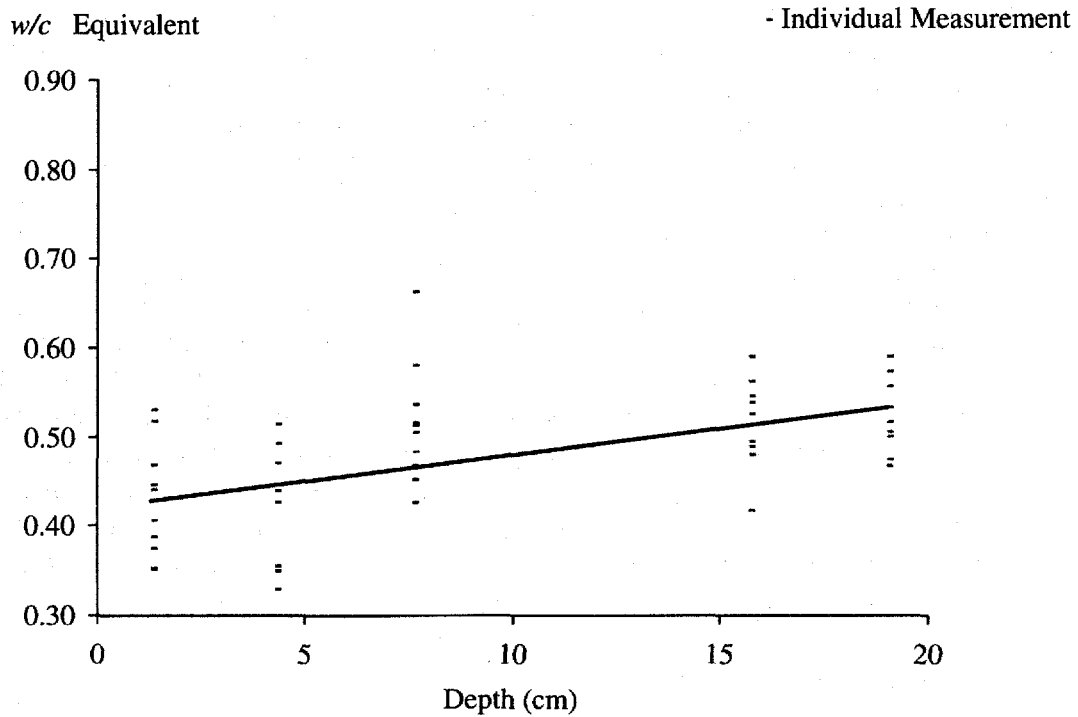
Figure 3-37. The w/c values versus depth from the 1950 concrete from mid-panel of the left-turn lane of site MN-065-064-001.

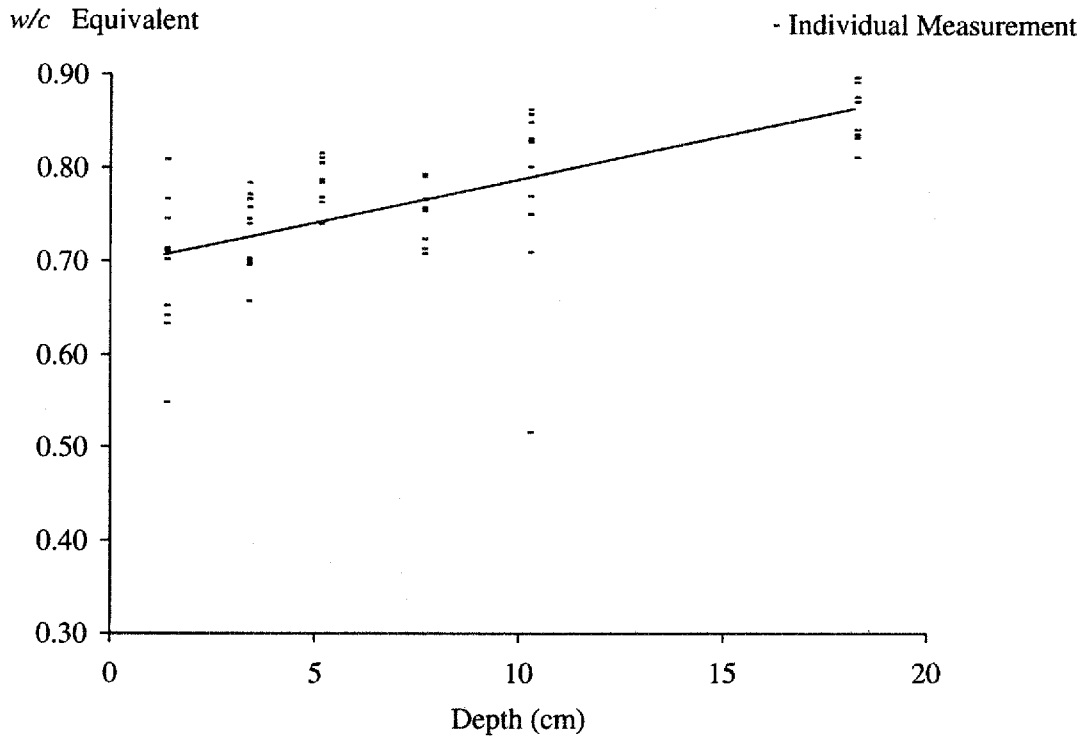
Figure 3-38. The  $w/c$  values versus depth from the 1990 concrete from mid-panel of the traffic lane of site MN-065-064-001.

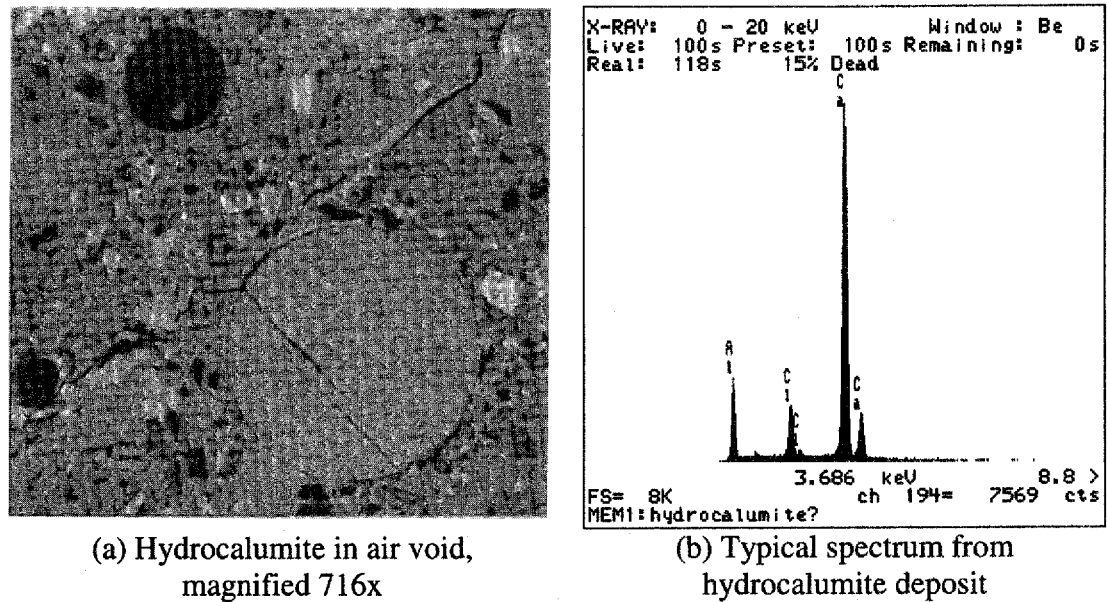
SEM was used to identify infilling material in voids and cracks. As indicated earlier, the principal materials identified were ettringite and hydrocalumite as shown in the typical SEM micrographs and x-ray analyses presented in figures 3-39 and 3-40.

Figure 3-40. Typical SEM micrograph and x-ray analysis for hydrocalumite infilling air void.

*Deicer Attack* – This MRD may be opportunistic or it may be a contributor. Given the degree of distress seen near the joint, it is reasonable to infer that deicer attack was a factor. Also, the presence of hydrocalumite is an indicator that this concrete was exposed to a high chloride environment, given the necessary high chloride concentration required for this phase to precipitate.

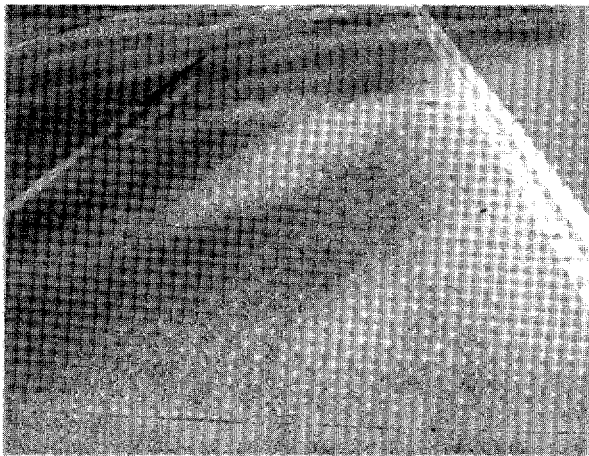
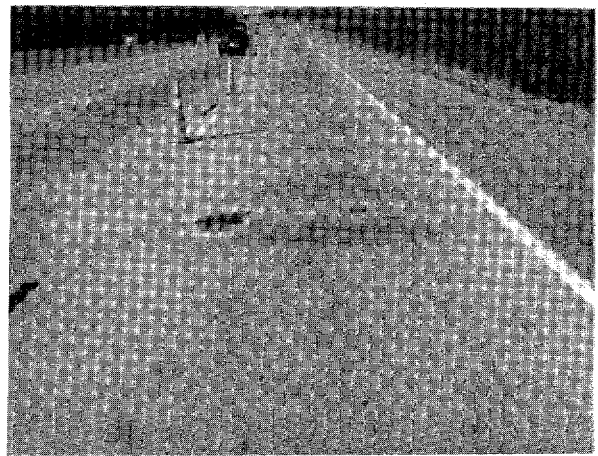
The primary distress, and the reason this section was selected as part of this project, is the extensive surface cracking exhibited over the entire pavement area. These hairline cracks run parallel to the longitudinal joints and are more prevalent near the outer edge of the slab (i.e., near the longitudinal joints). Some cracks are stained immediately around the cracks, which further highlights the presence of the cracks. The staining is typically dark gray areas around the crack; no exudate appears to be present in the cracks.

Figure 3-46. Typical cracking pattern at NC-444-015. Note distress over entire slab length with spalling occurring at joints.

For the most part, these surface cracks are not causing any immediate concerns or problems. At a few joints and at the two transverse cracks, the surface cracks have begun to deteriorate and create loose pieces and some large spalls were seen on the side of the road. These areas have been patched with AC. Otherwise, the cracks are not adversely affecting the ride quality.

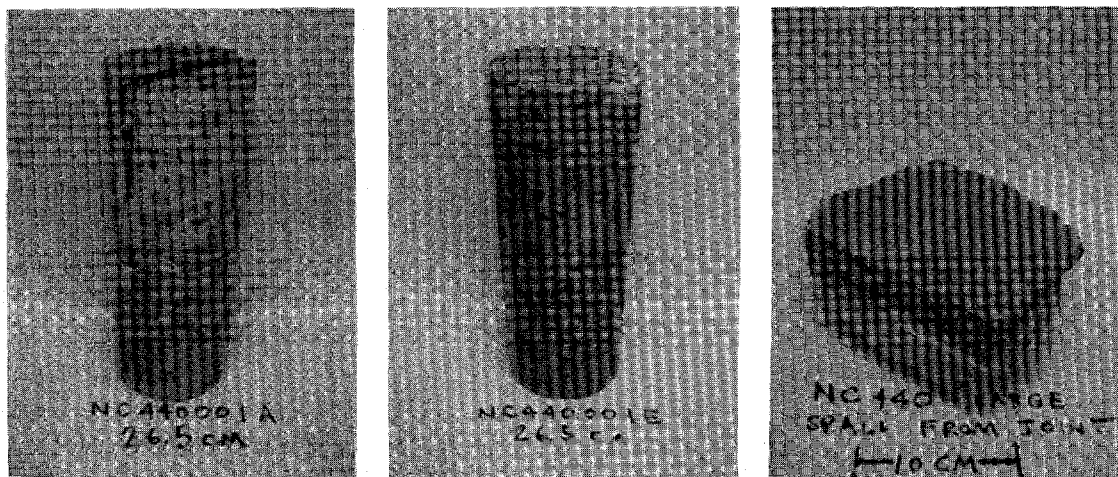
Figure 3-47. Cores and specimens evaluated from NC-440-015.

As with the other sites, mix proportions were not documented in the construction records and were only noted in the visual inspection as being normal. The concrete cores were 265 mm in depth, considerably greater than the design thickness of 250 mm. The concrete was well consolidated with no apparent segregation or parallelism of the aggregates. No scaling was present and there was no evidence of sub-parallel cracking or entrapped water voids under aggregates and surface cracking was seen in the cores that was thought not to be shrinkage cracks. Cracks extended from aggregates and through the paste. Secondary deposits were seen in some entrapped air voids and darkened rims were seen on coarse aggregate particles.

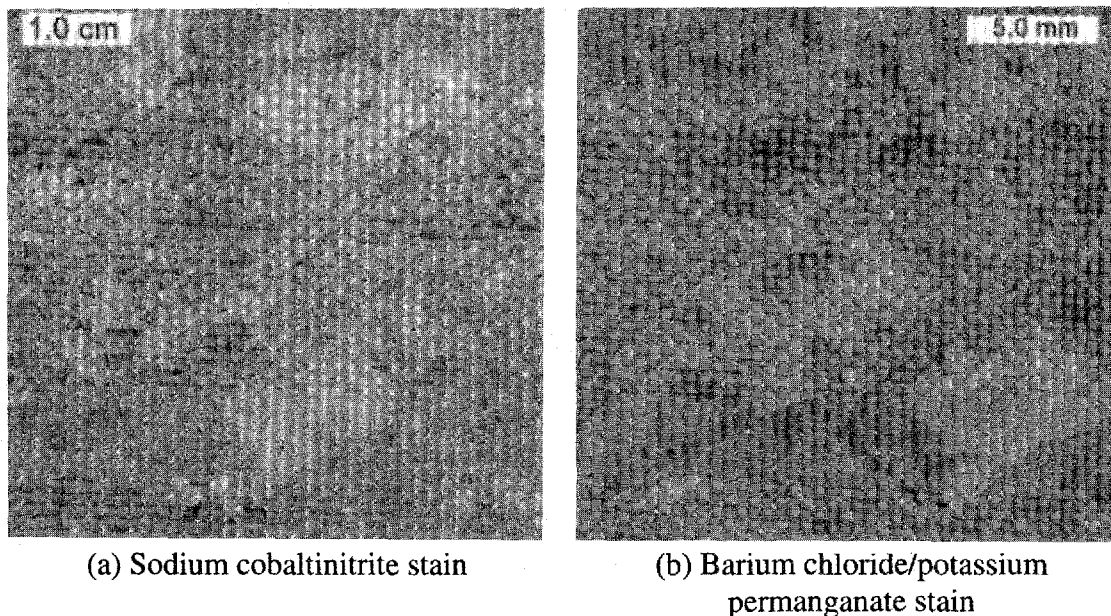
The results of staining indicate that both sulfate minerals and ASR gel are present as infilling material in cracks and voids. Figure 3-49 below shows some typical results for these tests. The characteristic yellow of the sodium cobaltinitrite stain is seen on the left and the brilliant purple color associated with the barium chloride/potassium permanganate is seen on the right. The phenolphthalein stain indicated a depth of carbonation of approximately 5 mm at the road surface and at the bottom of the slab.

Figure 3-49. Typical stereo optical micrographs of stained concrete. Note that the broad banding occurs from the montage process to create a single image.

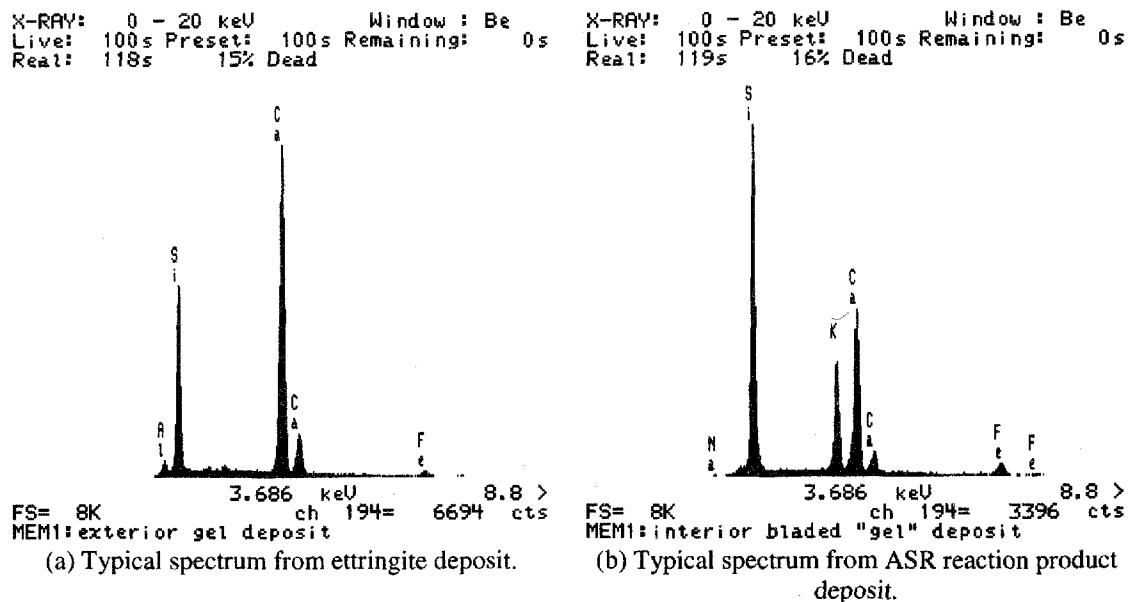
Using the SEM, quantitative measurements of ettringite and ASR “gel” compositions were made. Ettringite deposits were extensive and found both in entrained air voids and in cracks in the cement paste and in cracks along the contact with coarse aggregates. Measurements were made of the coarse aggregate ASR product pictured in figure 3-54, both within the crack in the coarse aggregate, and in the region where the crack comes into contact with the cement paste. Measurements were also made of the gel blobs associated with the fine aggregates. The presence of small amounts of iron in the ASR product is unusual. Figures 3-55 and 3-56 are SEM micrographs of ettringite and ASR reaction product. Figure 3-57 shows the typical spectra for ettringite and ASR reaction product.

Figure 3-57. Typical spectra for ettringite and ASR reaction product.

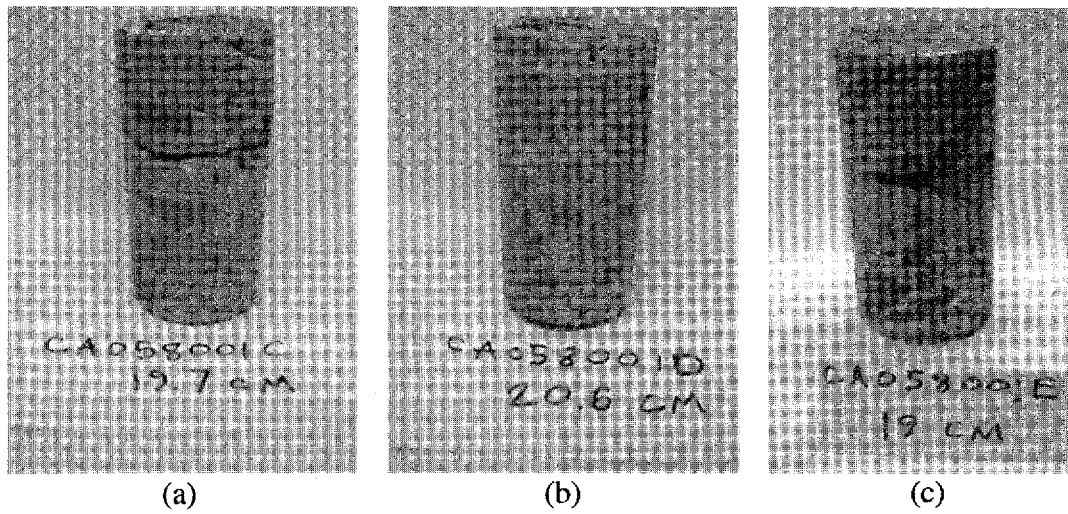
Based upon the field survey, distress was widespread. The joints were badly deteriorated and coring at the transverse joint produced pieces rather than an intact core. Cores C, D, and E were relatively intact and were thus analyzed. Photos of these cores are shown in figure 3-64. All cores were cut to produce slabs for examination with stains.

Figure 3-64. Photographs of core specimens analyzed from CA-058-141.

Mix proportions were estimated by inspecting the cores visually before and after slicing. In this case, construction records were unavailable to verify the mix design. The concrete was well consolidated with no apparent segregation or parallelism of the aggregates. No scaling or sub-parallel cracking was apparent on these sites. No entrapped water voids were seen under aggregates or embedded steel. Surface cracking was apparent that was not plastic shrinkage cracking. Darkened reaction rims were seen around some of the coarse aggregates. Abundant cracks filled with white deposits were visible with the unaided eye. The coarse aggregates used were a natural igneous (both intrusive and extrusive) and the natural fine aggregate used appear to be similar in lithology.

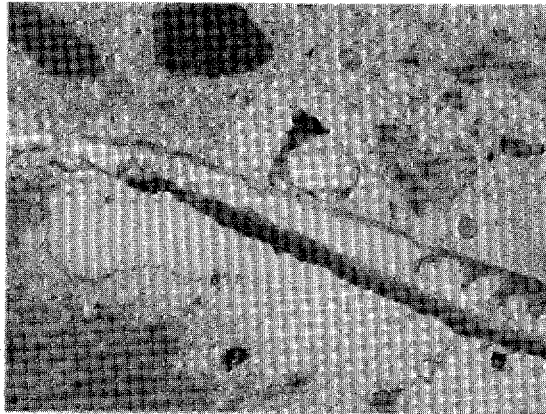
Cores C and D were slabbed and stained using the sodium cobaltinitrite stain for identifying ASR reactive aggregates and reaction products. Also, slabs were stained with the potassium permanganate/barium chloride stain for identifying sulfate minerals. ASR reaction product was seen in cracks associated with the coarse aggregate. Ettringite was common in cracks and voids, and actually was more common than ASR reaction product. Examples of these stains as applied are shown in figure 3-65.

(a) Sodium cobaltinitrite yellow stain picked up in crack within felsic volcanic coarse aggregate

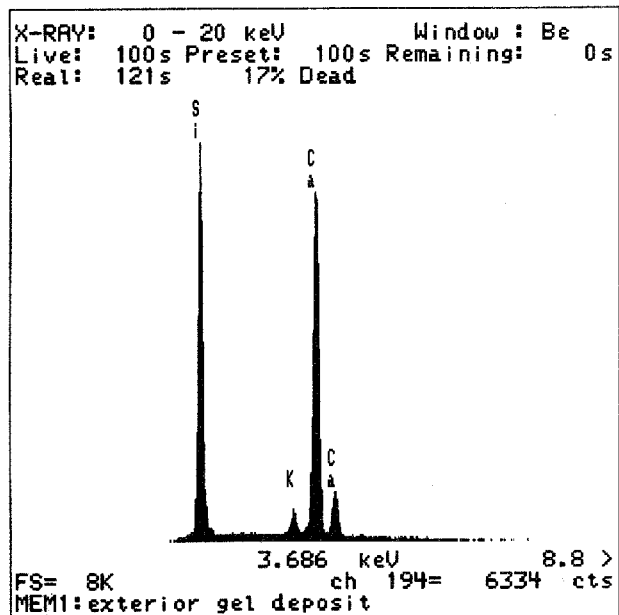
(a) Typical spectrum from ASR gel adjacent to volcanic aggregate pictured in (b).

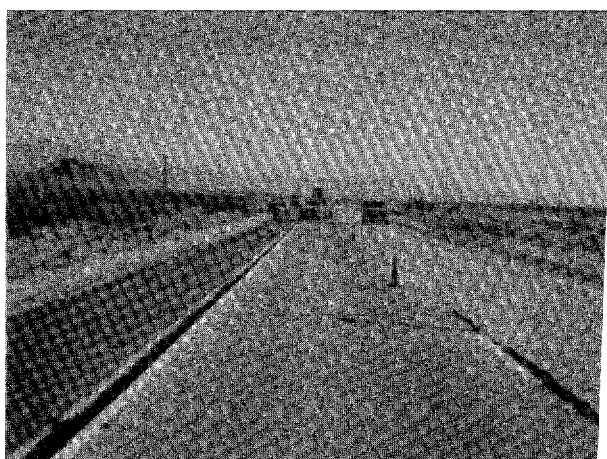
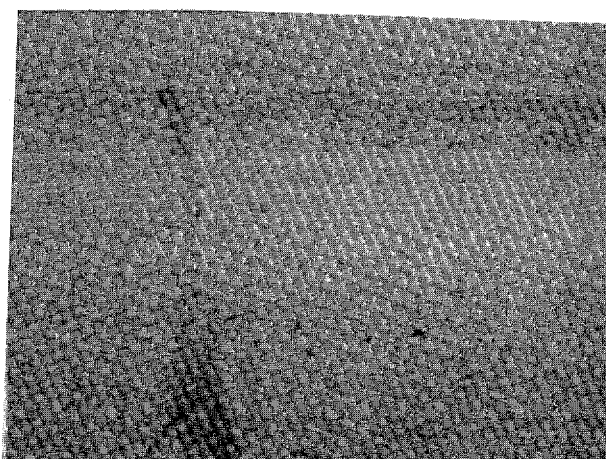
Figure 3-74. Typical conditions at CA-014-011.

The potential MRD is characterized by map cracking over the entire pavement surface. These cracks, made up of multiple interconnecting surface cracks, form a honeycomb pattern on the pavement surface. The cracks are generally hairline cracks but are more visible in the wheel paths because they are slightly more open. No staining or exudate was observed within or surrounding the cracks and joints. Figure 3-74 shows the typical site conditions.

(a) Section overview

(b) Close up of observed map cracking

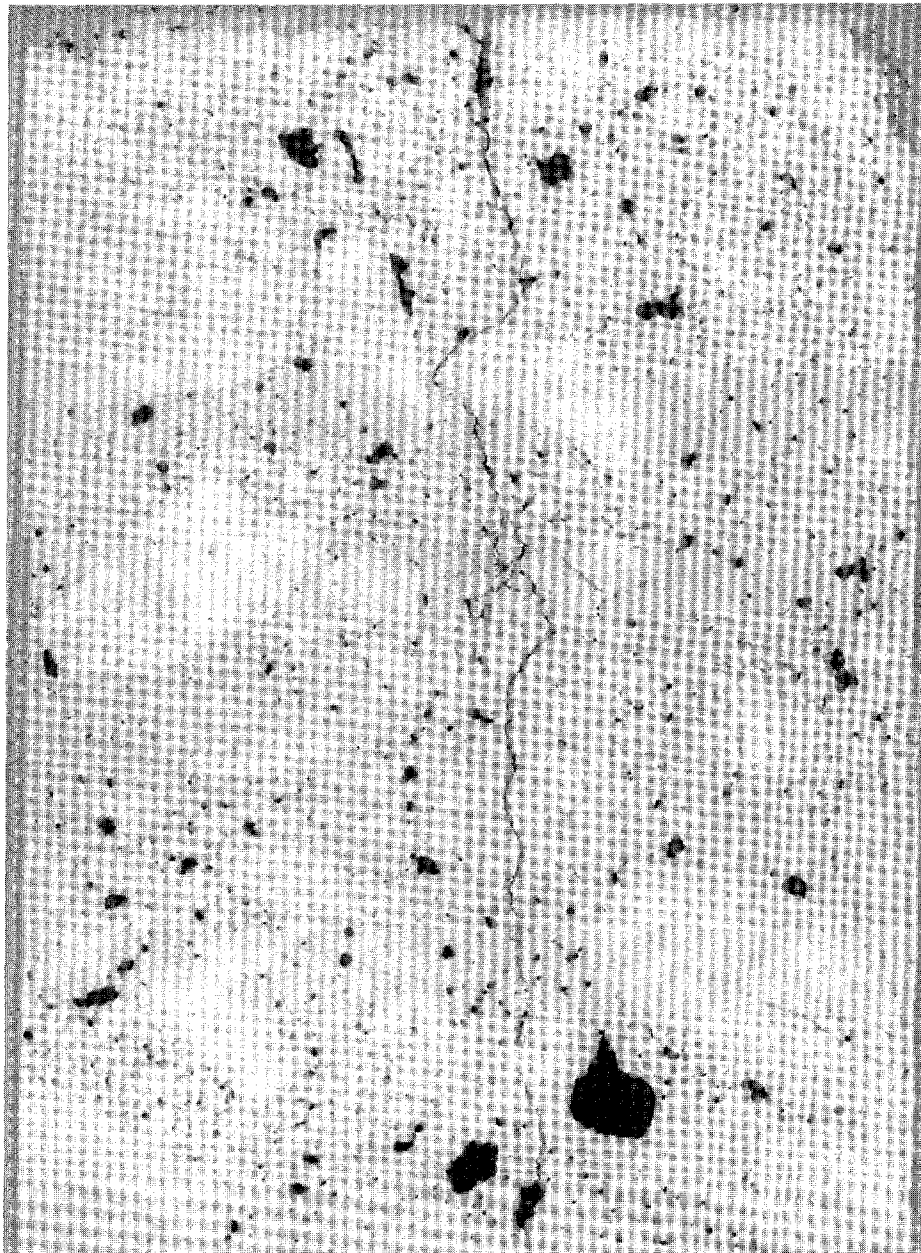
In figure 3-76, a crack is seen that runs the length of the image. It starts wide at the top and narrows as it goes deeper into the concrete, jogging around one large aggregate grain. That portion of the crack is typical of plastic shrinkage, wide and irregular at the pavement surface, where the paste was soft and cracked preferentially. The rest of the crack is more typical of drying shrinkage where much larger stresses are applied to the aggregates as the paste hardens with time. Stresses build to the point where the crack already started at the surface propagates through an aggregate and continues. Figure 3-77 is a normal scan of the same specimen. Some darkened rims are evident on the coarse aggregate, which is typical of ASR.

Figure 3-76. Inverse image of polished cross section of core CA-014-011-001E, through pavement, after painting the surface black and pressing white powder into the voids and cracks (magnified 1.5x).

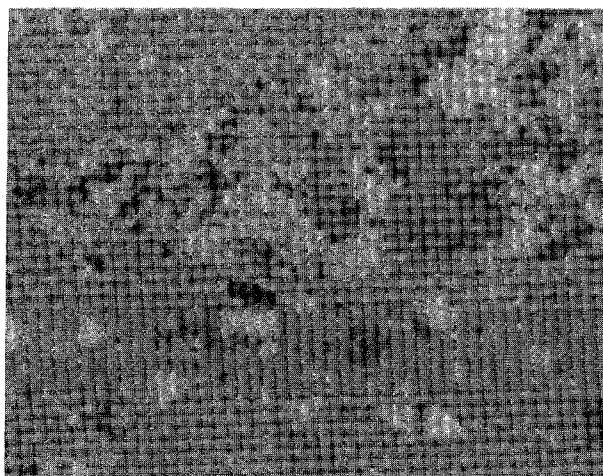
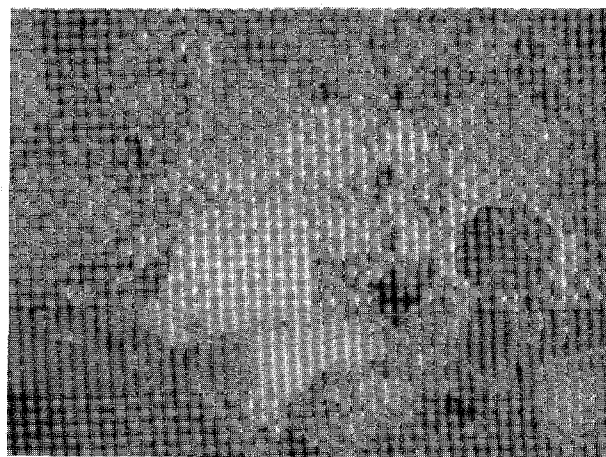
Figure 3-78. Results of staining test applied to core CA-058-011-001E.

The sodium cobaltinitrite and barium chloride/potassium permanganate stains were applied and both were positive meaning ASR reaction products and sulfate minerals were present in the concrete. Micrographs showing ASR reactive particles and ettringite inclusions are shown below in figure 3-78. Also the phenolphthalein stain was used to determine the depth of carbonation. This slab was scanned and is shown in figure 3-79. Note the areas of deeper carbonation in the vicinity of the plastic shrinkage crack, indicating the increased permeability of the cracked surface.

(a) Yellow sodium cobaltinitrite stain for ASR gel in cracks associated with granitic coarse aggregate

(b) Ettringite filled air voids that have picked up the purple to pink stain from the solution of barium chloride and potassium permanganate
