# Guidelines for Detection, Analysis, and Treatment of Materials-Related Distress in Concrete Pavements Volume 3: Case Studies Using the Guidelines

PUBLICATION NO. FHWA-RD-01-165

AUGUST 2002

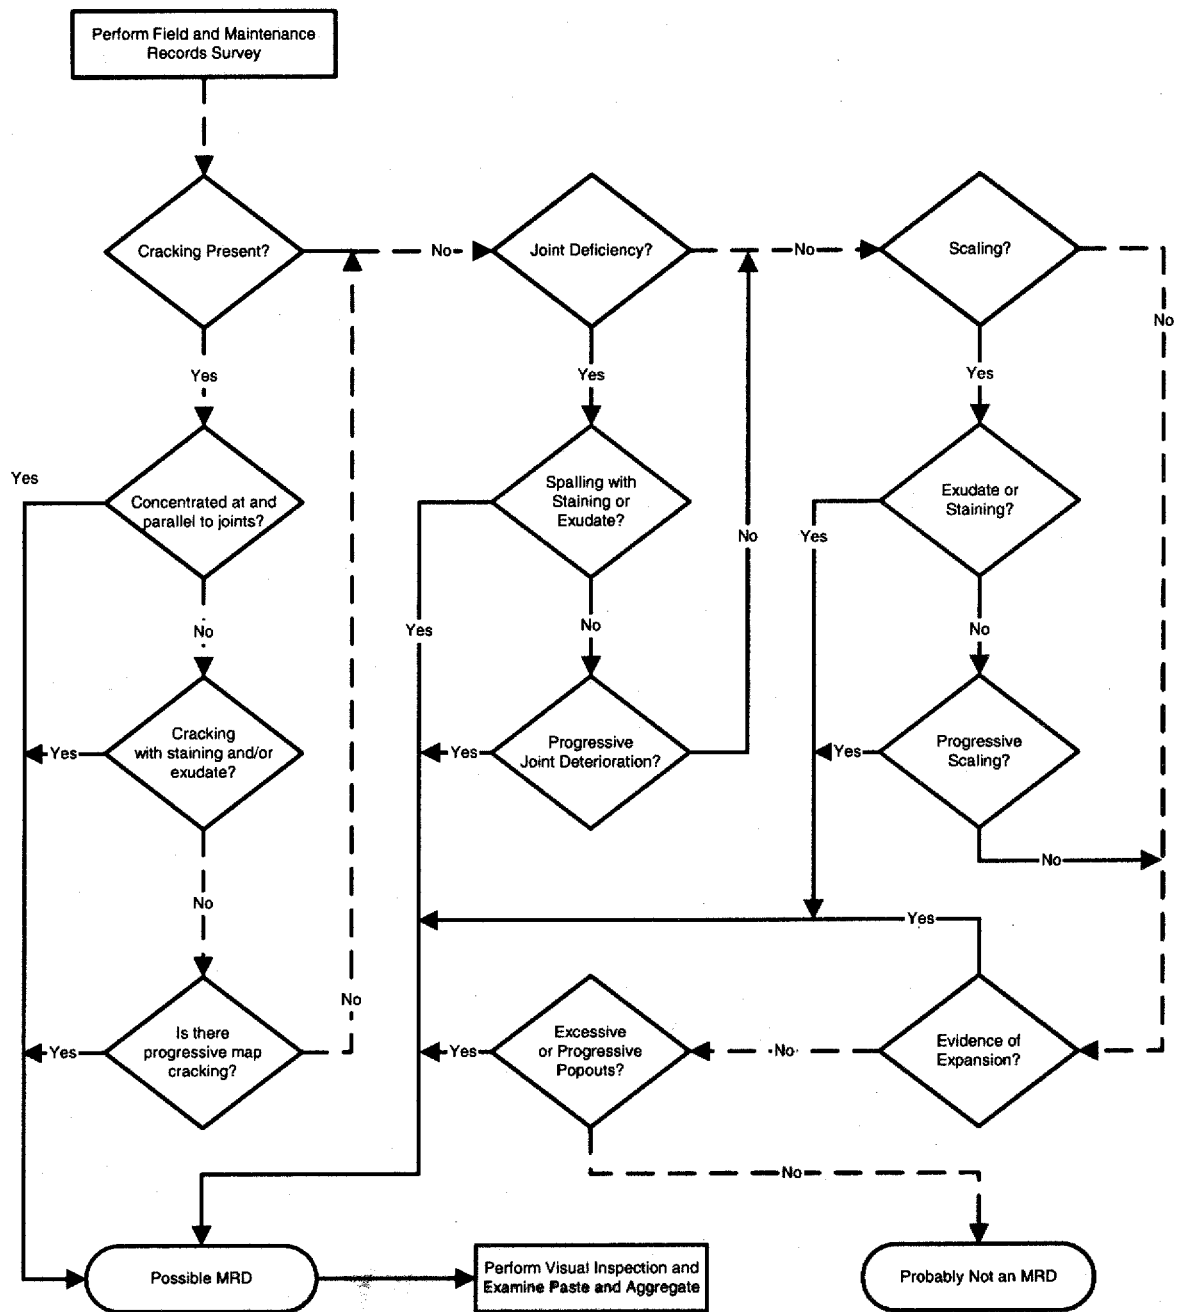
This site provides an excellent case for demonstrating the value of the guidelines. First, through the rigorous field inspection, it was decided that an MRD was likely not the cause of the observed distress. The logic for this conclusion is shown in figure 3-80. But it was believed that laboratory work should be conducted to verify this conclusion. As discussed in Guideline II, to reach a diagnosis, the concrete must be observed using stereo microscopy. Because of this examination, the true nature of the surface cracking was documented, confirming the field evaluation. In addition, it was determined that there were diagnostic features of MRD, specifically ASR reaction products. Mild infilling of air voids and cracks with ettringite was also observed but not considered significant.

Figure 3-80. Flowchart for assessing the likelihood of MRD causing the observed distress in the pavement as applied to CA-014-011.

ASR - ASR is certainly occurring in this pavement, but at this time there is little to no distress resulting from ASR. Additionally, there are no cracks associated with the ASR reaction products found in this concrete. These reaction products are filling adjacent voids and cracks within the aggregate. It is thus concluded that the ASR is not currently deleterious and is not a major contributor to the distress of this pavement at this time. Monitoring the pavement condition over time will demonstrate whether this distress is progressive, possibly helping engineers in planning maintenance schedules if the ASR does become deleterious.

In summary, applying the guidelines as proposed provided information for engineers that can help establish a maintenance program for this pavement, thereby extending its life. Specifically, shrinkage cracks propagating with time and applied load are the most probable cause of the distress. As the concrete becomes more permeable as a result of the cracking, opportunistic MRDs occur such as ASR. Some mitigation of ASR may be appropriate.

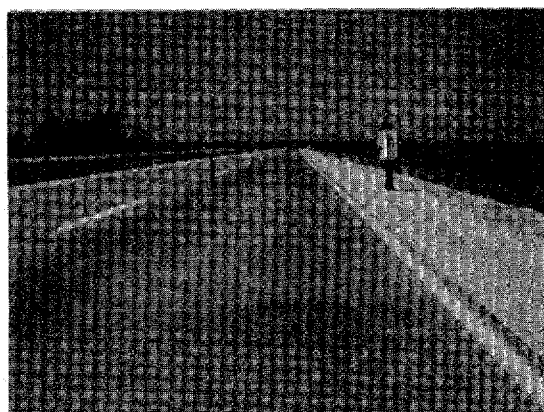
Figure 3-81. Site conditions at IA-002-002.

A characterization of potential MRD was conducted in the field to assist in the diagnosis of the type and cause of the distress. The potential MRD on both sections is the presence of short longitudinal cracks throughout the sections. These cracks are generally confined to the wheel paths and in many cases initiate at a transverse joint. There is some slight staining, which is brownish-gray in appearance, around transverse joints and in the wheel paths. There is no exudate observed at the cracks. Table 3-37 provides a summary of the MRD characteristics for this project. Figure 3-81(a) shows staining along longitudinal cracks and at the transverse joints. Figure 3-81(b) shows closeup views of the hairline cracks. Additional site conditions are shown in figure 3-82.

(b) Staining along transverse joints

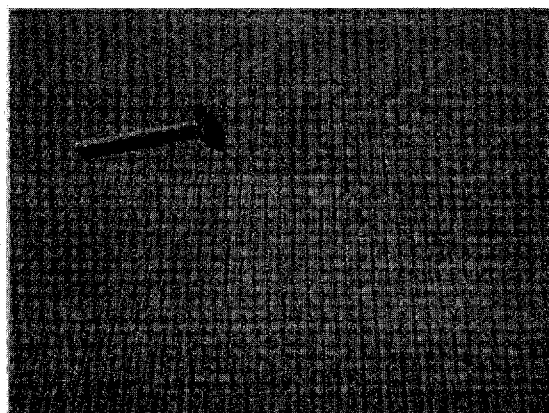
Figure 3-82. Closeup view of longitudinal hairline cracks.

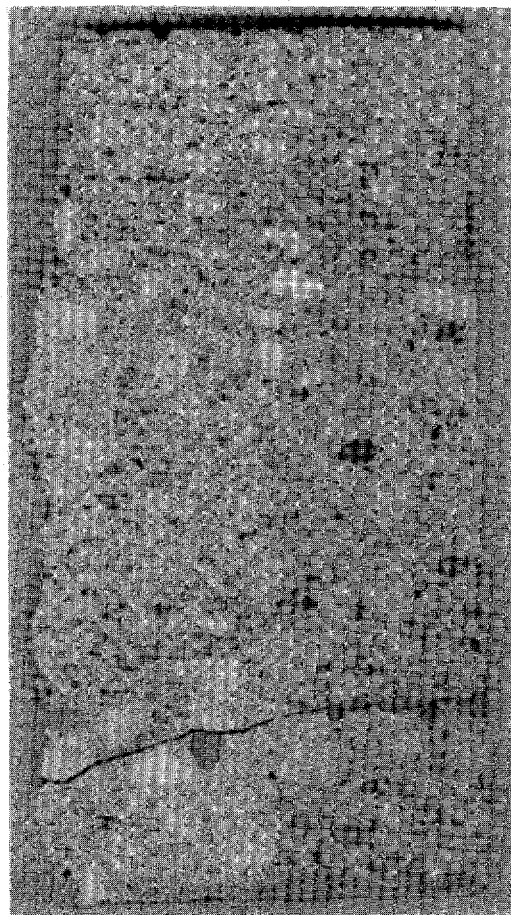
The distresses observed at both sections were similar, and appeared to be concentrated at the joints. Core A was selected from Section 001 for analysis. Core A exhibited hairline cracking at the pavement surface, and a large crack near the base running parallel to the subbase contact. Figure 3-83 shows a polished slab from core A. Other than the visible cracks, the concrete seemed in good condition. The coarse aggregate consisted of a blend of a quarried limestone and pink granite.

Figure 3-83. Polished slab from core IA-002-002-001A. The irregular surface along the left-hand side of the core is a cross-sectional view of the transverse joint texture.

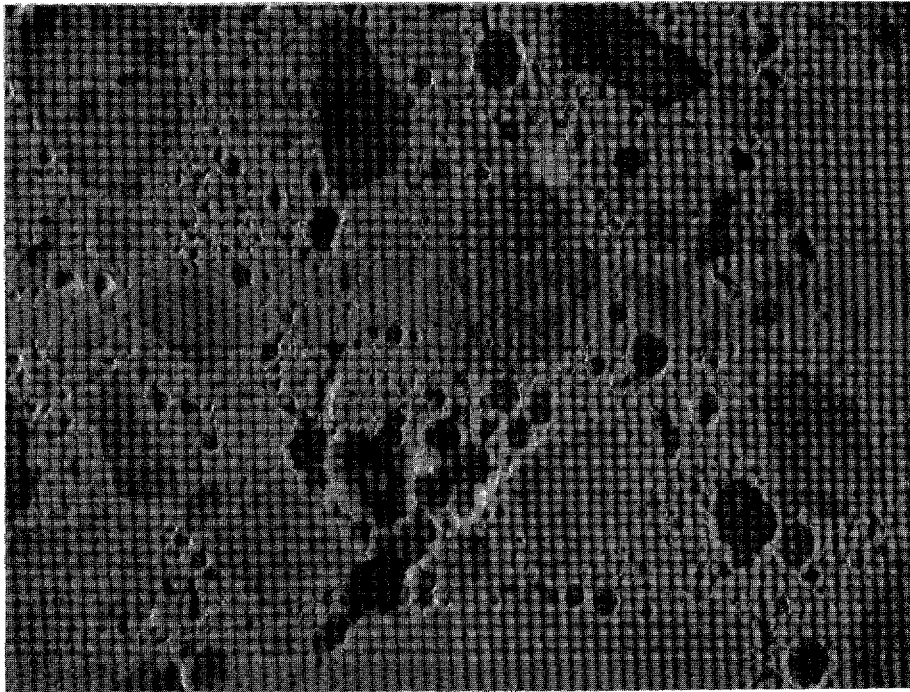
The most striking feature of the concrete was the abundance of small, entrained air voids, as shown in figure 3-84. Although the concrete did contain a large percentage of air, the specific surface and spacing factors were within reasonable values. A summary of the Modified Point Count is included in table 3-38. There was moderate infilling of the void structure by secondary ettringite. Some isolated alkali-silica gel deposits were observed with some of the fine aggregate particles. The gel deposits were found filling air voids near the reactive particles, and were not associated with any cracking. The coarse aggregates were intact, and did not appear to be reactive.

Figure 3-84. Stereo micrograph showing air void structure of IA-002-002-001A, magnified 7.5x.

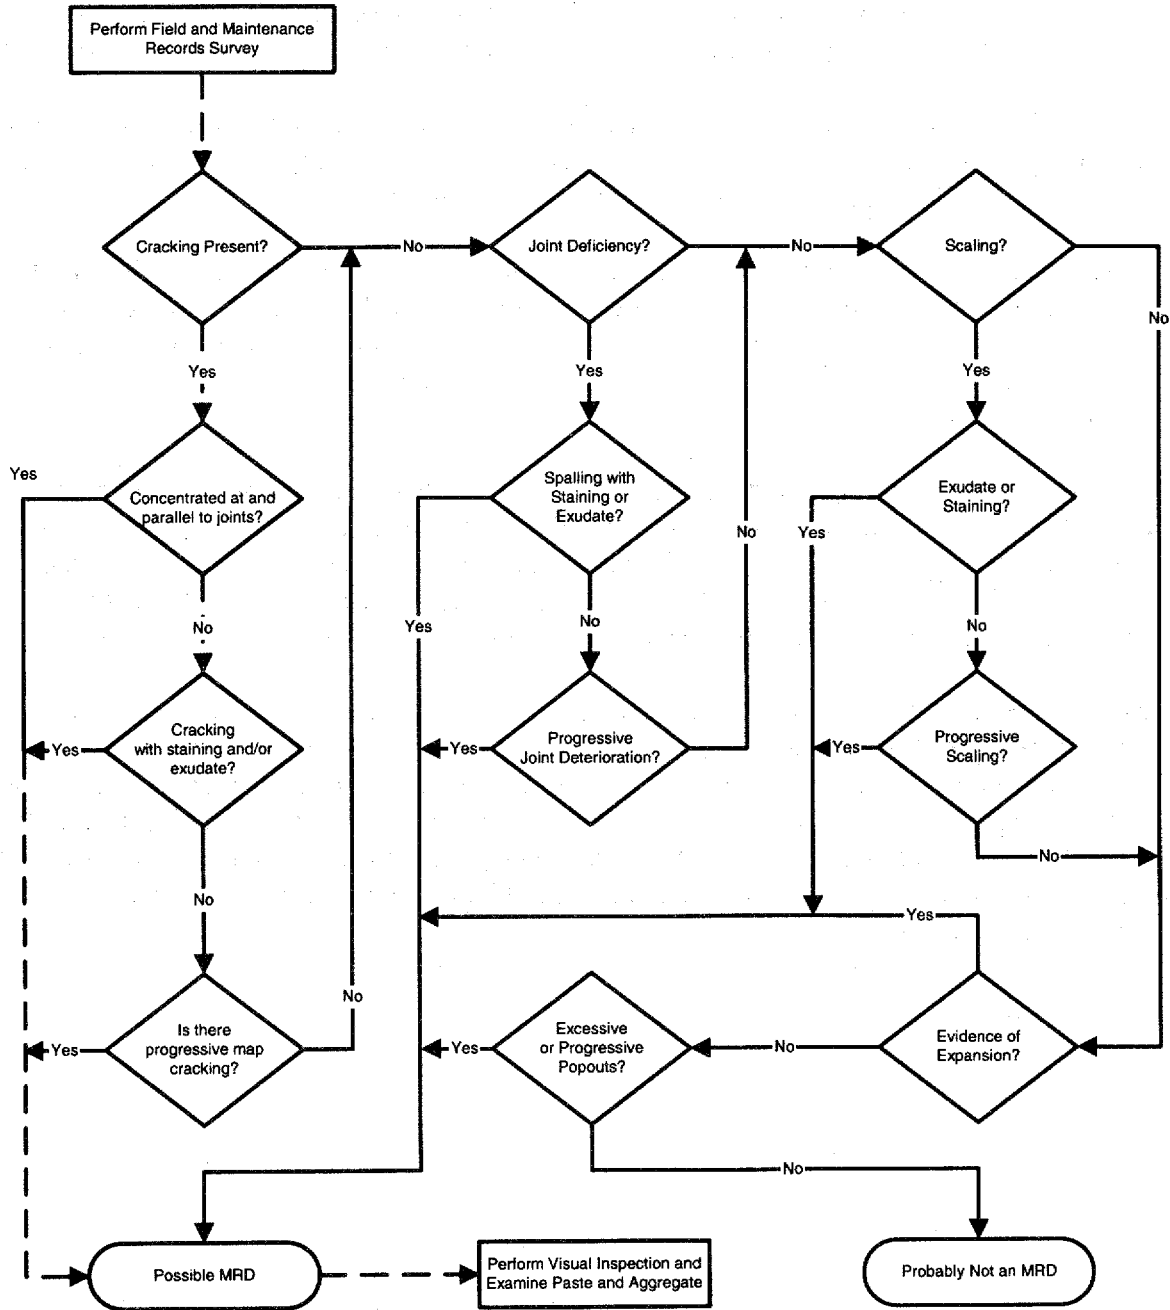
Having performed the described laboratory analyses and applied the diagnostic flowcharts, as shown in figures 3-86 through 3-90, three possible MRDs were identified in IA-002-002, including paste freeze-thaw, ASR and sulfate attack with none being dominant or extensive. To

In summary, the exact nature of the observed distress is not known. The unusual air-void structure may be a contributor but the exact mechanism could not be discerned from this analysis. It is noted that the concrete had a very fine coarse aggregate grading, which may also be a contributing factor but, again, no evidence of a specific mechanism for the observed distress was seen related to this gradation. The guidelines do help rule out the obvious types of MRD but in the end, this is an example of a pavement that cannot be absolutely diagnosed using the developed guidelines.

Figure 3-86. Flowchart for assessing the likelihood of MRD causing the observed distress in the pavement as applied to IA-002-002.

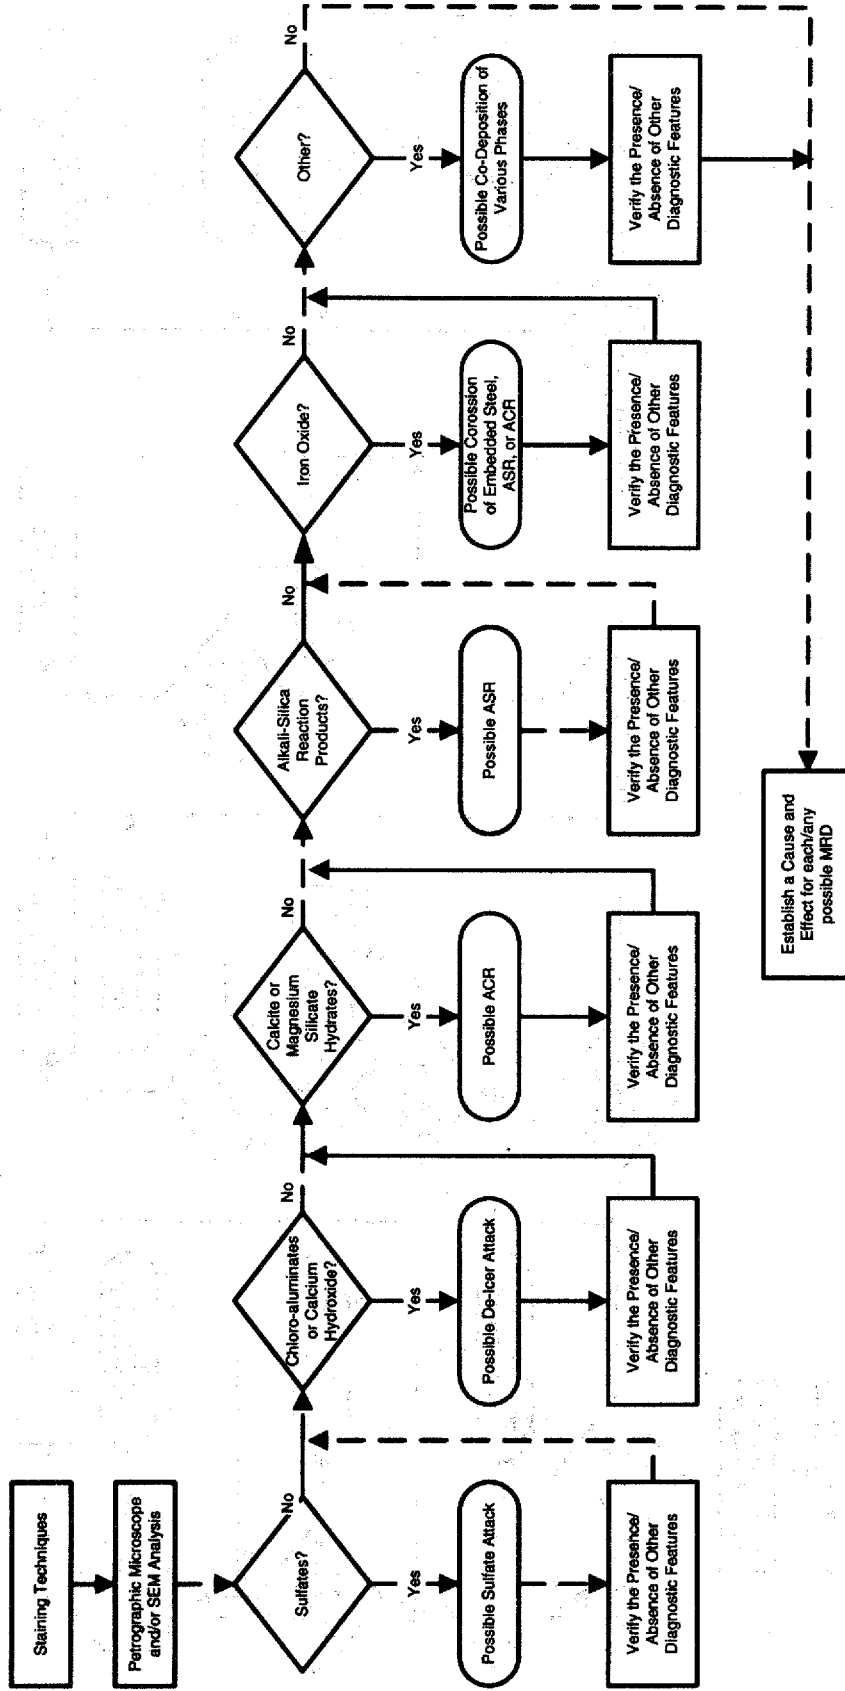
*Sulfate Attack* – The only diagnostic feature of sulfate attack was ettringite infilling in entrained air voids. This was considered a low significance diagnostic feature for a variety of reasons. First, ettringite deposits by themselves are not diagnostic of sulfate attack. Second, the amount of infilling was limited, not extensive. Finally, no other diagnostic feature of sulfate attack was observed. Therefore, sulfate attack is ruled out as a major cause of the observed distress.

Figure 3-90. Flowchart for identifying infilling materials in cracks and voids as applied to IA-002-002.
