Re: Inaccurate SJM 3219 Safety Alerts & Skyjack Service Bulletins 60 and 77

Service Bulletin #60 SJM3219 Scissor Ends Inspection And Repair

Service Bulletin #77
SJM3219 Scissor Ends Inspection and Repair
*******SAFETY RELATED*******

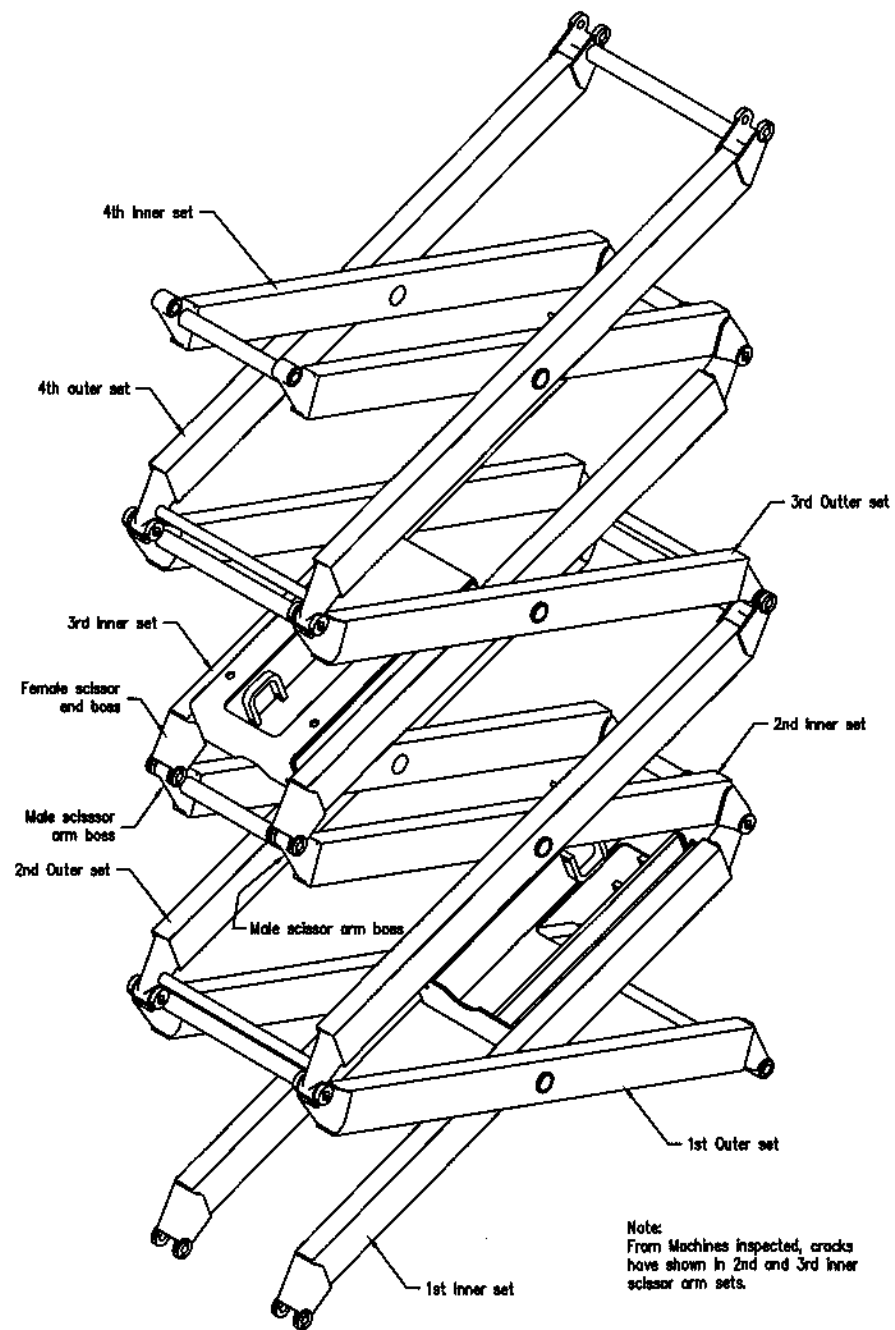
Fig. 1

1. Raise the machine to approximately a platform height of six feet.
2. Set safety bar in place
3. Visually inspect for cracks on all male and female scissor end weldments. Special attention should be focused on the second and third inner level scissor end weldments, both ends and the tubes up to approximately one-inch from the weld. (Note: Level #1 is the bottom level)

Note:
From Machines inspected, cracks
have shown in 2nd and 3rd inner
scissor arm sets.
