Lunar Roving Vehicle (LRV) Missing Fender Extension Saga

Retractable Fender Extensions Required For Folding of LRV Wheels

Extracts From Apollo Mission Flight Evaluation Reports

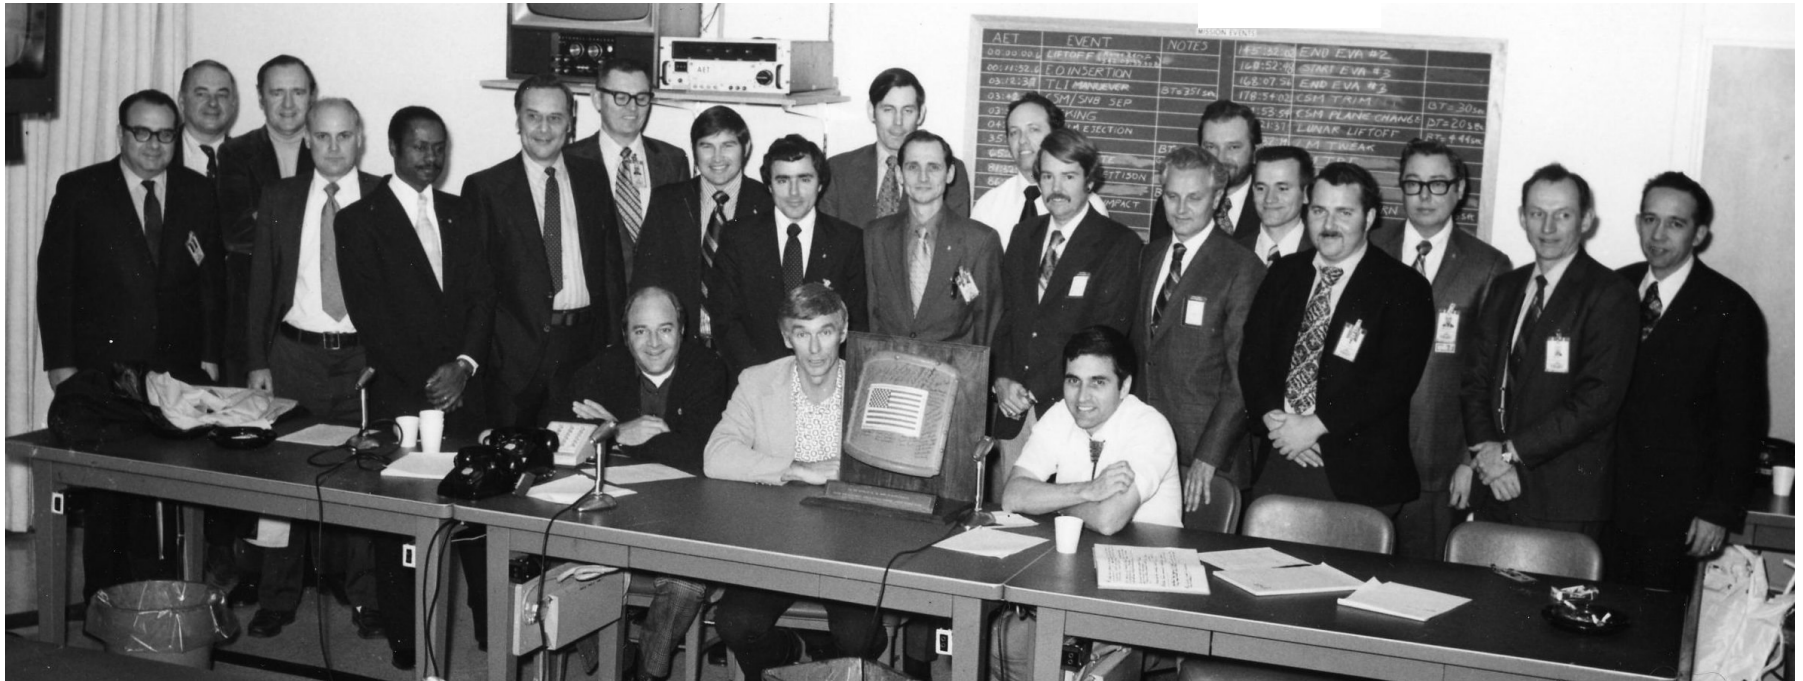
Post Apollo 17 – Astronauts With LRV Team

Astronauts Were Presented With Fender Extension From LRV Qualification Unit

Autographed By MSFC Support Team

(This fender extension had been used to examine potential repair during the Apollo 17 mission. Crew did not indicate any status of fender extensions from LRV left on the moon at the conclusion of Apollo 17)
