**U. S. Department of Energy
Oak Ridge Operations Office**

Type B Accident Investigation

**Bechtel Jacobs
Company LLC
Subcontractor Employee
Injuries from a
November 15, 2000,
Fall Accident at the
Oak Ridge National
Laboratory**

December 2000

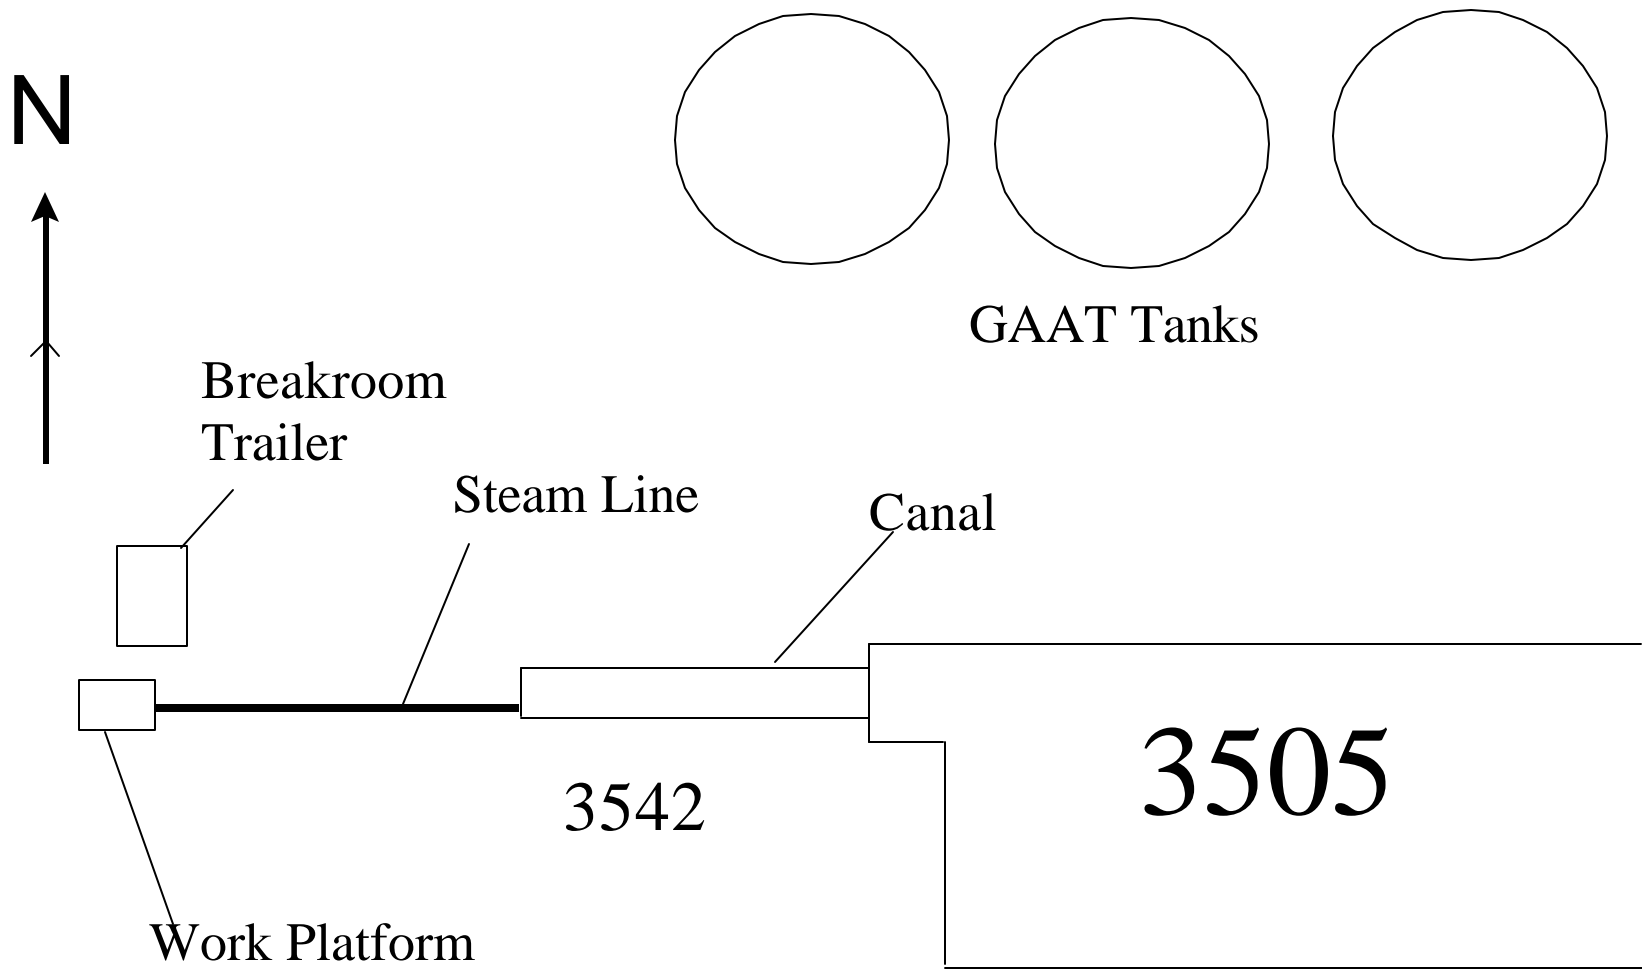
Figure 1-2. Site Layout with Steam Pipe and Platform Locations

Building 3505 is a steel-siding structure set on a concrete slab. The facility includes concrete process cells, the canal, a dissolver pit, and support structures. The canal is a 6' x 35' x 14' deep concrete basin located adjacent to Building 3505. The canal has been emptied, cleaned, and filled with crushed stone. Figure 1-2 is a graphical depiction of the site layout of the project. The accident occurred on the fixed ladder at the work platform shown on the left side of Figure 1-2.

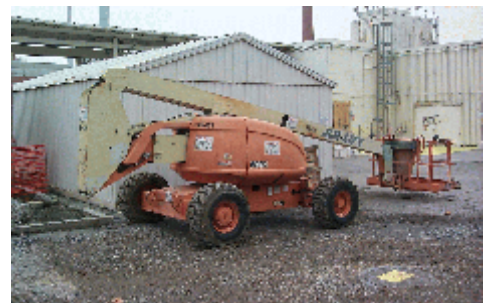
Exhibit 2-3. JLG Lift

As the work progressed, Asbestos Worker #1 (AW-1), the injured employee, and Asbestos Worker #2 (AW-2) realized that they could not complete the job from the JLG lift. The pipe sections above the steam valve access platform were not accessible from the JLG lift due to interference from the railing around the platform. Consequently, the asbestos workers suspended work and asked the DRS Foreman if they could access the platform via the fixed ladder. The DRS Foreman checked with the FIU Site Environment, Safety, and Health Representative (SESHR), who performed a visual inspection and determined that it was permissible to use the ladder. After SESH approval and since the ladder was not tagged out, AW-1 climbed the ladder to the platform on the afternoon of November 14, 2000, and resumed asbestos abatement.

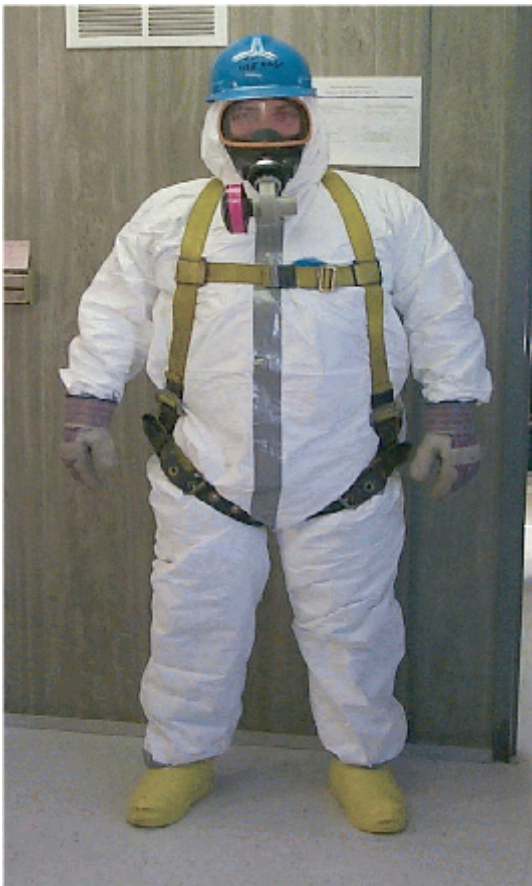
Exhibit 2-4. Asbestos Worker PPE for the MRF D&D Project – Front View

- C Work clothes,
- C Tyvek suit with booties and hood,
- C Steel-toe boots,
- C Disposable shoe scuffs with a traction bottom surface,
- C Full-face powered air-purifying respirator (PAPR) that included a power pack belt around the waist (worn under the tyvek suit),
- C Full body harness,

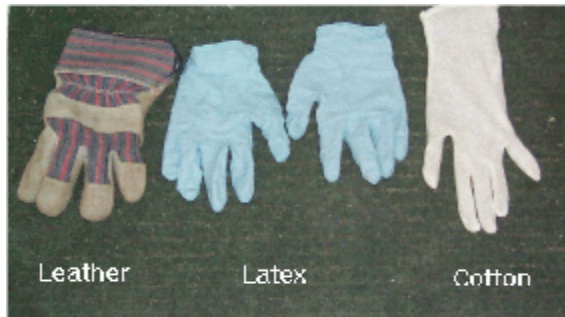
Exhibit 2-7. Protective Gloves Worn by Asbestos Workers

- C Hard hat,
- C Four pairs of gloves that included a cotton inner glove, two layers of latex gloves, and outer leather work gloves.
