FINAL REPORT

OCTOBER 2002

**TYPE B ACCIDENT INVESTIGATION
BOARD REPORT OF THE JUNE 2002
HIGH RADIATION DOSE TO EXTREMITIES
IN BUILDING 151
LAWRENCE LIVERMORE NATIONAL LABORATORY,
LIVERMORE, CALIFORNIA**

**OAKLAND OPERATIONS OFFICE
DOE/OAK—505**

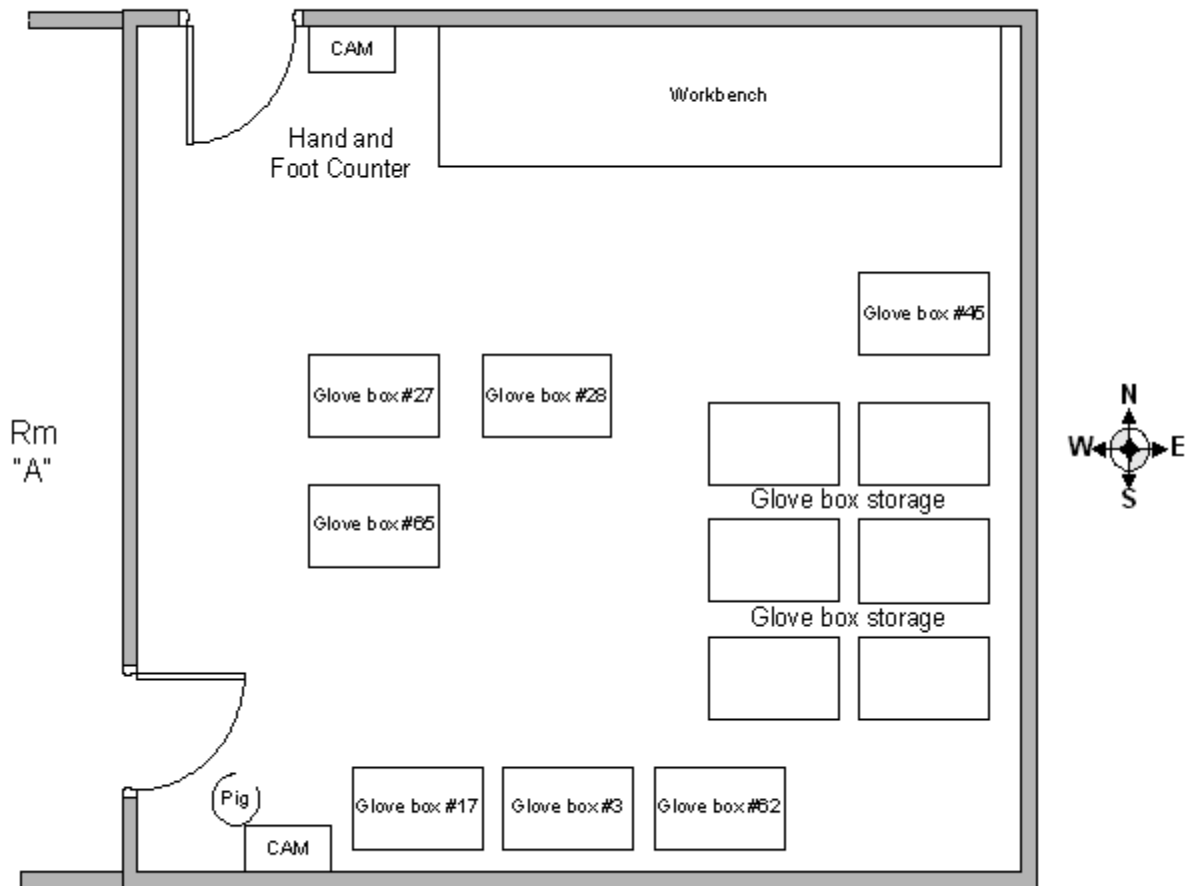
Figure 2. Room "B" Layout.

Figure 1 is a schematic of Room "B" in B151. Room "B" is a research room used for high level radiochemistry and Authorization Level 4 operations. Level 4 is work that is not commonly performed by the public and necessitates the preparation of an IWS and Safety Plans (e.g., Operational Safety Plan). The research room houses several HEPA-filtered gloveboxes, two Continuous Air Monitors, and a hand and foot counter. Room "A" is mainly used for counting and storage of radioactive materials and wastes.

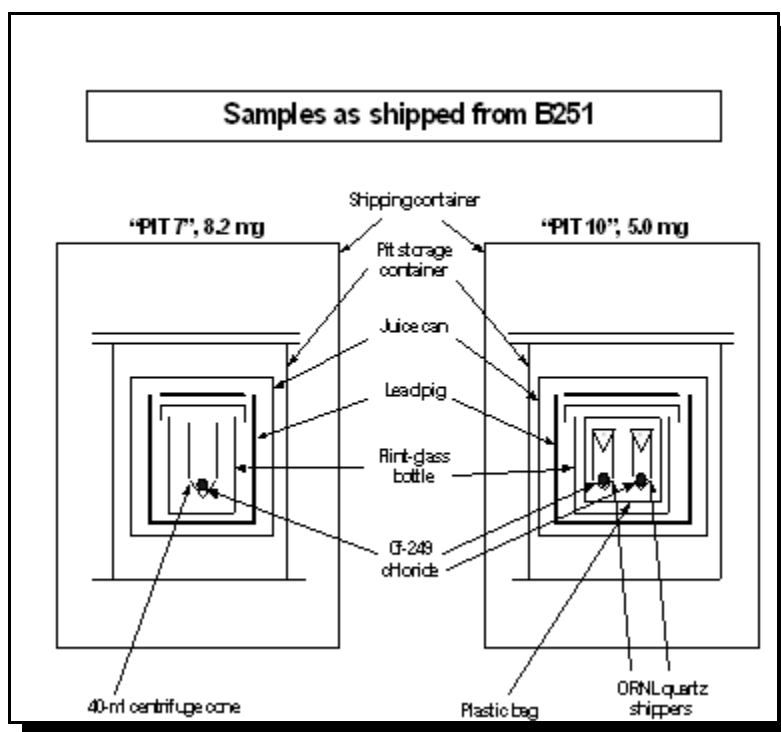
Figure 4. Packing Diagram.

June 6, 2002—At the request of the Researcher, two radioactive packages from B251 were transferred to B151 Room “A”. The transfer was conducted in accordance with LLNL operating procedures. One package, with a “Controlled Material ID Tag No. 299911”, contained two ORNL quartz tubes with an estimated quantity of 5 milligrams (20.4 millicuries) of Cf-249. The second package, with ID Tag No. 299912, contained 8.2 milligrams (33.5 millicuries) of Cf-249 in a single 40-ml centrifuge cone (Lot 5). The ORNL quartz tubes, Lots 1197 & 1244, were packed in a Flint-glass bottle, and then over packed respectively in a lead pig, a juice can, a Pit storage container, and finally in a shipping container. The 40-ml centrifuge cone (Lot 5) was similarly over packed (Figure 3 Packing Diagram).
