# **Type B Accident Investigation Board Report**

**BNFL Inc. Employee Foot Injury  
on December 17, 2003, at the  
East Tennessee Technology Park,  
Building K-31**

**February 2004**

**Oak Ridge Operations Office  
U.S. Department of Energy**

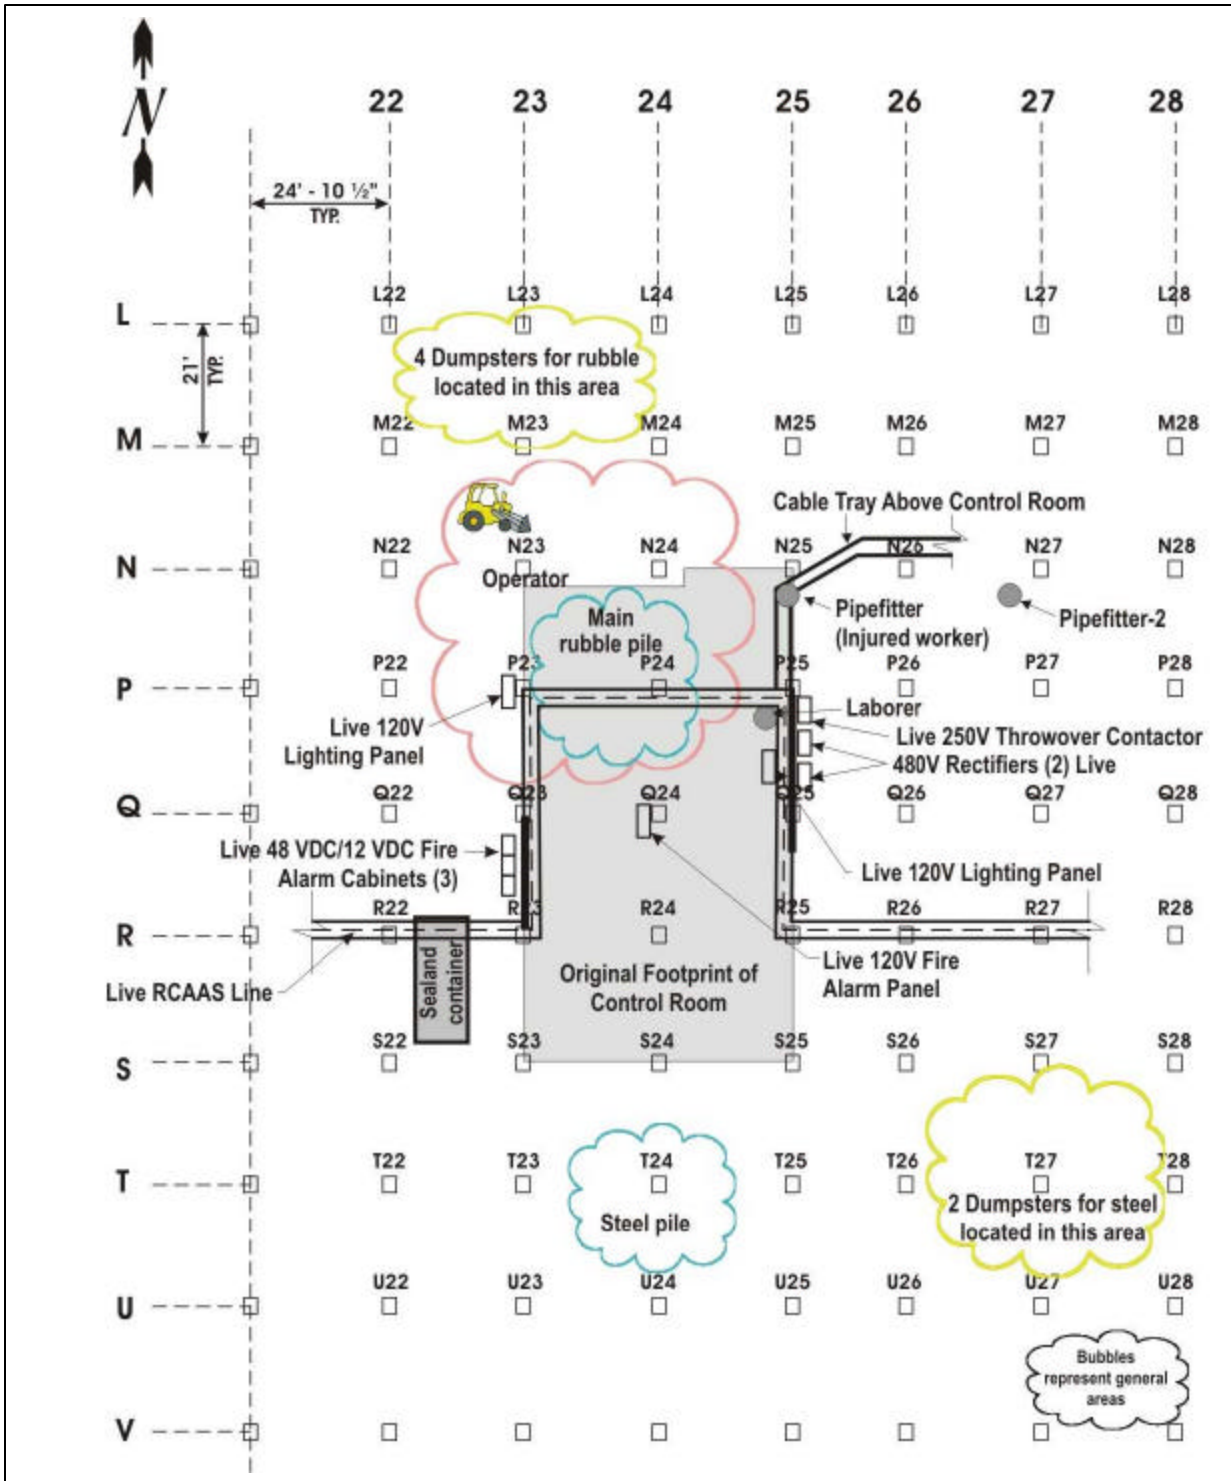
Figure 2-1. Schematic of Control Room Area on Day of Accident (12/17/2003)

(NOTE: In Building K-31, columns are numbered 1 to 50 [west to east] and lettered A to EE [north to south]—the Control Room is located in the center of the building.)

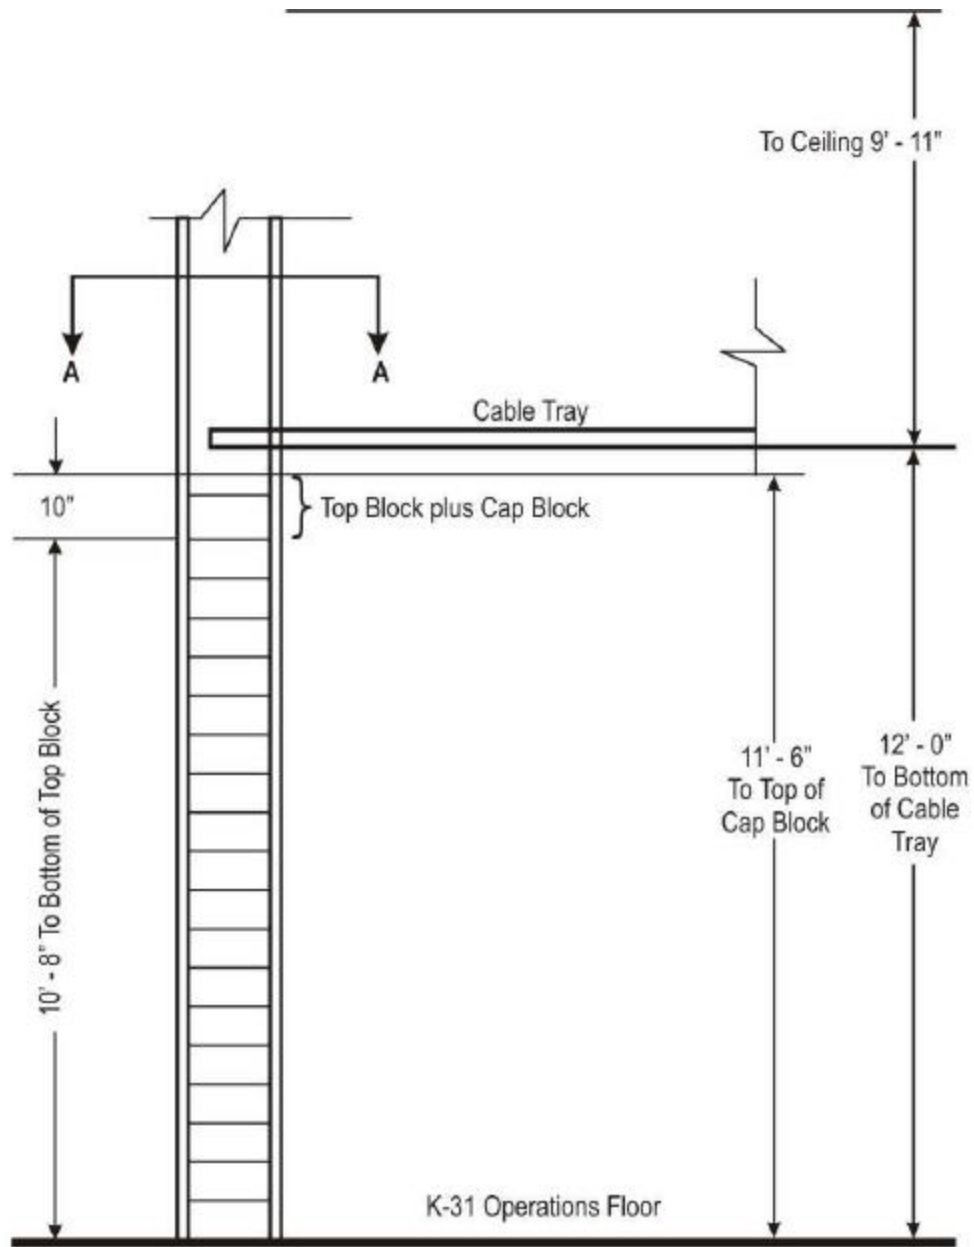
**Elevation View of Column N25**  
(Looking North)

An elevation schematic of Column N25 depicting where the Pipefitter was standing is shown in Figure 2-2. Figure 2-3 provides elevation and plan schematics of Column N25 and pertinent dimensions. Figure 2-4 shows a section view of the wide-flange column and top view of the cable tray that ran in front of Column N25 at the time of the accident. (*Note:* The section of cable tray shown in the schematic had been removed before the Type B Investigation began.)

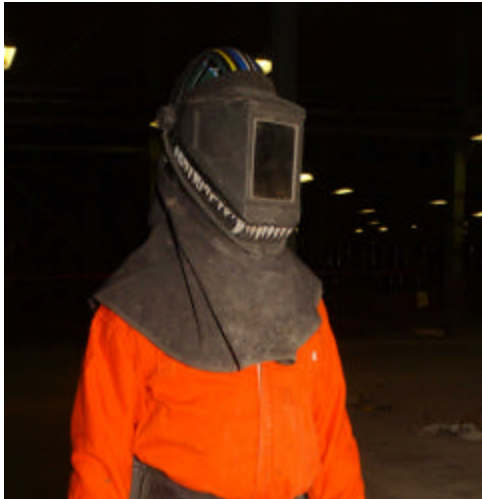
**Exhibit 2-10-a. Worker Wearing  
Flame Retardant Anti-C PPE  
(with Cutting Shield Down)**

Metatarsal guards, which were identified for use in the draft critique planned by the Building Manager, are sometimes worn for hand demolition work. The guards were not part of the crew's PPE. Metatarsal guards (see an example of a metatarsal guard in Exhibit 2-11) are tested in the same manner as a steel-toe, work boot and classed accordingly (75, 50, and 30 pounds) (ANSI Standard Z41-1991, Personal Protective Footwear). A metatarsal guard would also equate to protection of approximately 110 foot-pounds of kinetic energy. Based on the class ratings of work boots and metatarsal guards, neither of these types of PPE would have supported the 500 foot-pounds of energy released by the impact of the free-falling concrete block.
