**Type B Accident Investigation of the
August 5, 2003 Plutonium-238 Multiple
Uptake Event at the Plutonium Facility,
Los Alamos National Laboratory
New Mexico**

December 2003

**National Nuclear Security Administration
United States Department of Energy
Washington, DC 20585**

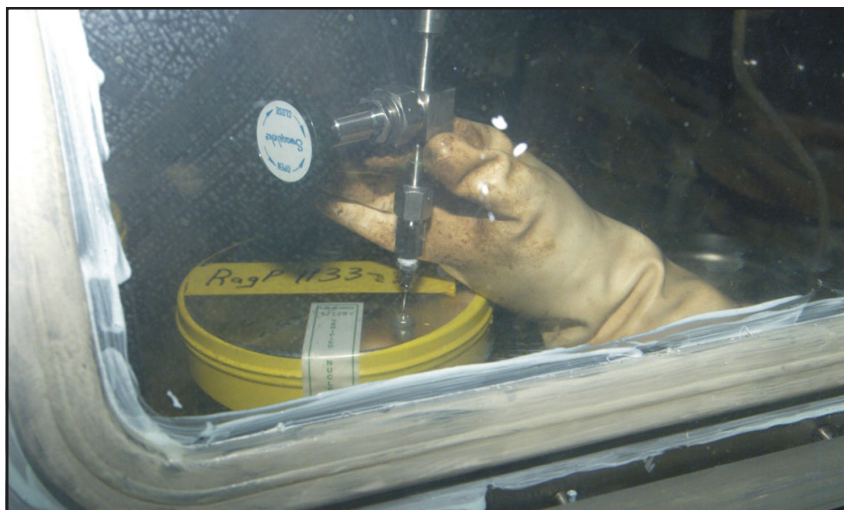
The packages were disassembled in an inert-atmosphere glovebox to evaluate their contents. When the tape was removed from the lid of the outer cans, rust deposits were observed on the tape where the tape was in contact with the lid seal (see Exhibit 2-7). In all three packages, the buildup of rust in the gap between the outer can lid and the lip of the can was extensive. In fact, for one of the packages (P1) it was necessary to pry the outer can lid off because

of this rust buildup. Samples of the outer can rust were analyzed with a scanning electron microscope to determine their content. As expected, iron oxide was the major component, however there was a notable amount of chlorine present in the samples, which was likely due to the degradation of the PVC bags. The hydrogen chloride generated from the bag would combine with the water vapor and form hydrochloric acid, which would then attack the outer can. This would accelerate the corrosion process.

Exhibit 2-6 shows the head gas sample being taken on one of the packages.
