**Type B Accident Investigation
Board Report**

**Subcontractor Radioactive Release During the
May 14, 2004, Transportation Activities
Bechtel Jacobs Company LLC
Oak Ridge, Tennessee**

June 2004

**U.S. Department of Energy
Oak Ridge Operations Office**

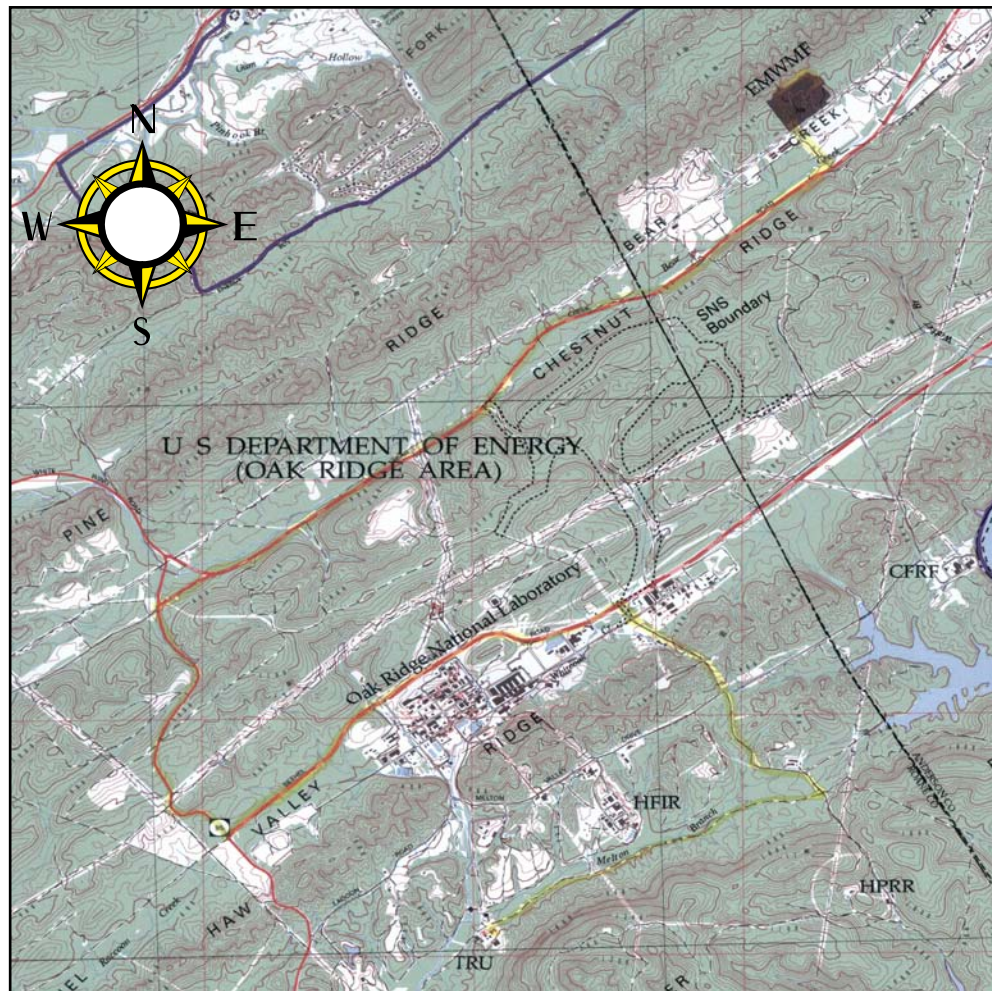
Figure 2-1. Map with Shipment Route for Tank T-12 Highlighted in Yellow

As a result of these initial surveys, the investigation into radiological contamination was extended to the entire truck route (see Figure 2-1). At approximately 1:00 p.m., the truck was moved to a controlled area within the EMWMF where any liquid leakage could be contained. Contamination of the road along the truck route at the Oak Ridge National Laboratory (ORNL) was confirmed by 1:20 p.m.

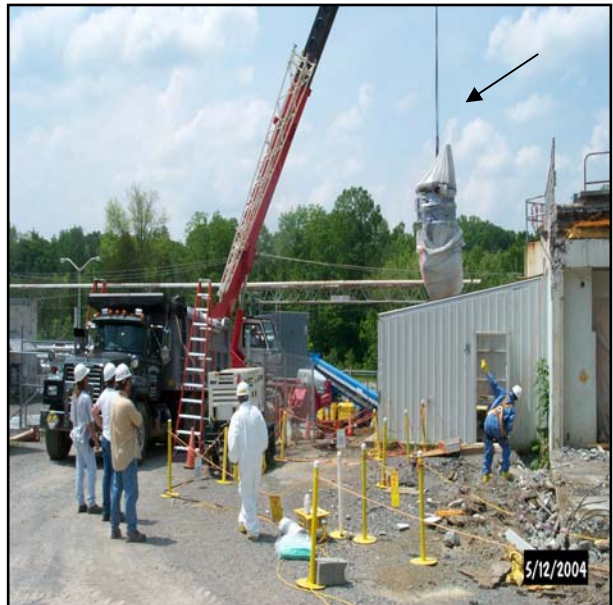
Figure 2-2. Lifting a Tank from the T-13 Annex

On April 16, 2004, in order to comply with the EMWMF WAC, Tank T-12 was grouted to fill the void space. On April 19, 2004, two variance requests were submitted due to a concern for Tank T-12's overall size and dose rates. The following day, the tank was lifted from the mixing cell, wrapped in plastic, and placed in the T-13 Annex for interim storage. See Figure 2-2 for a photograph of this lifting process. The BJC STR's progress report notes that during the lift, there was liquid leaking from the opening that had been capped with a piece of plywood and a notification was made to SEC RADCON. The Board found no evidence to indicate this condition was evaluated further.
