**TYPE B ACCIDENT
INVESTIGATION BOARD REPORT
OF THE JULY 2, 1997
CURIUM INTAKE BY SHREDDER OPERATOR
AT BUILDING 513
LAWRENCE LIVERMORE NATIONAL LABORATORY,
LIVERMORE, CALIFORNIA**

This report is an independent product of the Type B Accident Investigation Board appointed by James M. Turner, Ph.D., Manager of the U.S. Department of Energy, Oakland Operations Office.

The Board was appointed to perform a Type B Investigation of this accident and to prepare an investigation report in accordance with the DOE Order 225.1, *Accident Investigations*.

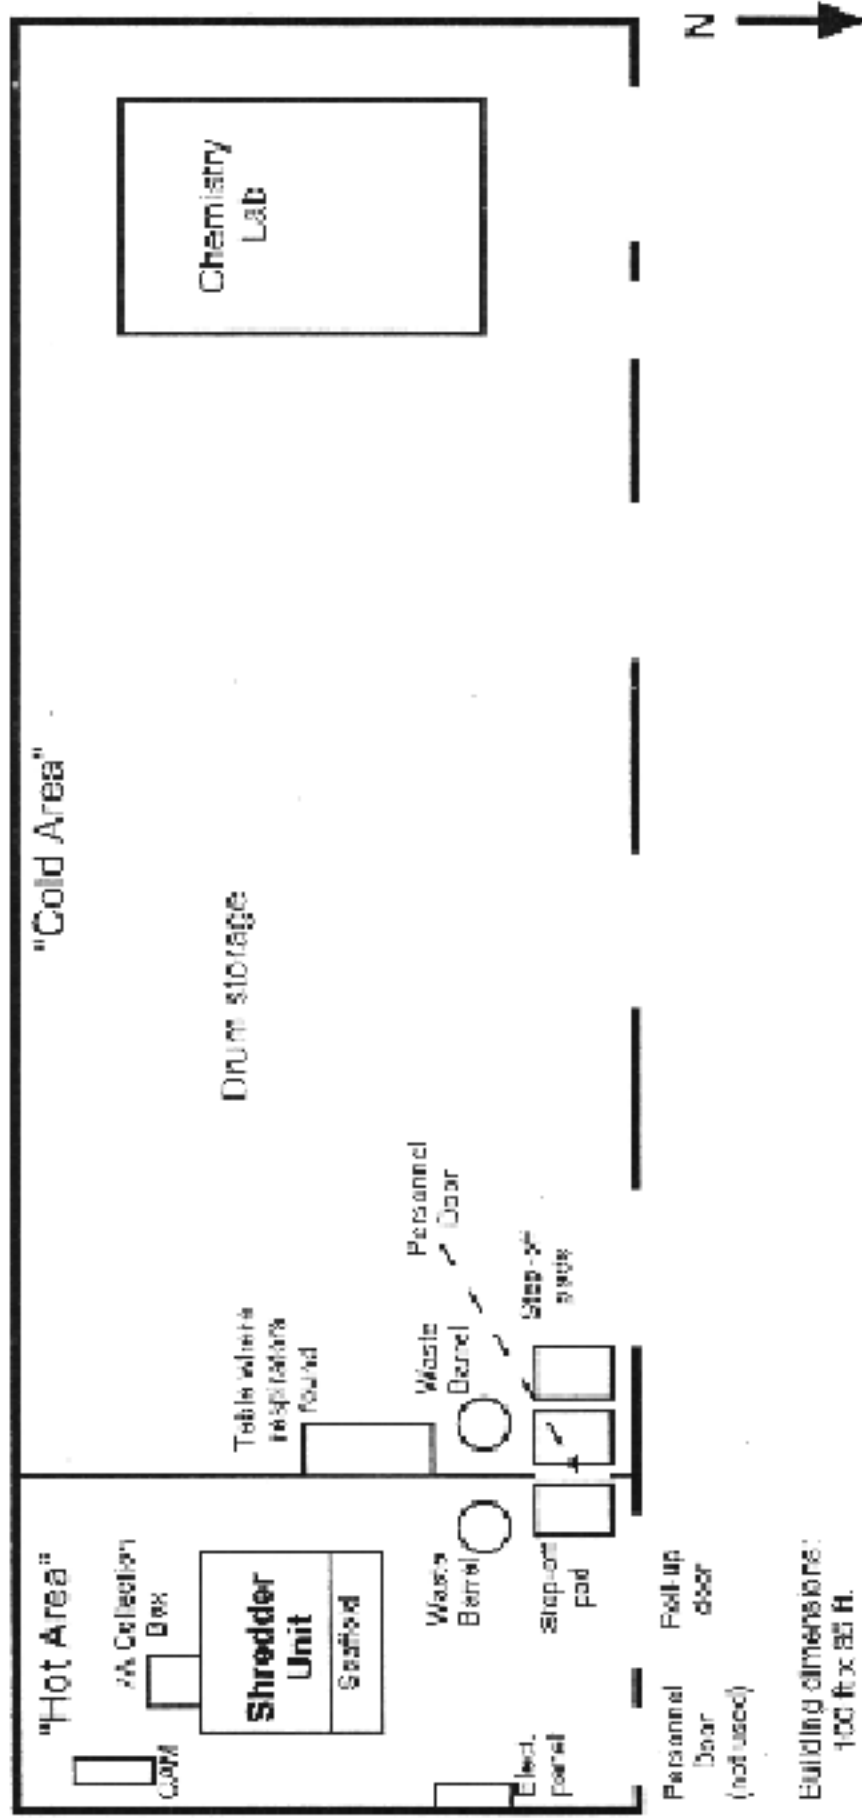
Figure 1-1: Floor Plan of Building 513

B-513 is a pre-engineered, one-story building totaling approximately 3,500 square feet area (see Figure 1-1, Floor Plan of Building 513). Construction is of metal sheeting bolted to a steel framework on a concrete slab floor. It has five metal roll-up doors and two personnel access doors along its north side. The ventilation in the building is controlled by louvers in the east and west walls, two ceiling-mounted electric supply fans/heaters, and five passive roof vents.

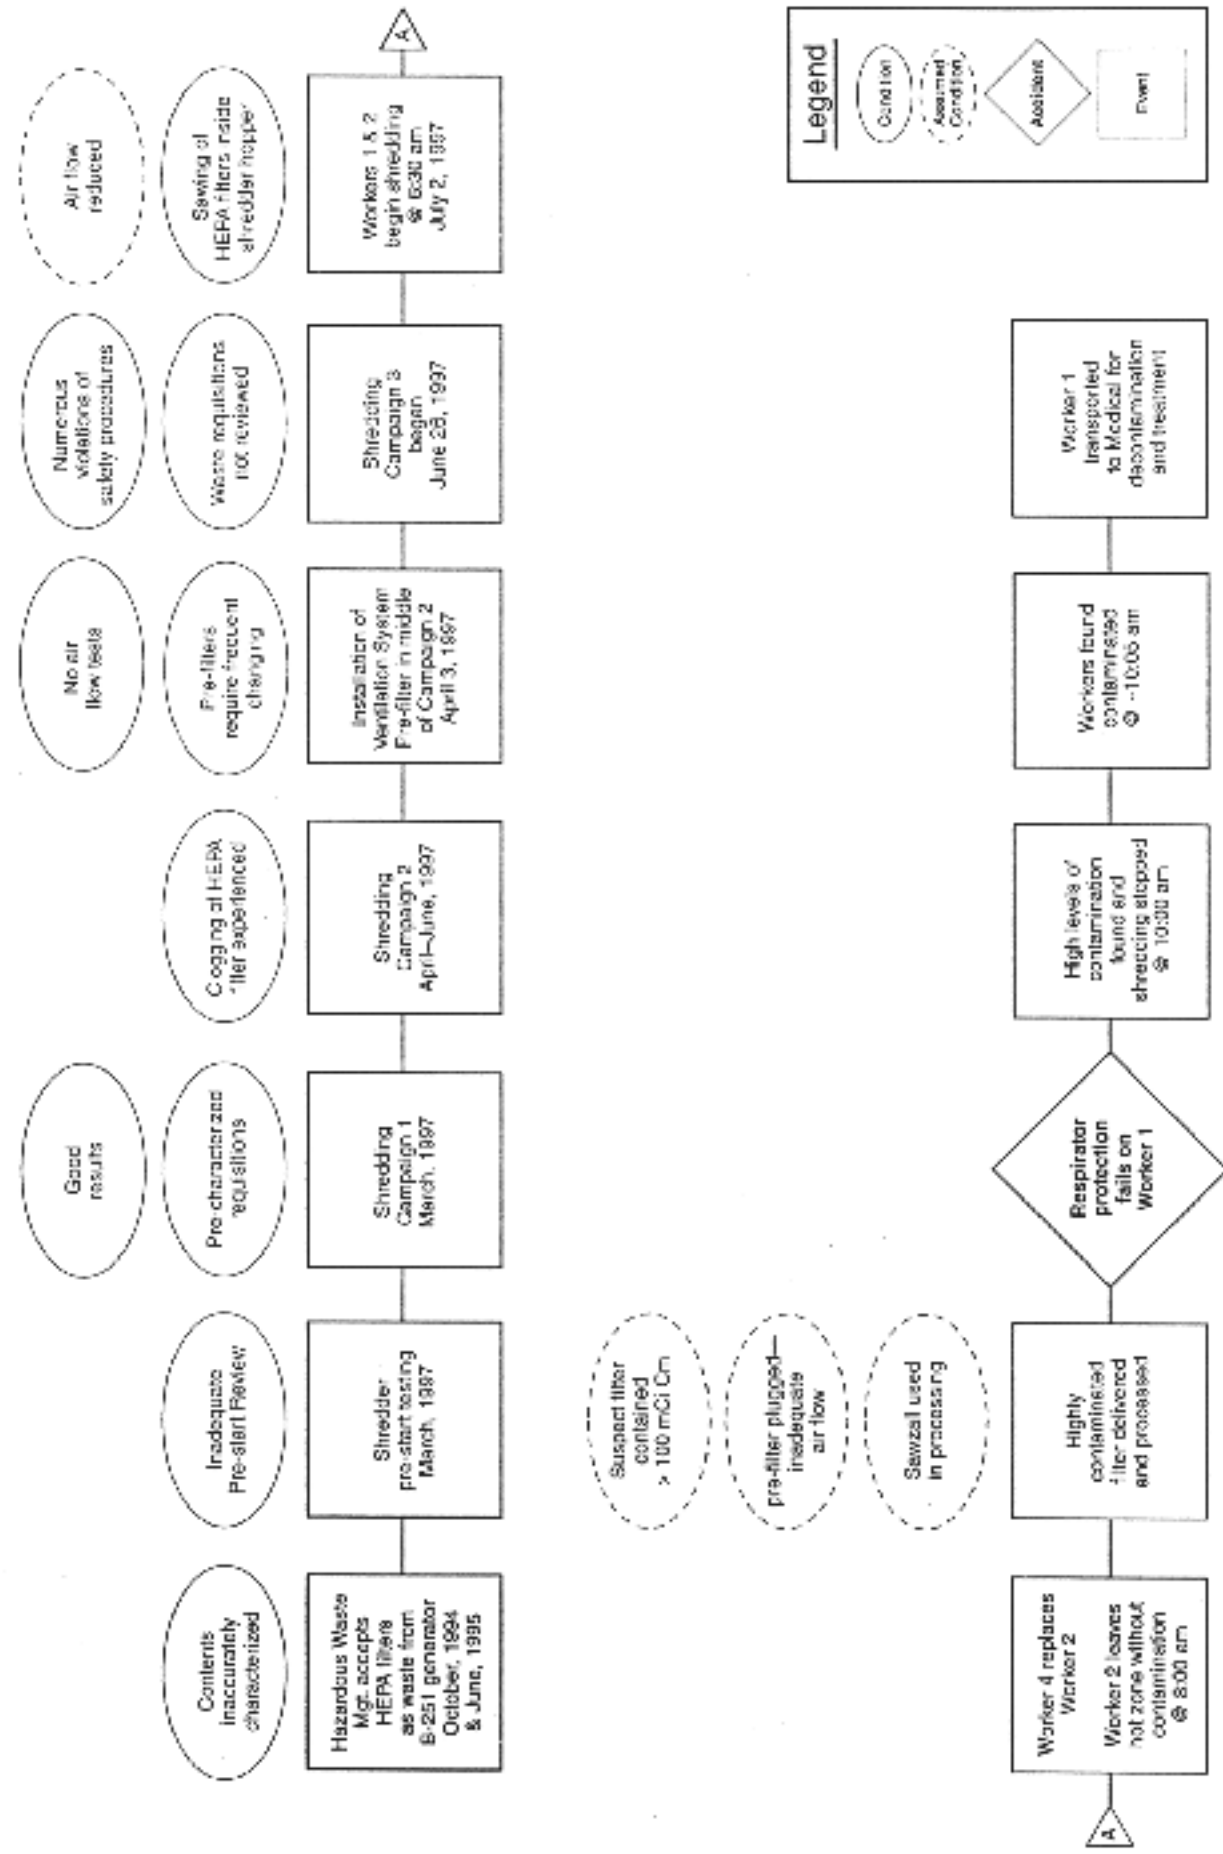
Figure 2-1: Summary Events Chart and Accident Chronology

A time-line documenting key events that lead up to the July 2, 1997 accident is illustrated in Figure 2-1, Summary Events Chart and Accident Chronology.
