**Type B Accident
Investigation Board Report
on the March 27, 1998
Rotating Shaft Accident
at
Ames Laboratory
Ames, Iowa**

April 1998

**Chicago Operations Office
U.S. Department of Energy**

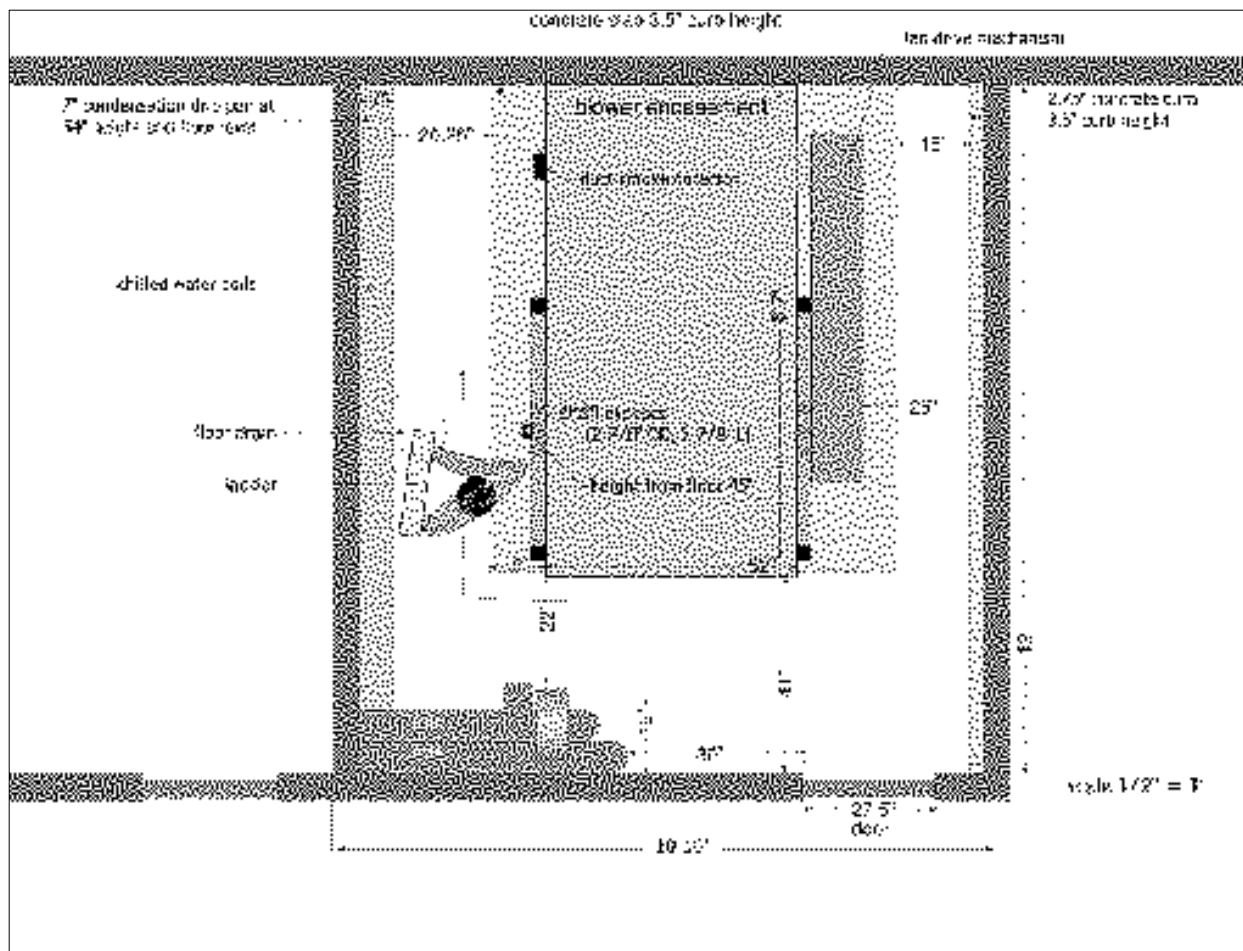
Figure 2-1. Supply Fan Room Layout

The Mechanic and Electrician entered the supply fan room to scope the job and determine what equipment would be needed – the fan and chiller (see Figure 2-1 and Exhibit 2-1) were on while they were inside the supply fan room at this time. The Electrician left the area to get the necessary tools and, having felt cold in the supply fan room, returned with a nylon jacket on. The jacket was not buttoned.
