**Type B Accident Investigation Board Report
on the September 4, 1998,
Flammable Liquid Fire/Explosion
at Fermi National Accelerator Laboratory
Batavia, Illinois**

October 16, 1998

**Chicago Operations Office
U.S. Department of Energy**

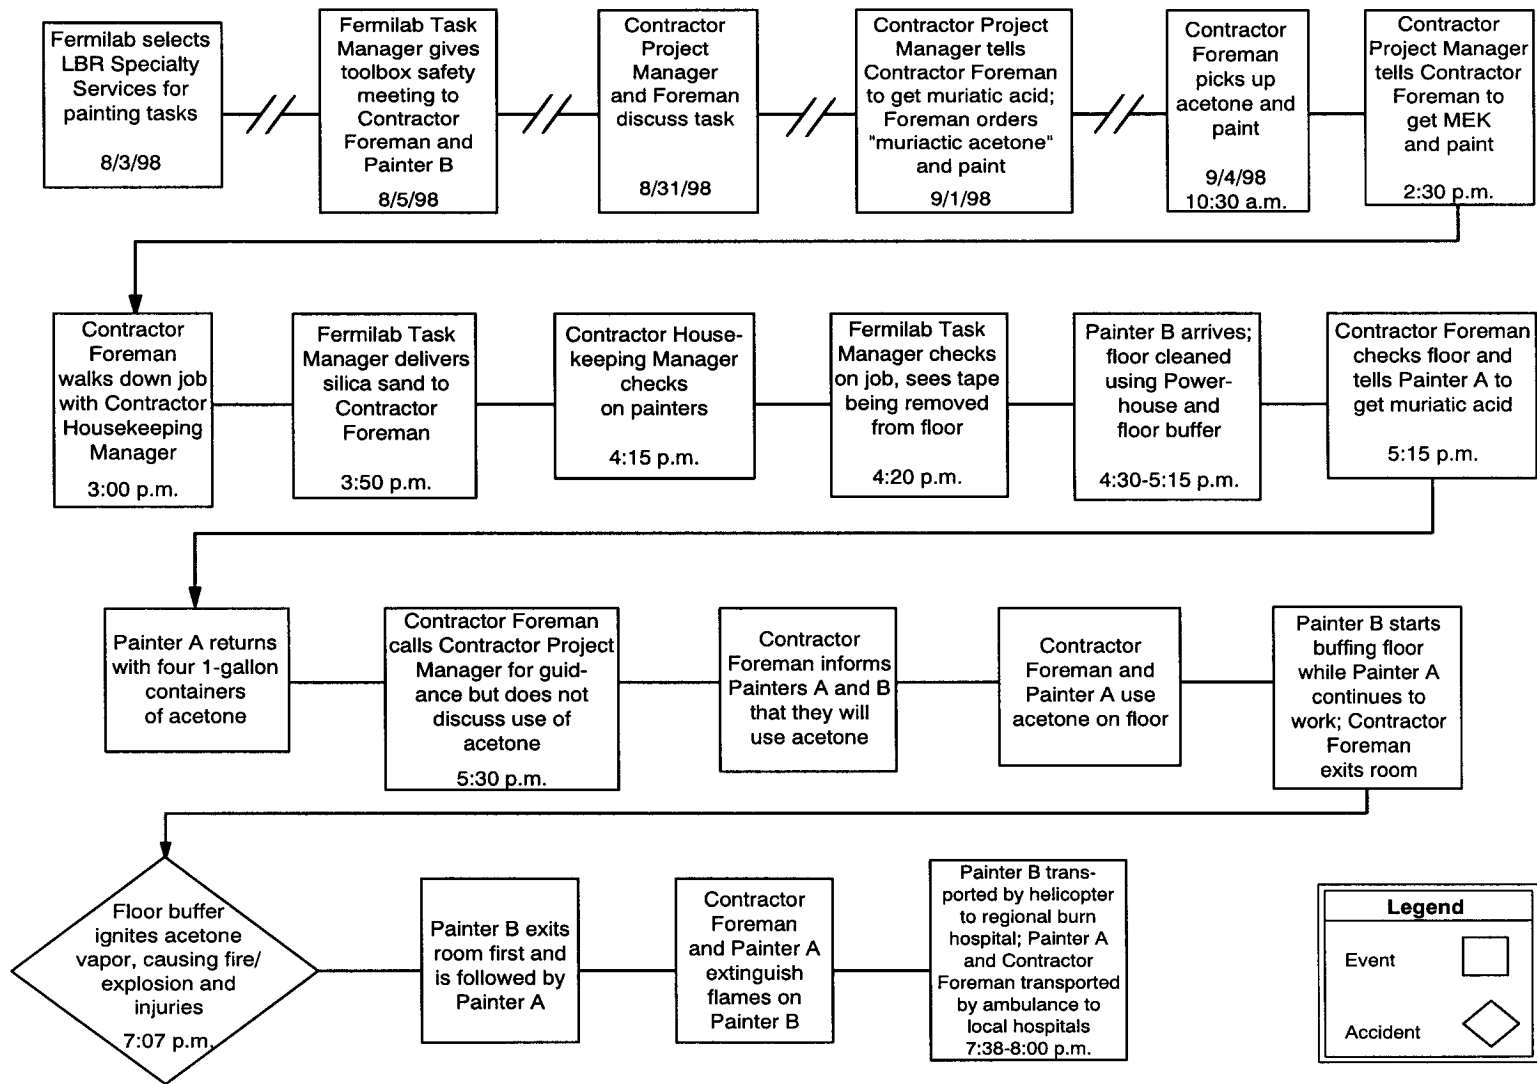
FIGURE 5 Summary of Significant Events and Accident Chronology (all times are approximate)

Figure 5 summarizes the chronology of events leading up to the fire and explosion.

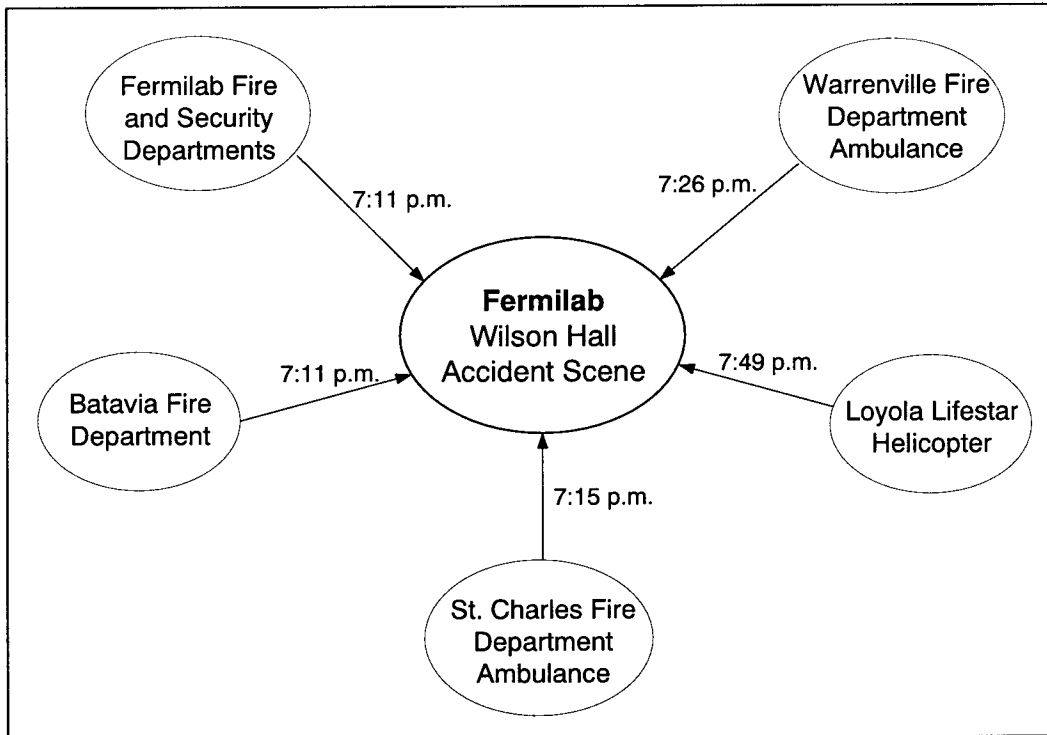
FIGURE 6 Emergency Responders and Arrival Times

The initial emergency response involved the Fermilab Fire and Security departments and four other mutual aid companies as shown in Figure 6. The Board concluded that the initial

The Board concluded that the initial response was timely and well coordinated.

response for fire-fighting activities, medical treatment of injured, and bringing the scene to a safe condition was timely and well coordinated. See Appendix B for a detailed sequence of events.
