**Type B Accident  
Investigation Board Report  
on the Worker Injury  
at the BNFL Inc.  
East Tennessee Technology Park  
Three-Building Decontamination and  
Decommissioning and Recycle Project  
Site**

Oak Ridge Operations  
U.S. Department of Energy

**May 1999**

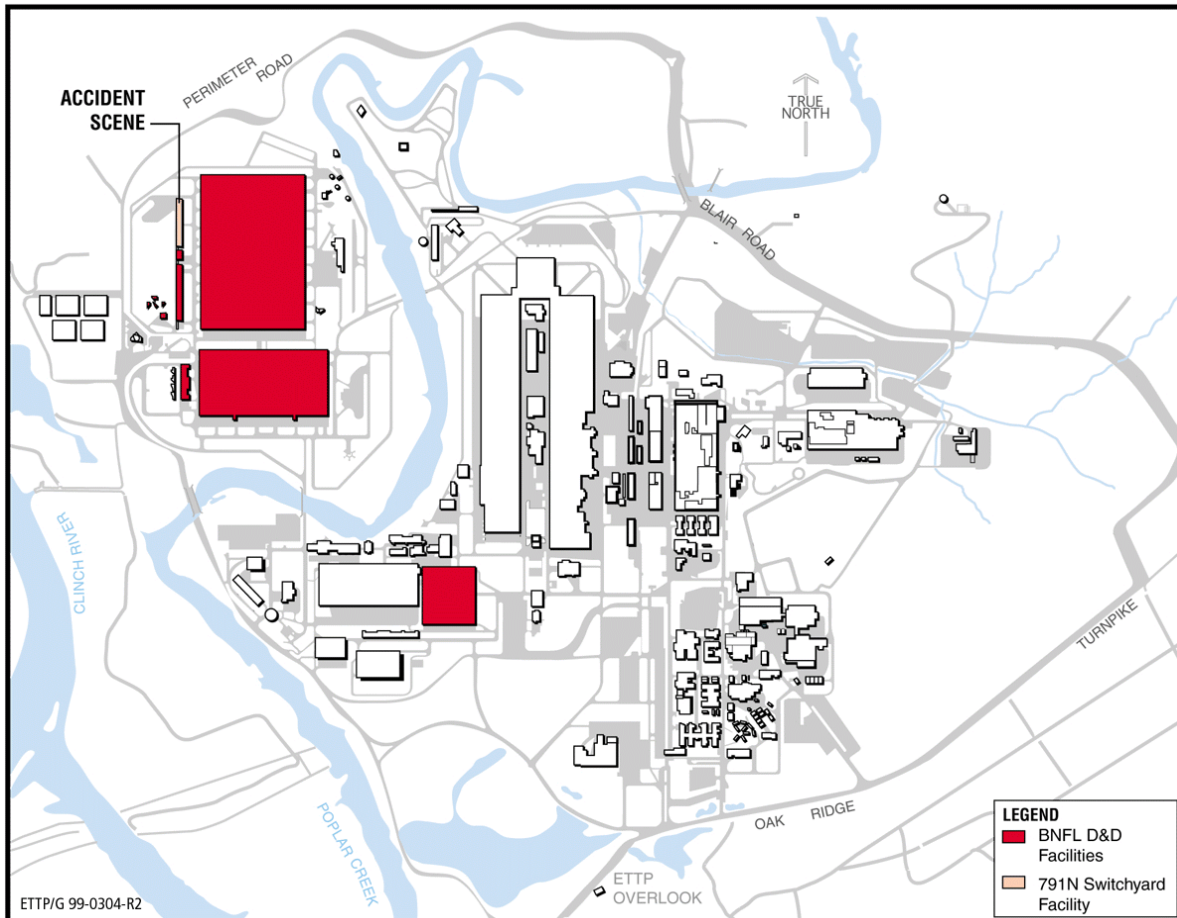
On March 26, 1999, at approximately 11:00 a.m., an ironworker apprentice employed by IDM Environmental Corporation (IDM) was injured by a flying piece of chainlink fence. At the time of the accident, he and a coworker were egressing a work area at Building K-791 North in the K-33 Switchyard where they had been removing buss bars from air circuit breaker (ACB) cabinets. The K-33 Switchyard is located at the East Tennessee Technology Park (ETTP) Three-Building Decontamination and Decommissioning (D&D) and Recycle Project site, which is operated by BNFL Inc. (BNFL) under contract no. DE-AC05-97OR22576 to the U.S. Department of Energy (DOE). *Figure 1-1* shows the Three-Building D&D and Recycle Project site's location at ETTP and delineates the area where the accident occurred.

Figure 1-1. ETTP Three-Building D&D and Recycle Project Site and Accident Location.

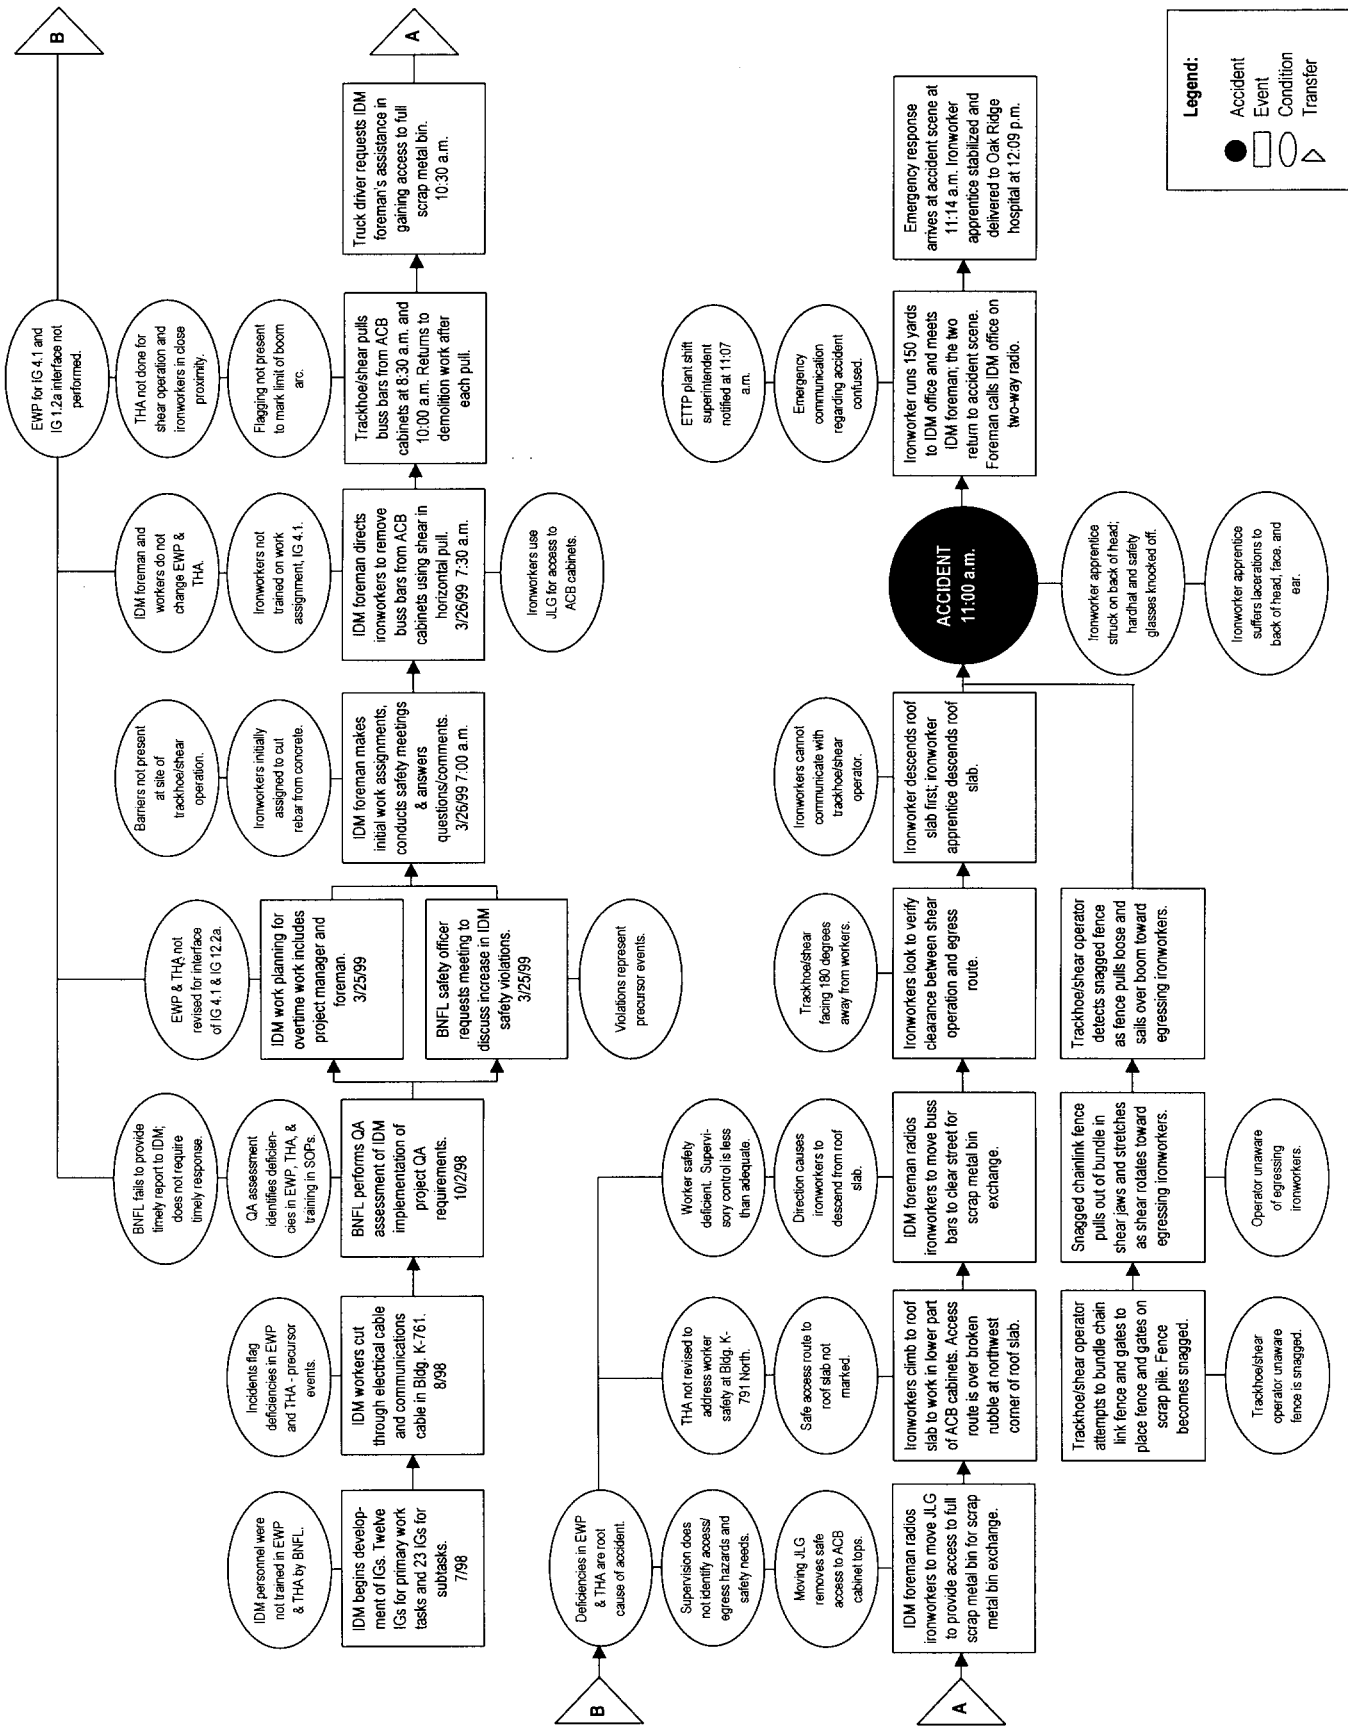
The following are facts associated with the significant events preceding the accident. *Figure 2-1* summarizes the chronology of significant events and associated causal factors.

Figure 2-1. Summary Events and Causal Factors Analysis
