Accident Investigation Report

Serious Personal Injury While Doble Testing

May 19, 1999

***Hayden Substation
Hayden, Colorado***

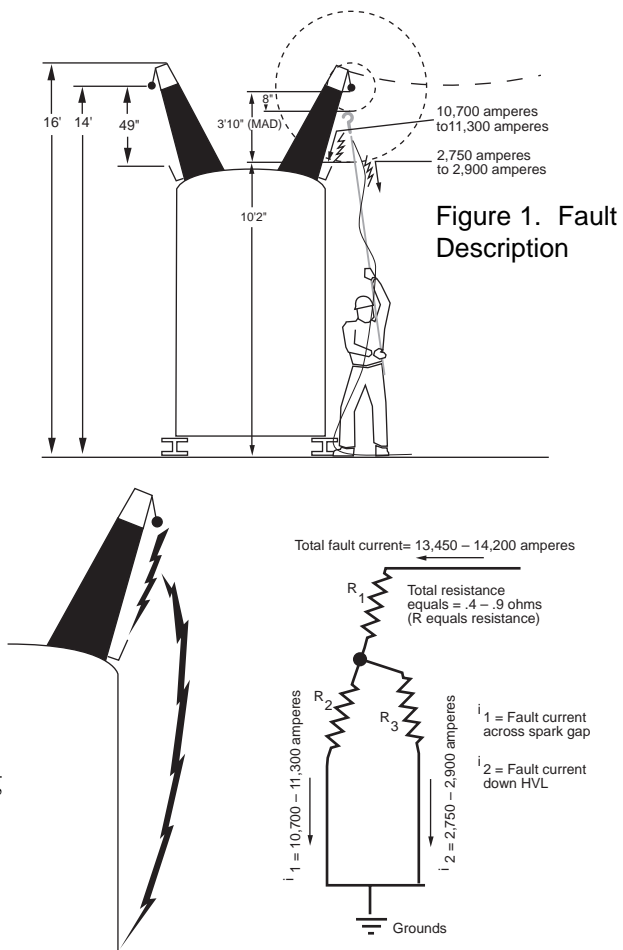
See enlarged drawing on page 27

As Electrician 3 was walking backward taking up the slack of the HVL, he held the hotstick in a nearly vertical position. With the grounded HVL still attached to the top of the hotstick, the hook of the HVL got within 8 to 10 inches of the spark gap located on the top of bushing 5 of the energized 138-kV BK 2772. It initiated an arcing fault to ground. (See Exhibits B and G.) The fault current had a magnitude between 13,450 and 14,200 amperes that split, with the majority (10,700 – 11,300 amperes) traveling to ground through the spark gap. The remaining fault current (2,750 – 2,900 amperes) flashed down the HVL, which was against the hotstick and Electrician 3, causing his clothing to ignite. (See Exhibits C and F.)

The arc flashed down the HVL and launched the HVL's attachment hook from the end of the lead to approximately 120 feet from the fault location. The fault current down the HVL reached ground potential on the corner of the grounded circuit breaker, the grounded Doble test

equipment (see Exhibit D) and the grounded test trailer (see Exhibit A). The blast from the arcs caused Electrician 2 to fall from the ladder from a height of about 5 feet above the ground. Immediately following the explosion, the Acting Foreman turned and saw Electrician 3 fall to the ground with his clothing on fire. Fault current within the ground shield and the conductor of the HVL overloaded the Doble test equipment located in the test trailer, creating an explosion and causing Electrician 1 to fall to the floor. The trailer immediately filled with smoke following the explosion (see Exhibit E).
