Type B
Accident Investigation Board Report
Of the November 1, 1999
Construction Injury
At the
Monticello Mill Tailings Remedial Action
Site
Monticello, Utah

December 1999
Albuquerque Operations Office
U.S. Department of Energy

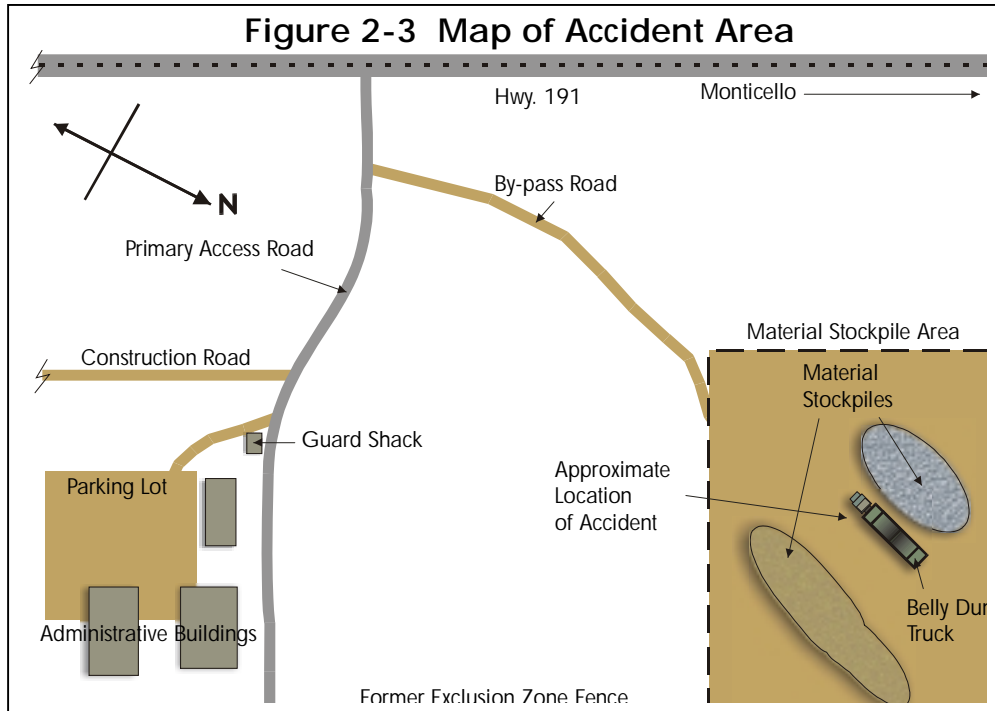
- On May 4, 1999, Crowley received purchase order from OHM to produce and deliver sand and rock.
- On October 19, 1999, Crowley received contract from MACTEC to re-contour a MPP adjacent to the millsite.
- On October 25, 1999, Crowley hired trucks and drivers from four truck owners, since Crowley did not have enough equipment to perform both jobs.
- On October 25, 1999, a truck owner hired Driver 1 and provided a belly dump truck. The belly dump trailer had been idle for one year.

- On November 1, 1999, Driver 1 delivered three truckloads of rock. Belly dump truck gates stick on each load.
- On November 1, 1999, Driver 1 opened gates successfully on first two loads using an iron bar.
- On November 1, 1999, on third load, at approximately 11:18 a. m., Driver 1 attempted to pry gates open using the metal bar and was struck by the iron bar as the gates opened.
- On November 1, 1999, at 11:23 a.m., a guard called 911.
- On November 1, 1999, at 11.28 a.m., an ambulance arrived at the accident scene.
