Type B Accident Investigation Board Report

**Arc Flash at
Brookhaven National Laboratory
April 14, 2006**

August 2006

**Brookhaven Site Office
U.S. Department of Energy
Upton, New York**

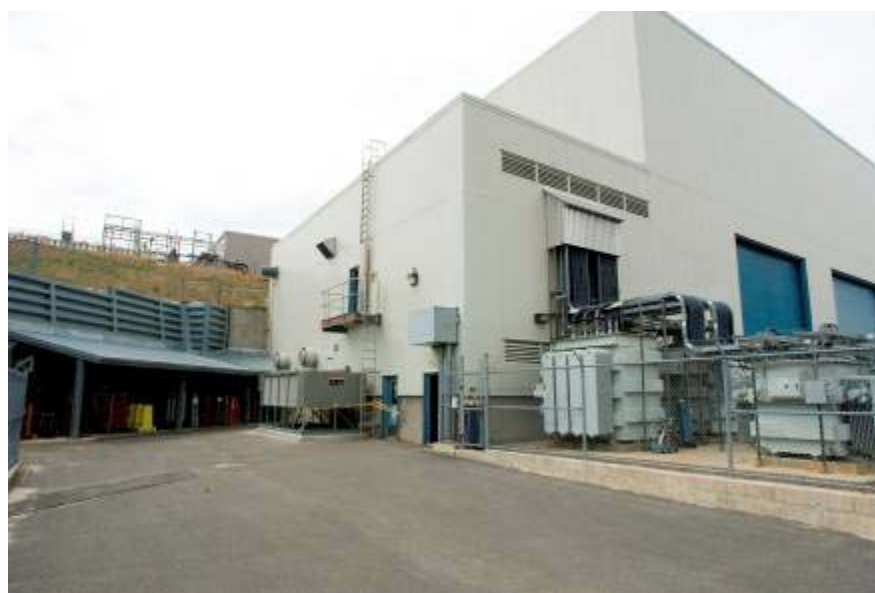
Figure 1-2. Building 1006A
(Arc flash occurred in the Mechanical Equipment Loft on the east side of the building)

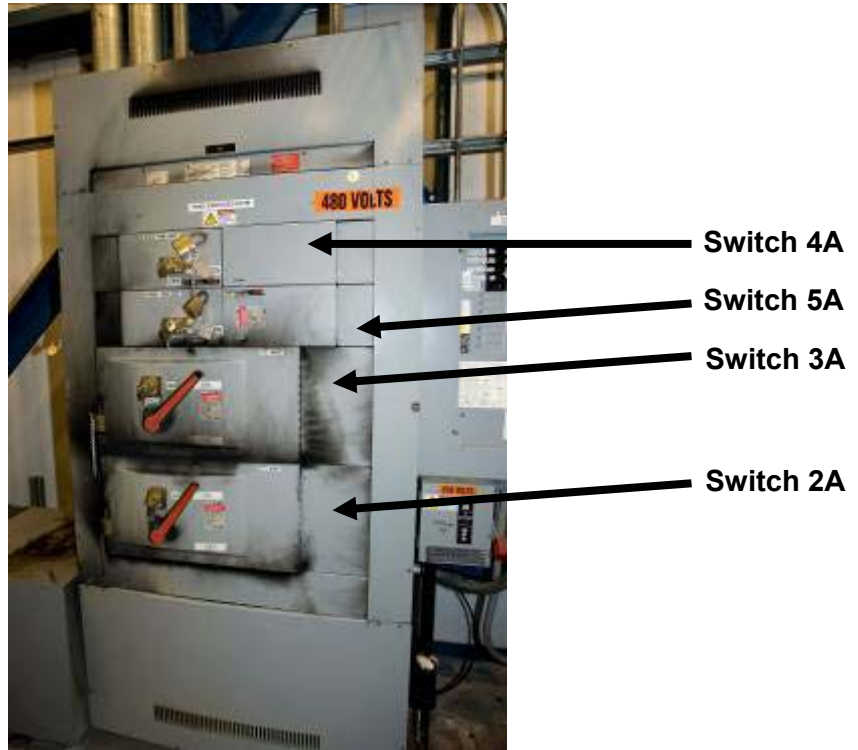
Figure 1-3. Electrical panel PB-1

Possible sources of foreign objects entering into the switches were found in panel PB-1. These consisted of conduits openings that entered panel PB-1. The conduits that had cables installed in them did not have the void spaces filled, and an empty conduit was not capped. No foreign objects were found during the inspection and removal of the failed switches. The switch cabinets covers were in place and locked closed before the arc flash occurred (see Figures 1-3 and 1-4).

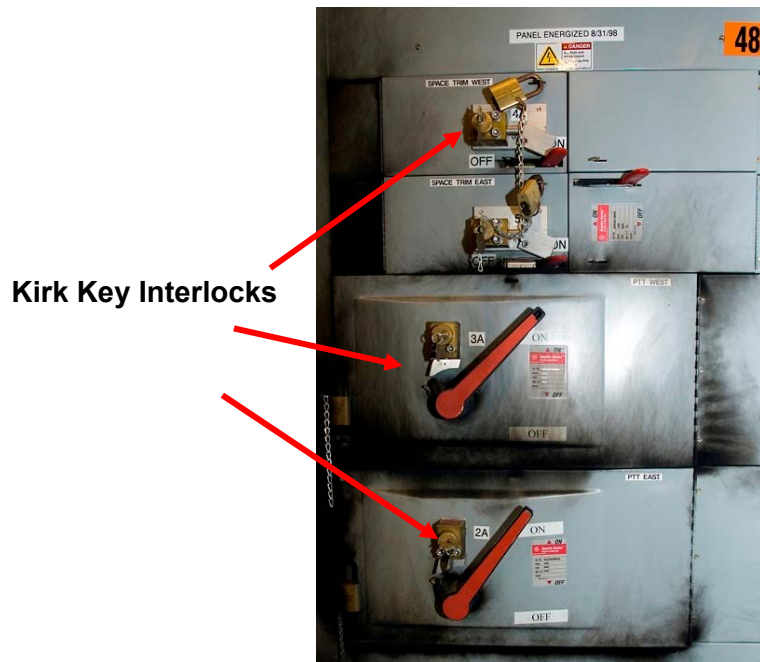
Figure 1-4. Kirk Key interlocks on switches 2A, 3A, 4A, and 5A

The inside of the two 400-amp switches 2A and 3A was coated with a thick layer of black soot. The switch components appeared from the front to be intact, except for thin plastic insulating sheets at the left end of the switches, opposite the load terminals. The left ends of the 400-amp switches were partially blown out, and the adjacent wiring insulation was melted from the heat of the arc flash. The vent panels on the ends of the switches were completely seared by the heat and blown off. The front covers were deformed and would have failed eventually if the fault persisted beyond the 0.2-second clearing time (see Figure 2-5 and Figure 1-4).

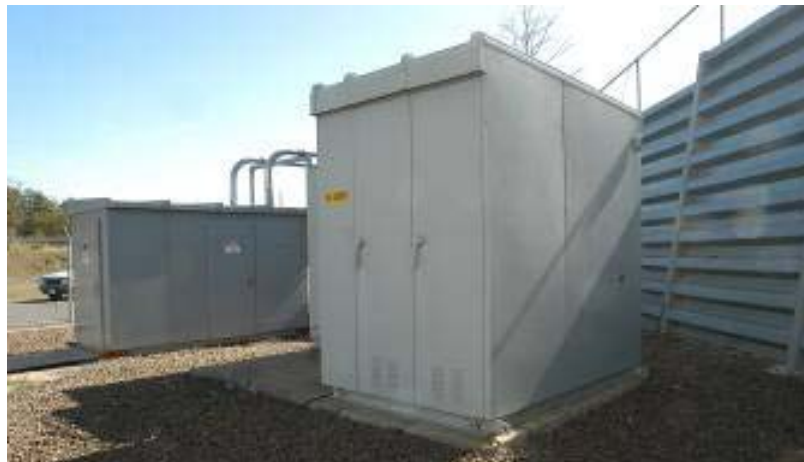
Figure 2-3. Substation 6C outside Building 1006A

The STAR Magnet power supplies receive 13.8-kV electrical power at substation 6C, which is located outside Building 1006A (Figure 2-3). Transformer 6C is a three-winding transformer rated at 3,000 kVA, 13.8 kV/480-volt/480-volt, delta/delta/delta, as shown in the one-line diagram (Figure 2-4). Transformer 6C has two 480-volt secondaries. One of the 480-volt secondaries feeds circuit breakers 6C41 and 6C42 in the outdoor substation as shown in Figure 2-3.

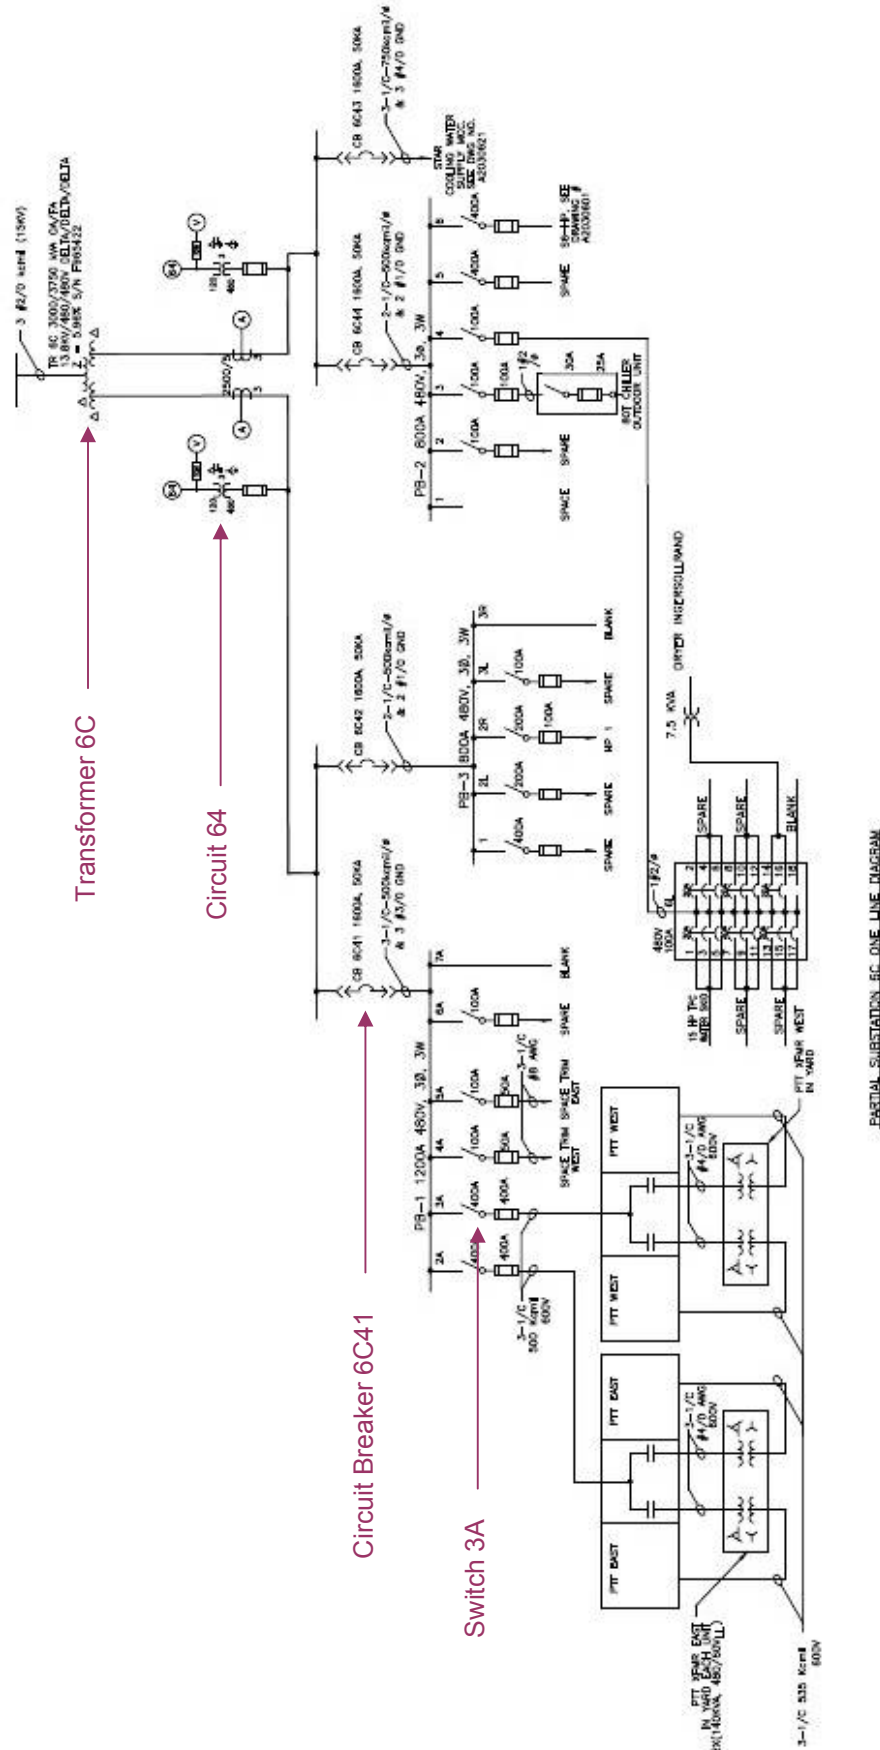
Figure 2-4. Partial one-line diagram substation 6C

Following the accident, BNL calculated the phase-to-ground fault current available at panel PB-1 as 36 kA for bolted faults and 16.7 kA for arcing faults. A bolted fault is caused when either a phase-to-phase or a phase-to-ground is directly connected together (bolted). Arcing faults occur when electrical clearances are reduced or compromised by deteriorating insulation or human error, causing an arc to form phase-to-phase or phase-to-ground. The arc burns in open air, releasing a large amount of energy until an upstream overcurrent protection device opens to clear the fault. Since this was an arcing fault, the current was limited to a maximum of 16.7 kA, which is below the 24-kA instantaneous trip setting of

the upstream circuit breaker (6C41). The short time-setting for circuit breaker 6C41 was 5,760 A, with an intentional 0.15-second time delay. This circuit breaker requires an additional 0.05 seconds to clear a fault, making the total clearing time about 0.2 seconds. Clearing time is the period of time required for the circuit breaker to open, thus “clearing” the fault.

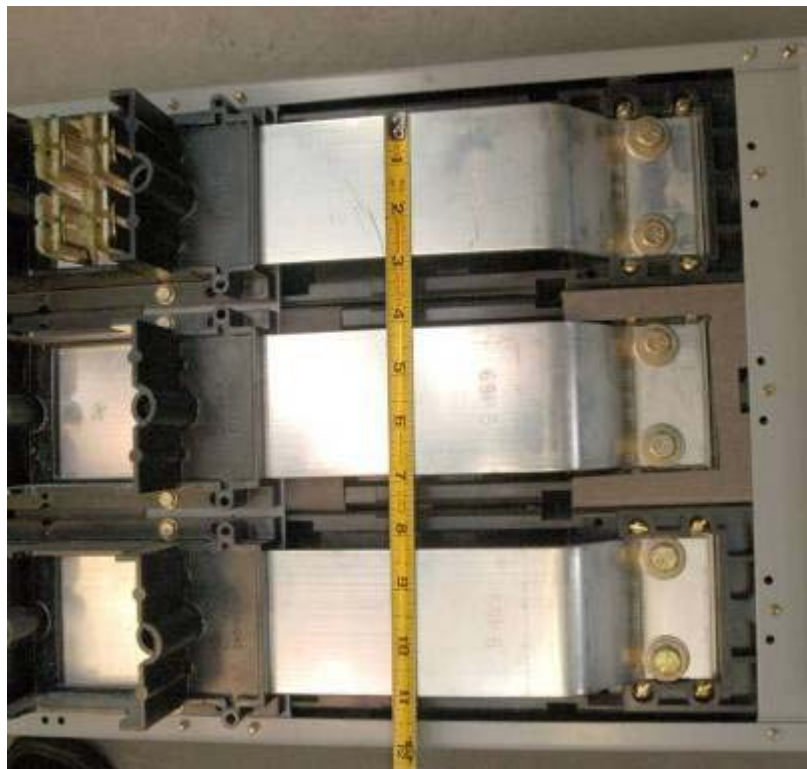
Figure 2-7. Undamaged bus on undamaged switch

Figure 2-7 shows the bus on an undamaged switch in another location that was not involved in the accident. As shown in Figure 2-8, arcing heavily eroded the ends of the switch bus bars, and the head of the attaching bolts were melted. The arcing had enveloped all six busses of the two adjacent switches 3A and 2A.
