**Type B
Accident Investigation
Board Report**

**Bechtel Jacobs Company LLC
Employee Fall Injury on
January 3, 2006,
at the K-25 Building
East Tennessee Technology Park
Oak Ridge, Tennessee**

February 2006

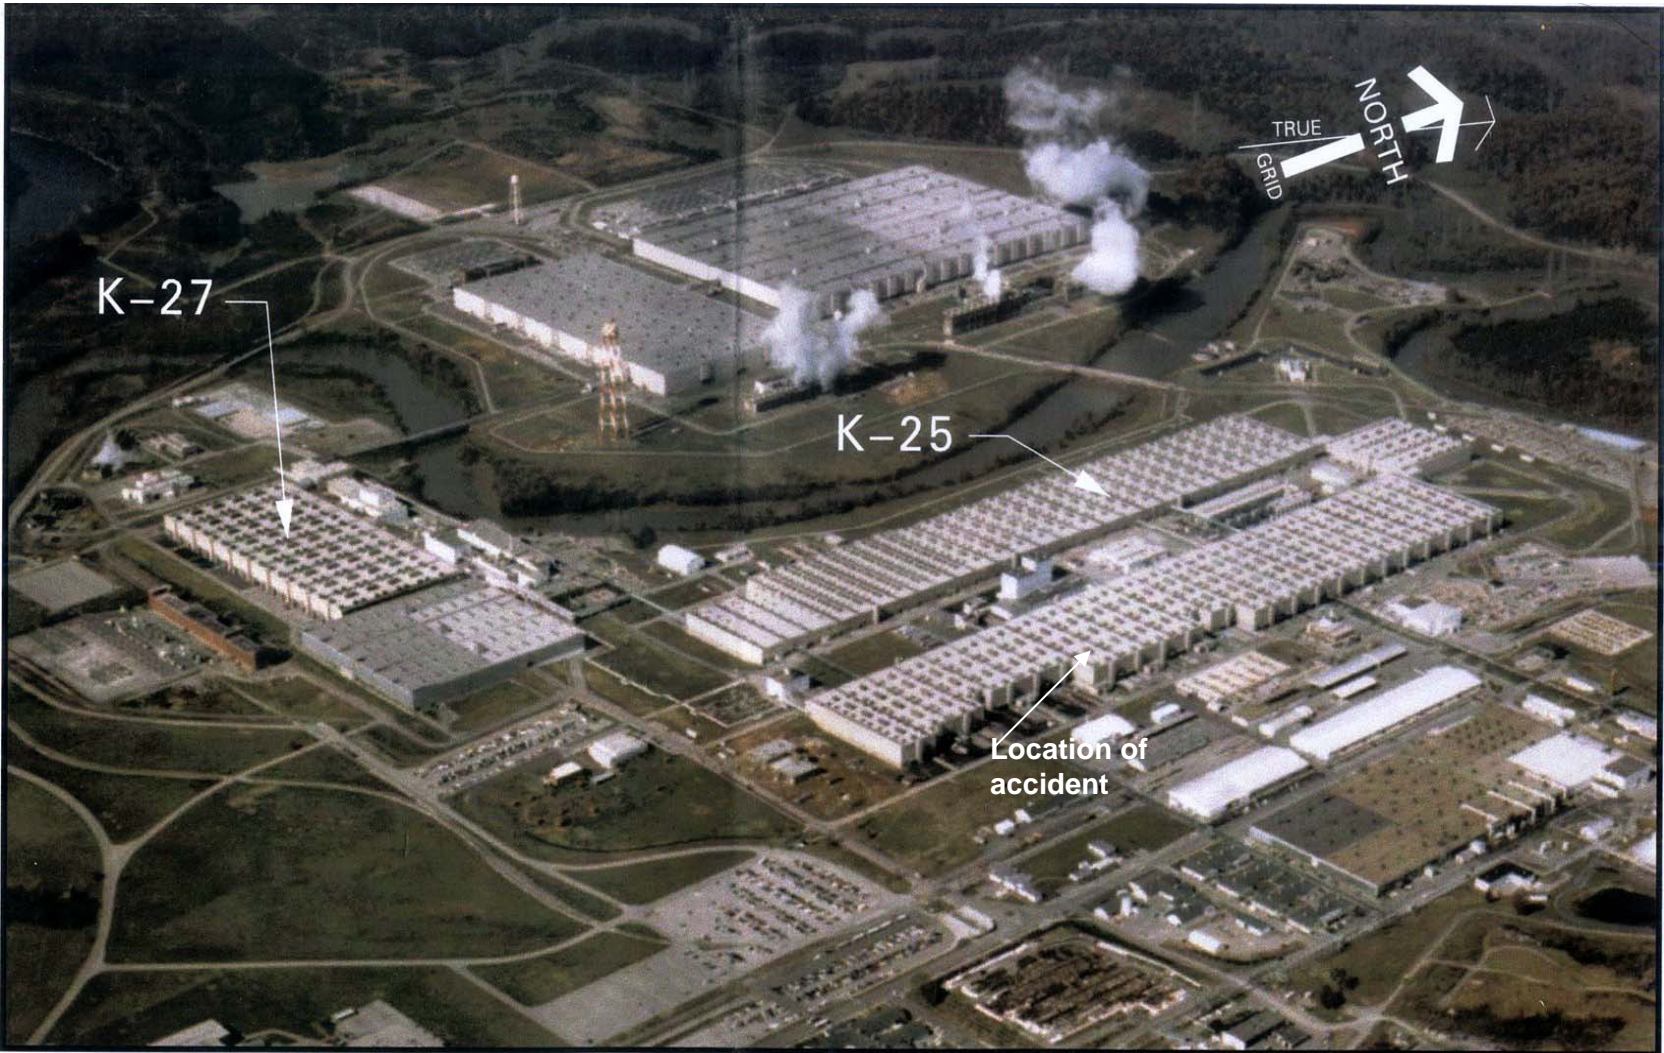
Figure 1-1. Aerial view of the K-25 and K-27 Buildings and the location of the accident

The K-25 and K-27 Buildings are presently part of a D&D program being conducted as a non-time-critical removal action under the Comprehensive Environmental Response, Compensation, and Liability Act. The approach is to remove, segment, stabilize, and package items for shipment and disposal to meet the physical security, nuclear materials control and accountability, and criticality limits for the identified items of high-risk equipment. High-risk equipment is identified as process gas equipment or components containing uranium masses greater than the allowable mass of 350 grams of Uranium-235. Other process gas equipment removal will continue with a similar approach to remove, characterize, stabilize, reduce, size, and package for disposal, as necessary. See Figure 1-1 on the following page for an aerial view of the K-25 and K-27 Buildings and the accident location.

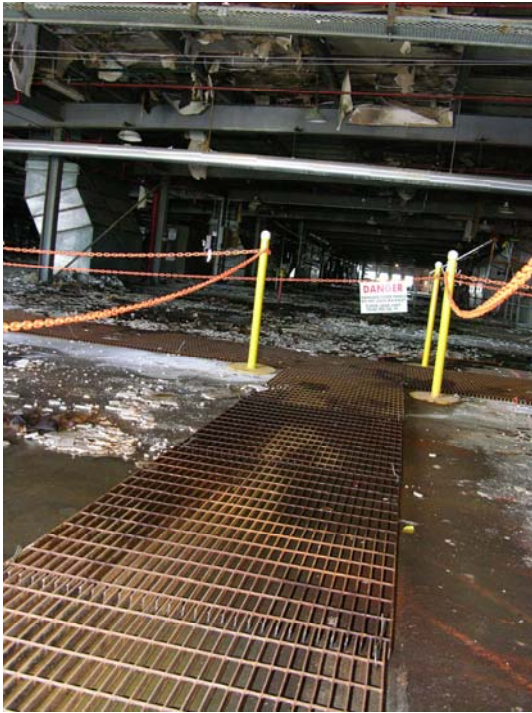
Figure 2-1. Grating walkway on the operating floor.

In June 2005, BJC began installing metal grating on the operating floor of the K-25 Building to establish safe walkways to access the operating floor. These safe walkways allow access to the Radiation/Criticality Accident Alarm System (RCAAS) electrical panels and fire protection equipment without the use of fall protection. The grating spans the building's structural beams, and the grates are lashed together to form a continuous walkway. This work was accomplished under Standing Work Package K25-05-03-1201-00 (Work Package). The portion of the work associated with the accident began in December 2005. Figure 2-1 is a photograph of the grating walkway.

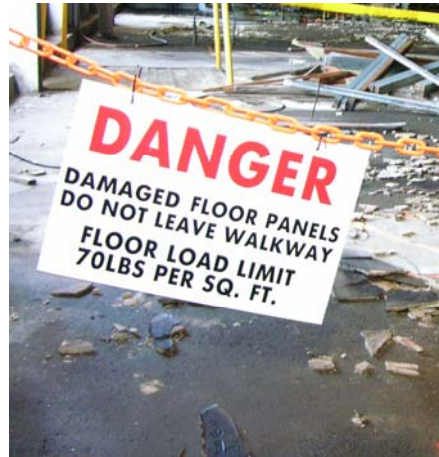
Figure 2-2. Warning sign on the operating floor.

floor. At unit 309-2, the grating was lifted up to the level of the operating floor from outside the east wall through a wall opening in the side of the building using a variable-reach forklift. This location is opposite the west wall where the stairs are located and where the north-south walkway was being installed. The workers installed grating from the wall opening across to where the north-south walkway was being installed to provide a walkway for transport of the grating material. After being laid down on the operating floor, the grating was lashed together at the ends using steel cable and crimps. These walkways are marked on both sides with stanchions, plastic boundary chains, and warning signs that read: "DANGER, Damaged Floor Panels, Do Not Leave Walkway, Floor Load Limit 70 lbs Per Sq. Ft." See Figure 2-2.

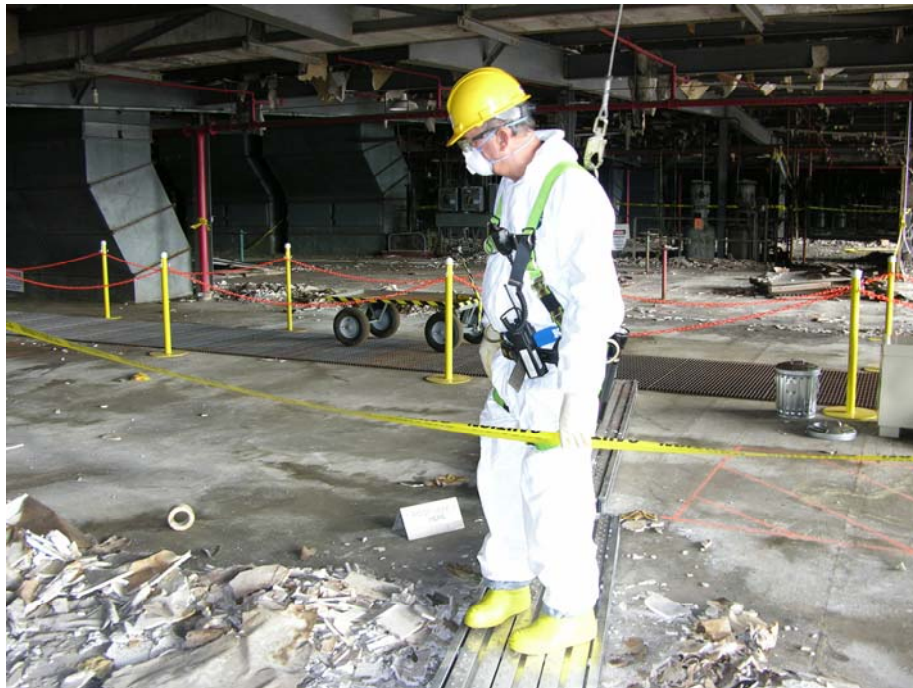
Figure 2-3. Employee wearing Level 1 PPE and a full-body harness with a retractable lifeline.

Additional PPE is added based on the hazard of the work activities, and this PPE may include leather gloves and fall protection equipment. See Figure 2-3 for an example of an employee wearing Level 1 PPE and fall protection equipment.

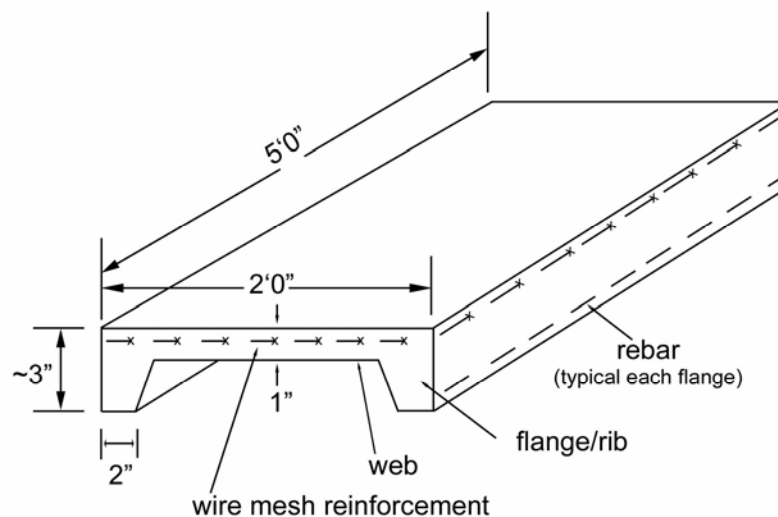
Figure 3-1. Typical dimensions of a concrete floor panel.

The K-25 Building operating floor is the top floor of the building and is constructed primarily of precast, reinforced concrete panels which nominally measure 2-feet-wide by 5-feet-long, with a 1-inch-thick reinforced web and approximately 2-inch by 3-inch flanges that run the entire length of the panel. The panels are supported by steel beams attached to the steel columns and are held in position by placing the panels adjacent to each other. The panels are not mechanically attached to the steel beams. The tops of the panels are covered with a rubberized coating that is approximately 1/2-inch thick. Figure 3-1 provides the typical dimensions of a concrete floor panel.
