**Type B Accident
Investigation Board Report
For the January 11, 2006,
Personal Injury During Table Saw Use
at the
Heyrend Way Facility
Idaho Falls, Idaho**

February 10, 2006

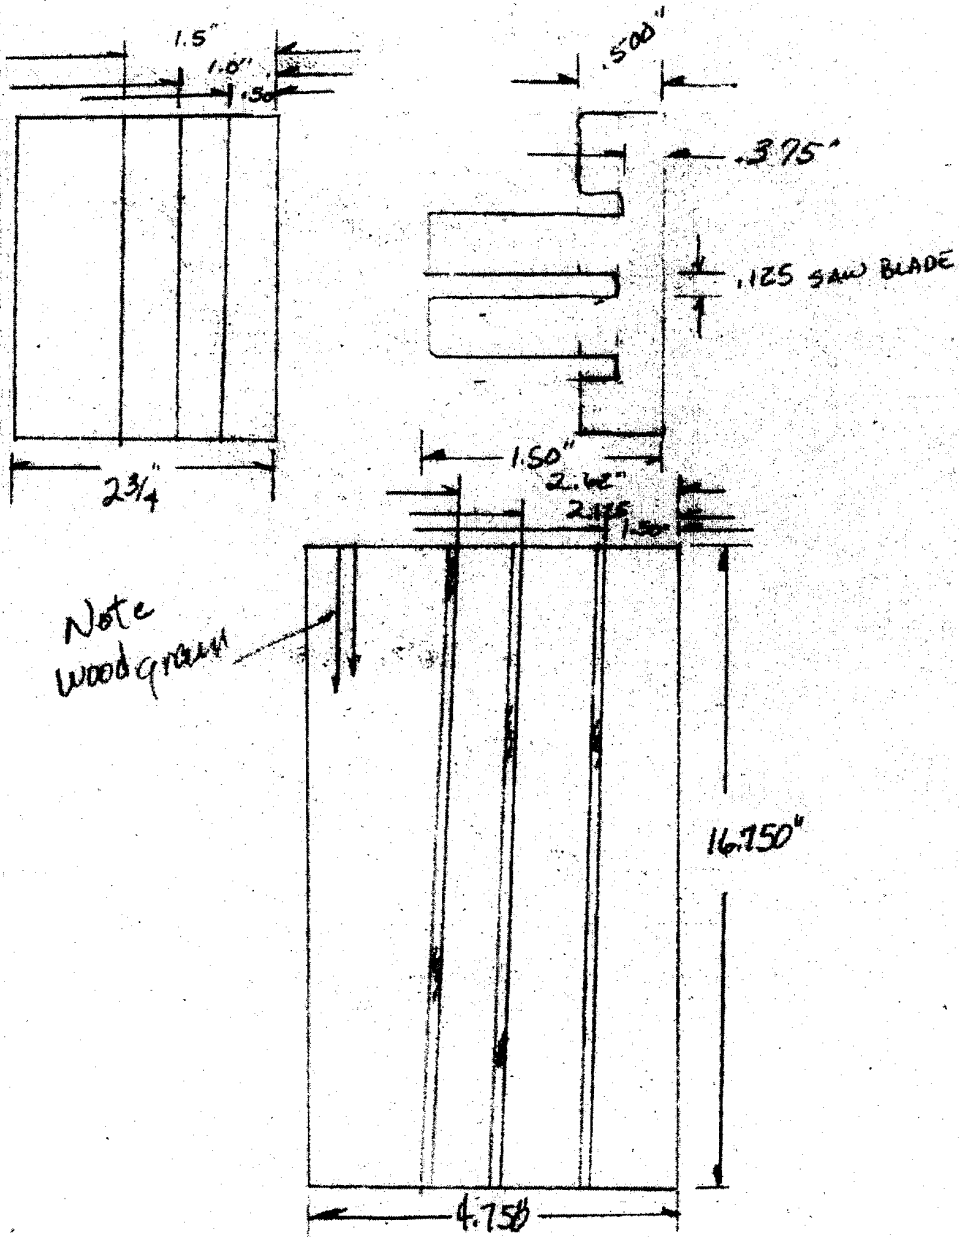
APPENDIX B: TECHNICIAN'S WORK DIAGRAM

SAW BOX BLADE
Poly 1/2" x 13" x 16 3/4" 3ea
Plywood 3/4" x 4 7/8" x 16 3/4" 1ea
H.D. Foam 2" - 11" x 2 3/4" x 13"
