**Type B
Accident Investigation
Board Report**

**Subcontractor Employee
Personal Protective Equipment
Ignition Incident
on February 18, 2003
Bechtel Jacobs Company LLC,
East Tennessee Technology Park,
Oak Ridge, Tennessee**

March 2003

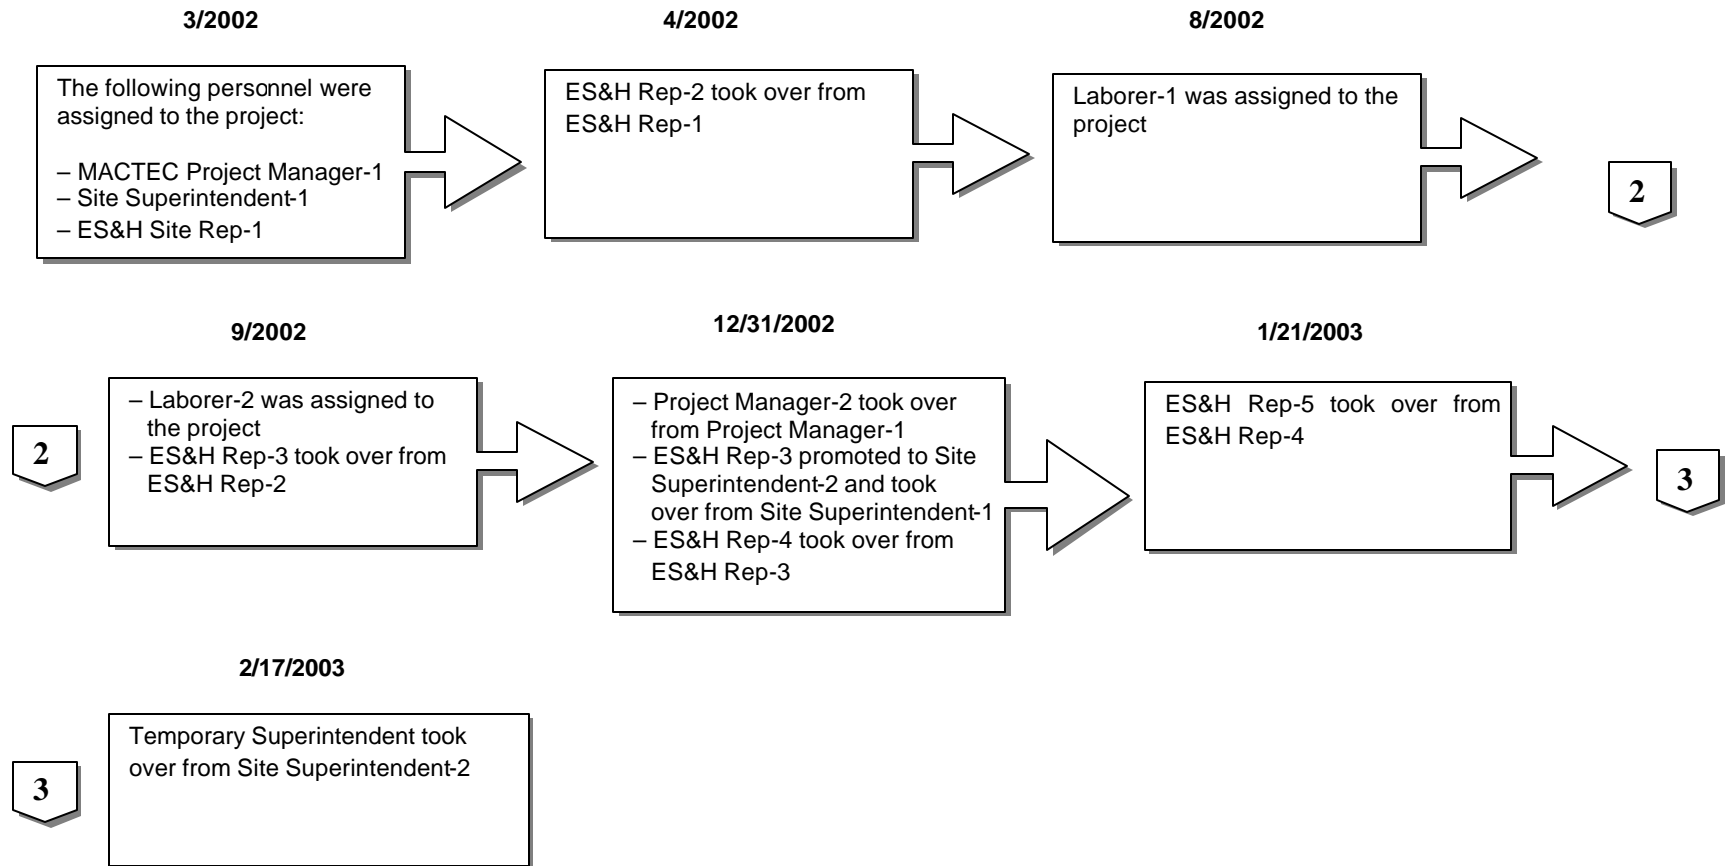
Figure 3. BJC Personnel Changes

During the investigation, numerous MACTEC and BJC personnel changes were evident to the Board, and it was difficult to keep track of just who was on the job site when important incidents occurred. Tracking personnel changes became pivotal to the Board's analysis, especially in the area of feedback and improvement. Over an 11-month period, there were 25 individuals occupying 10 positions in the BJC and MACTEC project staffs. Figures 3 and 4 illustrate the BJC and MACTEC personnel changes on the project. For convenience, each successive change in personnel for a single position has been numbered.

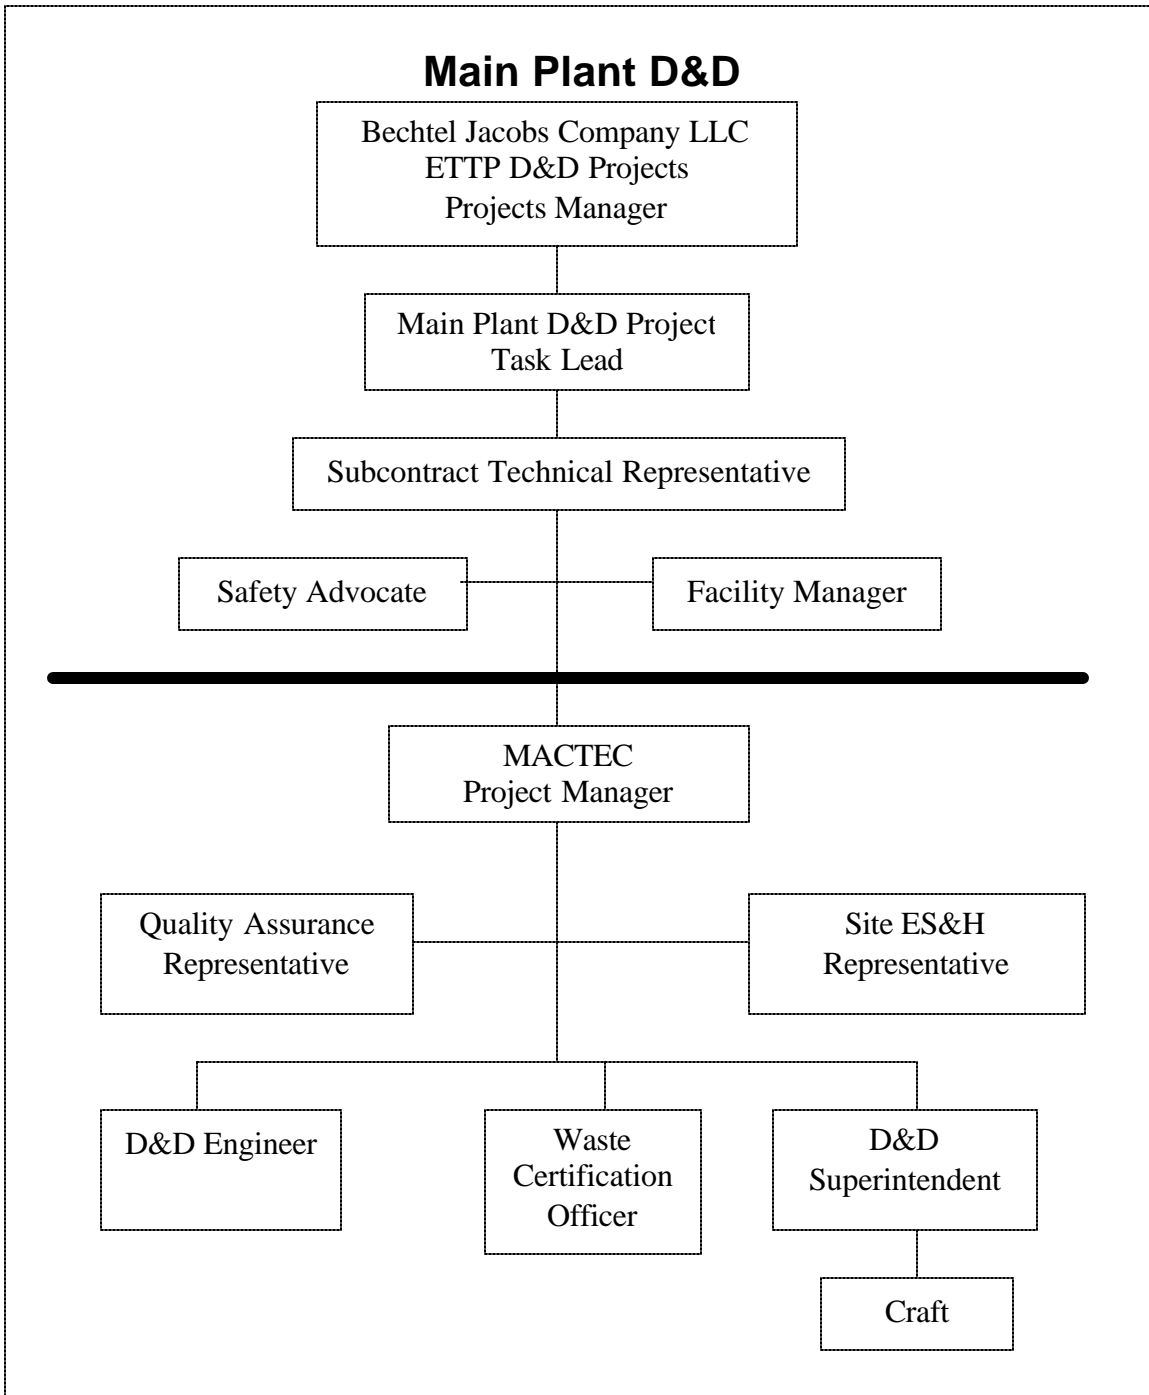
Figure 9. Line Management Organization for BJC and MACTEC on the Project

Despite the (1) existence of adequate staff and opportunities to ensure proper controls for the rebar removal job, (2) formal procedures and adequate knowledge of the formal procedures, and (3) the AHA, which indicates that this rebar removal job required a hot work permit, the decision made by BJC and MACTEC deviated from the AHA without first revising the AHA. BJC identified that a hot work permit was not required. BJC did

not execute its management role over the subcontractor to ensure the work was performed in accordance with the applicable requirements. The BJC contract with DOE, Part 1, Section C-1, "Role of Prime Contractor and Subcontractor" states, "The contractor is fully responsible and accountable for the safe accomplishment of all work, whether performed by its own personnel or subcontractors." The specific activities that contributed to this decision are noted in Section 2.1.1, "Event Description." Based on this description and other factors related to work planning, the Board noted the following issues related to the work controls for this incident:
