Motorcoach Run-Off-the-Road and Rollover
U.S. Route 163
Mexican Hat, Utah
January 6, 2008

NTSB/HAR-09/01
PB2009-916201

Highway Accident Report

Abstract: About 8:02 p.m., mountain standard time, a 2007 Motor Coach Industries 56-passenger motorcoach with a driver and 52 passengers on board was traveling southbound, descending a 5.6-percent grade leading to a curve to the left, 1,800 feet north of milepost 29 on U.S. Route 163. After entering the curve, the motorcoach departed the right side of the roadway at a shallow angle, striking the guardrail with the right-rear wheel and lower coach body. The motorcoach traveled approximately 350 feet along the foreslope, with the right tires off the roadway. The back tires lost traction as the foreslope transitioned into the drainage ditch. The motorcoach rotated in a counterclockwise direction as it descended an embankment. The motorcoach overturned, struck several rocks in a drainage ditch bed at the bottom of the embankment, and came to rest on its wheels. During the 360-degree rollover sequence, the roof of the motorcoach separated from the body, and 50 of the 53 occupants were ejected. Nine passengers were fatally injured, and 43 passe

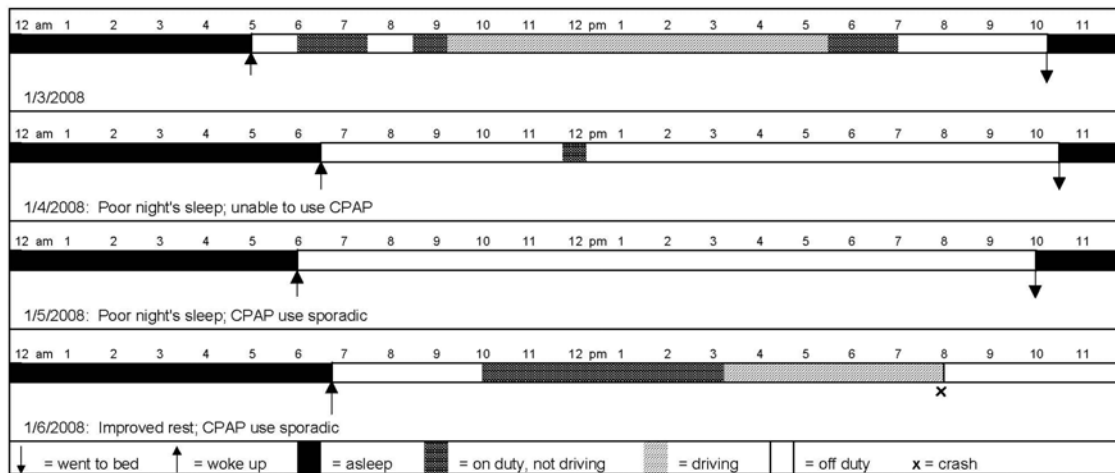
Figure 7. Accident driver's sleep and activity log. (Note: Black bars indicate time available for sleep, not necessarily sleep obtained. Driving time occurs within, but is not synonymous with, on-duty time.)

The driver told the tour group leader, who was one of his passengers, that he had been sick for the 3 days in Telluride preceding the return portion of the accident trip.²⁶ The driver stated to investigators that, due to his head congestion, use of the CPAP device was difficult. The driver could not use the CPAP device the first night in Telluride and used it only sporadically the other 2 nights, adversely affecting his sleep for the 3 nights preceding the accident. The driver's activities in the 72 hours before the accident are shown in figure 7.

The driver reported to investigators that during the trip, he experienced what he described as a head cold, including a constant “runny nose.” While he was in Telluride, the driver purchased the “non-drowsy” form of a cold medicine on two occasions and self-medicated throughout his stay. The driver stated that he did not use the medication on the day of the accident. Postaccident blood specimens were collected from the driver while he was hospitalized in Flagstaff, Arizona, for toxicological testing by the Civil Aerospace Medical Institute. These specimens tested negative for drugs and alcohol. The specimen samples were taken at 7:40 a.m. on January 7, nearly 12 hours after the accident. The police, lacking probable cause, did not administer any tests or require specimens from the driver.

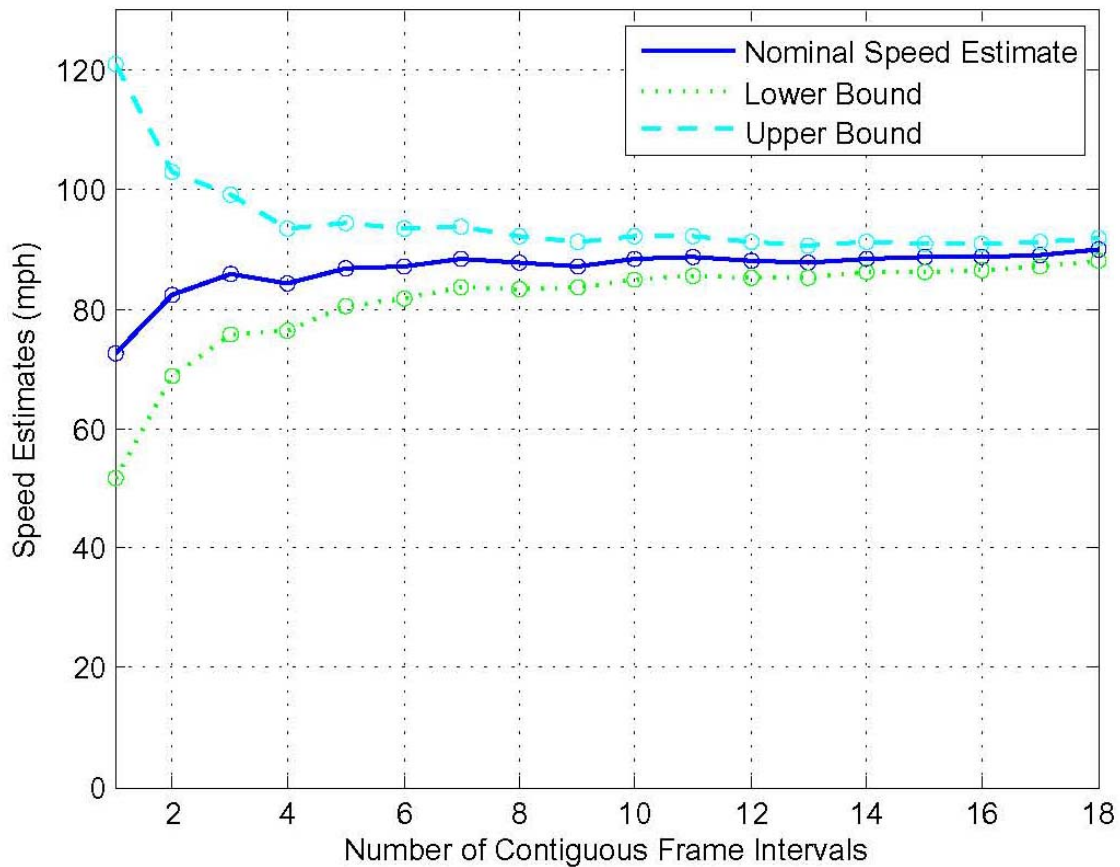
Figure 14. Vehicle speed estimate versus number of frame intervals (video analysis).

Motorcoach locations were estimated at 19 known vehicle positions (18 intervals) corresponding to the time period -8.75 to -4.25 second relative to the triggering event. A speed estimate based on exact 0.25-second timing of the camera frame intervals was calculated, as well as upper and lower speed estimates that take into account the potential ± 0.1 second timing error. The lower bound of the estimated speed at the end of the considered time period was 88 mph. (See figure 14.)

Safety Board staff also conducted analytical work to determine whether the accident motorcoach could have reached the estimated speeds shown in figure 14 with the engine governed at 72 mph.⁷⁸ That analysis was based on the physical parameters of the vehicle (including mass, aerodynamic drag coefficient, and tire rolling resistance coefficient) and the forces acting on the vehicle.⁷⁹ The acceleration was estimated using a simulation model of the

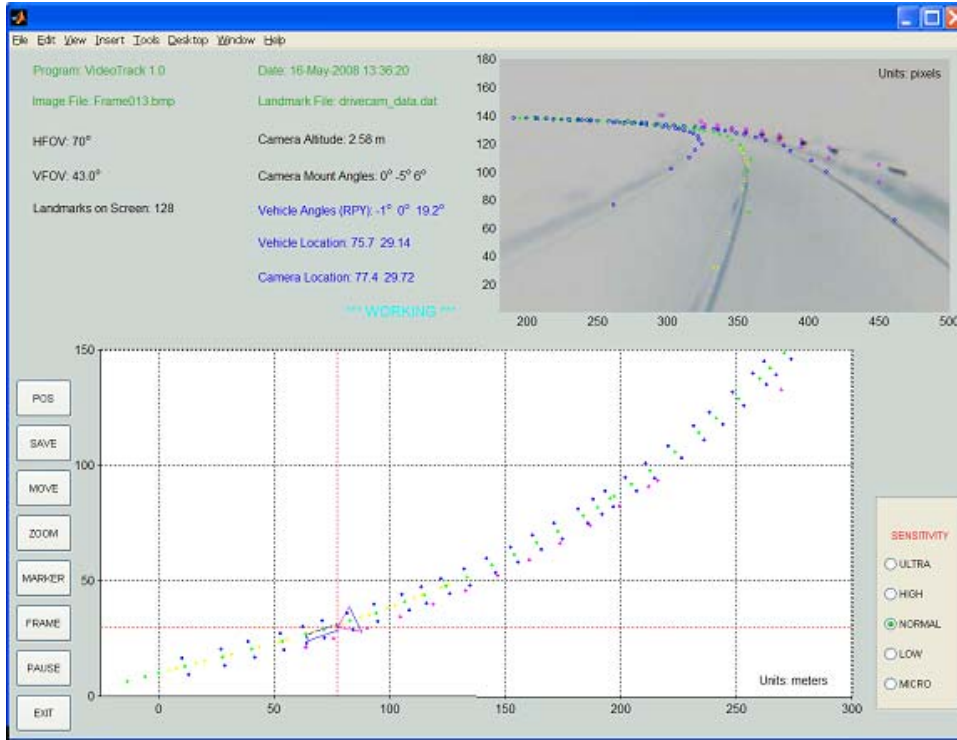
Figure C-1. Vehicle at time -7 seconds.

Speed estimation is performed interactively. The user moves the vehicle that is displayed in the program’s graphical user interface (GUI) until the landmarks coincide. Vehicle speed can be estimated by dividing the distance between two vehicle locations by the time difference between the corresponding camera image frames. Figures C-1, C-2, and C-3 show the program GUI at times -7 seconds, -6 seconds, and -5 seconds, respectively. The vehicle is positioned at its estimated locations at those times. The lower plot in figures C-1 through C-3 shows the surveyed landmarks and the vehicle, with plot points corresponding to survey points representing the white solid lines on the pavement, the solid yellow lane-dividing line, the ends of broken yellow line segments, and the locations of reflectors. The upper plot is the camera image (shown as negative of the original), which shows the locations of the survey points as computed by the camera model that is built into the analysis program. Each reflector is marked at the elevation of the reflective surface and at ground level beneath it.

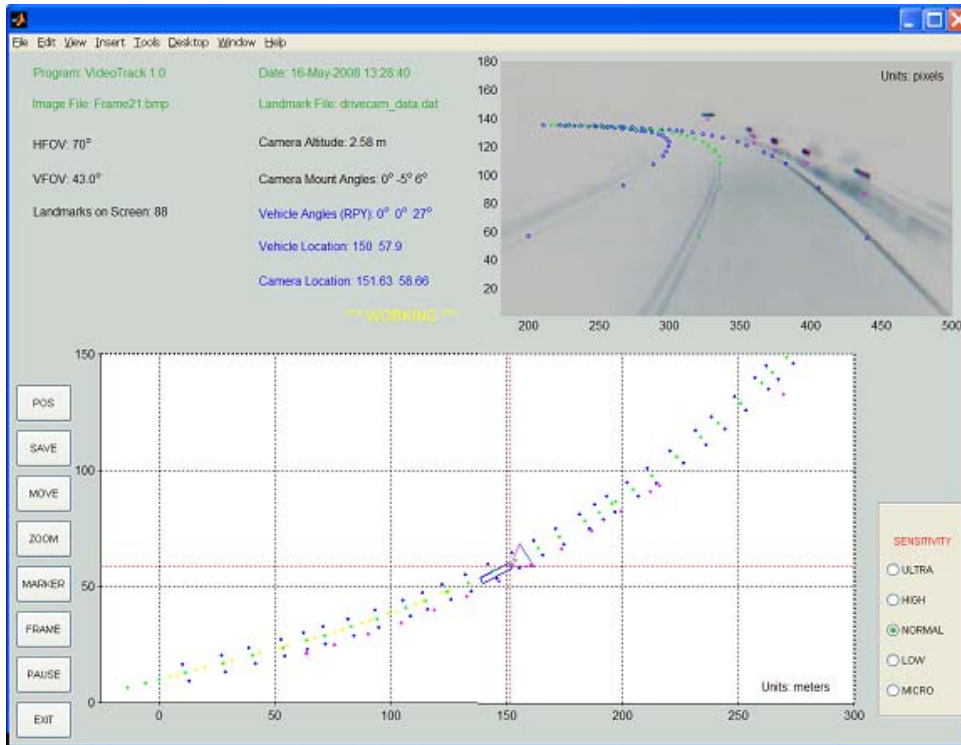
Figure C-3. Vehicle at time –5 seconds.

The motorcoach's location was estimated at 19 positions, corresponding to 19 camera frames spanning the time period from –8.75 to –4.25 seconds. The vehicle's speed was estimated using the formula $V_n = \Delta x / \Delta t$, where Δx is the total travel of the vehicle during n contiguous time intervals, and Δt is $0.25 \times n$. The middle line in the graph shown in figure C-4 represents this nominal speed estimate. The estimate becomes more accurate as more contiguous intervals are considered.

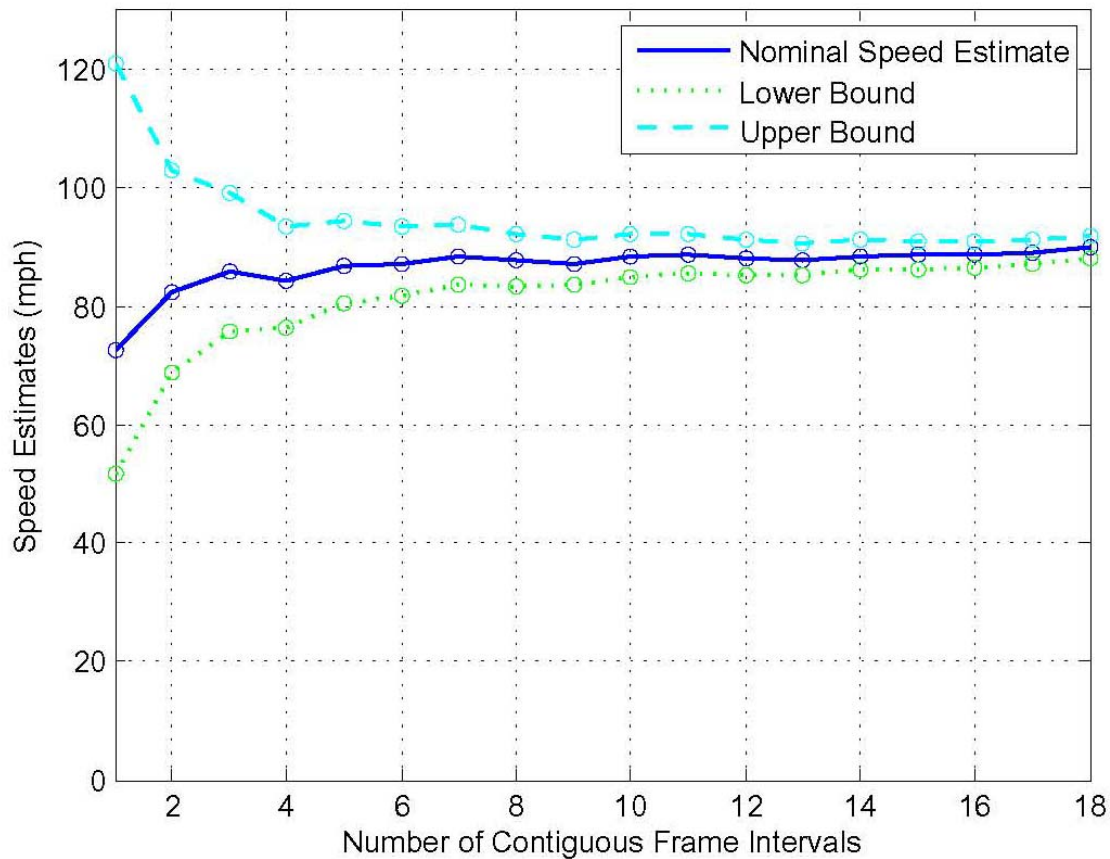
Figure C-4. Vehicle speed estimate versus number of frame intervals.

The nominal speed estimate is based on exact 0.25-second timing of the camera frame intervals. If camera timing is not exact, this nominal speed estimate could be too high (if the actual Δt was longer than $0.25 \times n$) or too low (if Δt was shorter than $0.25 \times n$). The possible speed estimation error due to such video frame timing was analyzed in detail and taken into account. The bottom line in the figure C-4 graph represents the lower bound of the speed estimate and the uppermost line represents the upper bound. The lower bound is higher than 85 mph if 10 or more camera frame intervals are considered. After 18 frame intervals, the lower bound of the motorcoach's speed is estimated to be 88 mph and the upper bound, 92 mph.
