**National Transportation Safety Board**

**Carlsbad, New Mexico**  
**August 19, 2000**

**Pipeline Rupture and Fire**  
**El Paso Natural Gas Company:**  
**Gas Transmission Line No. 1103**

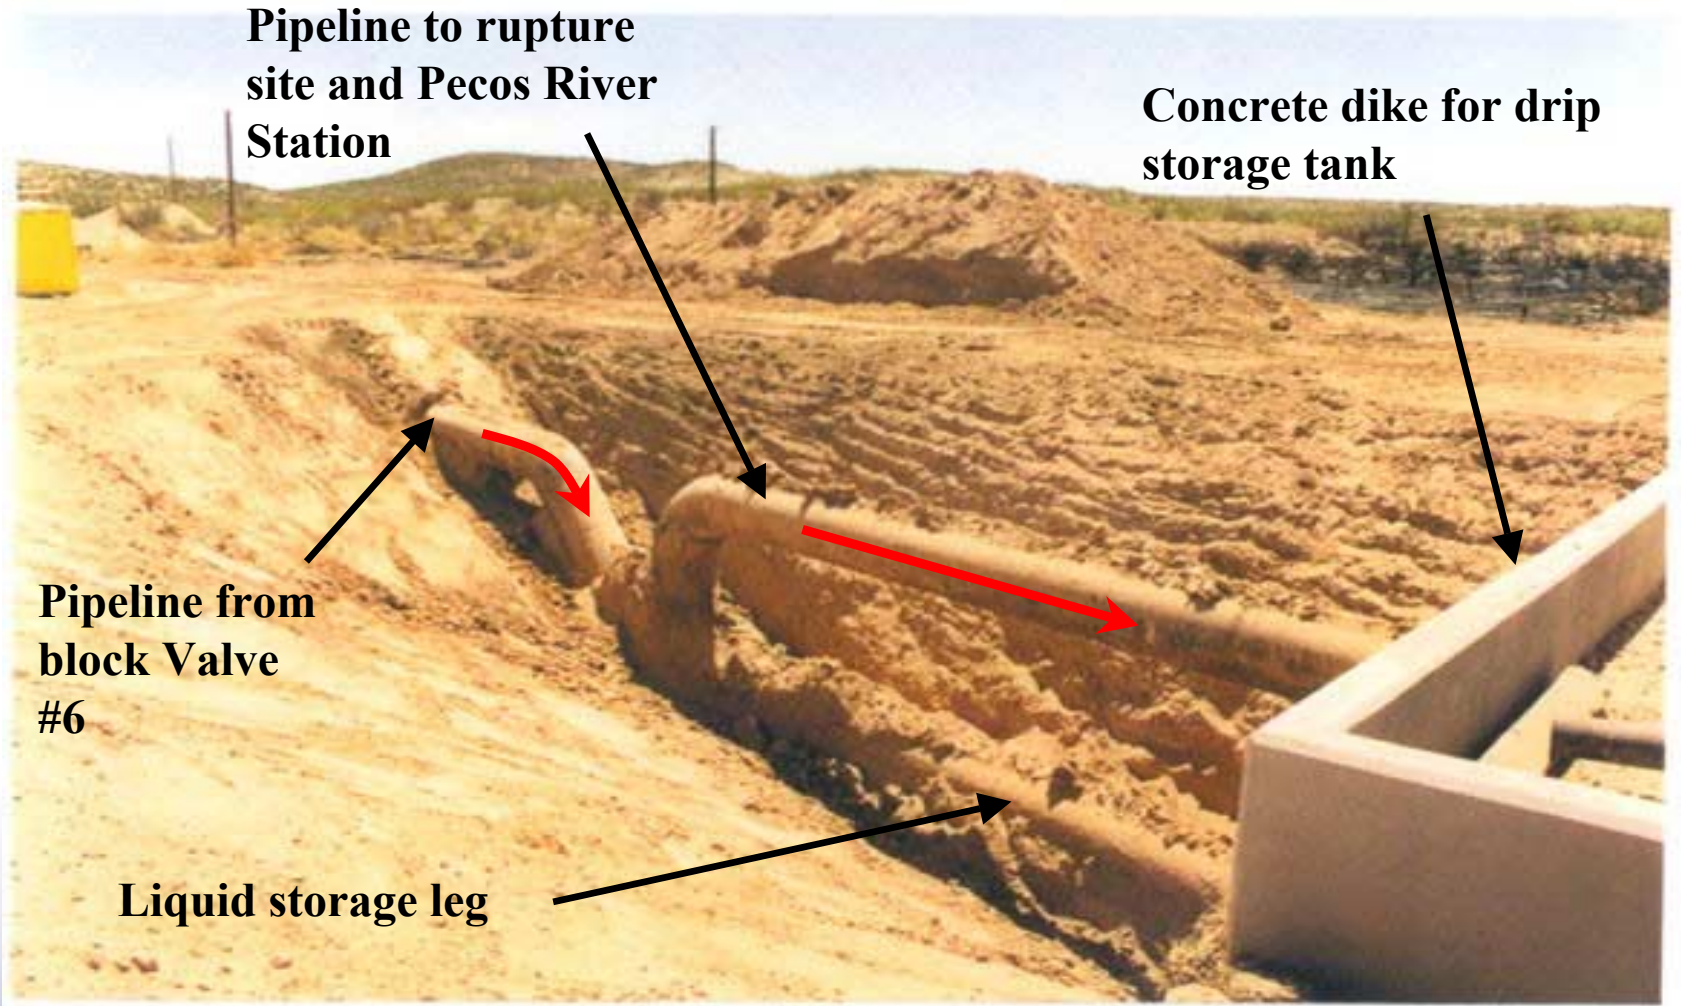
**Pipeline to rupture site and Pecos River Station**

**Concrete dike for drip storage tank**

**Pipeline from block Valve #6**

**Liquid storage leg**

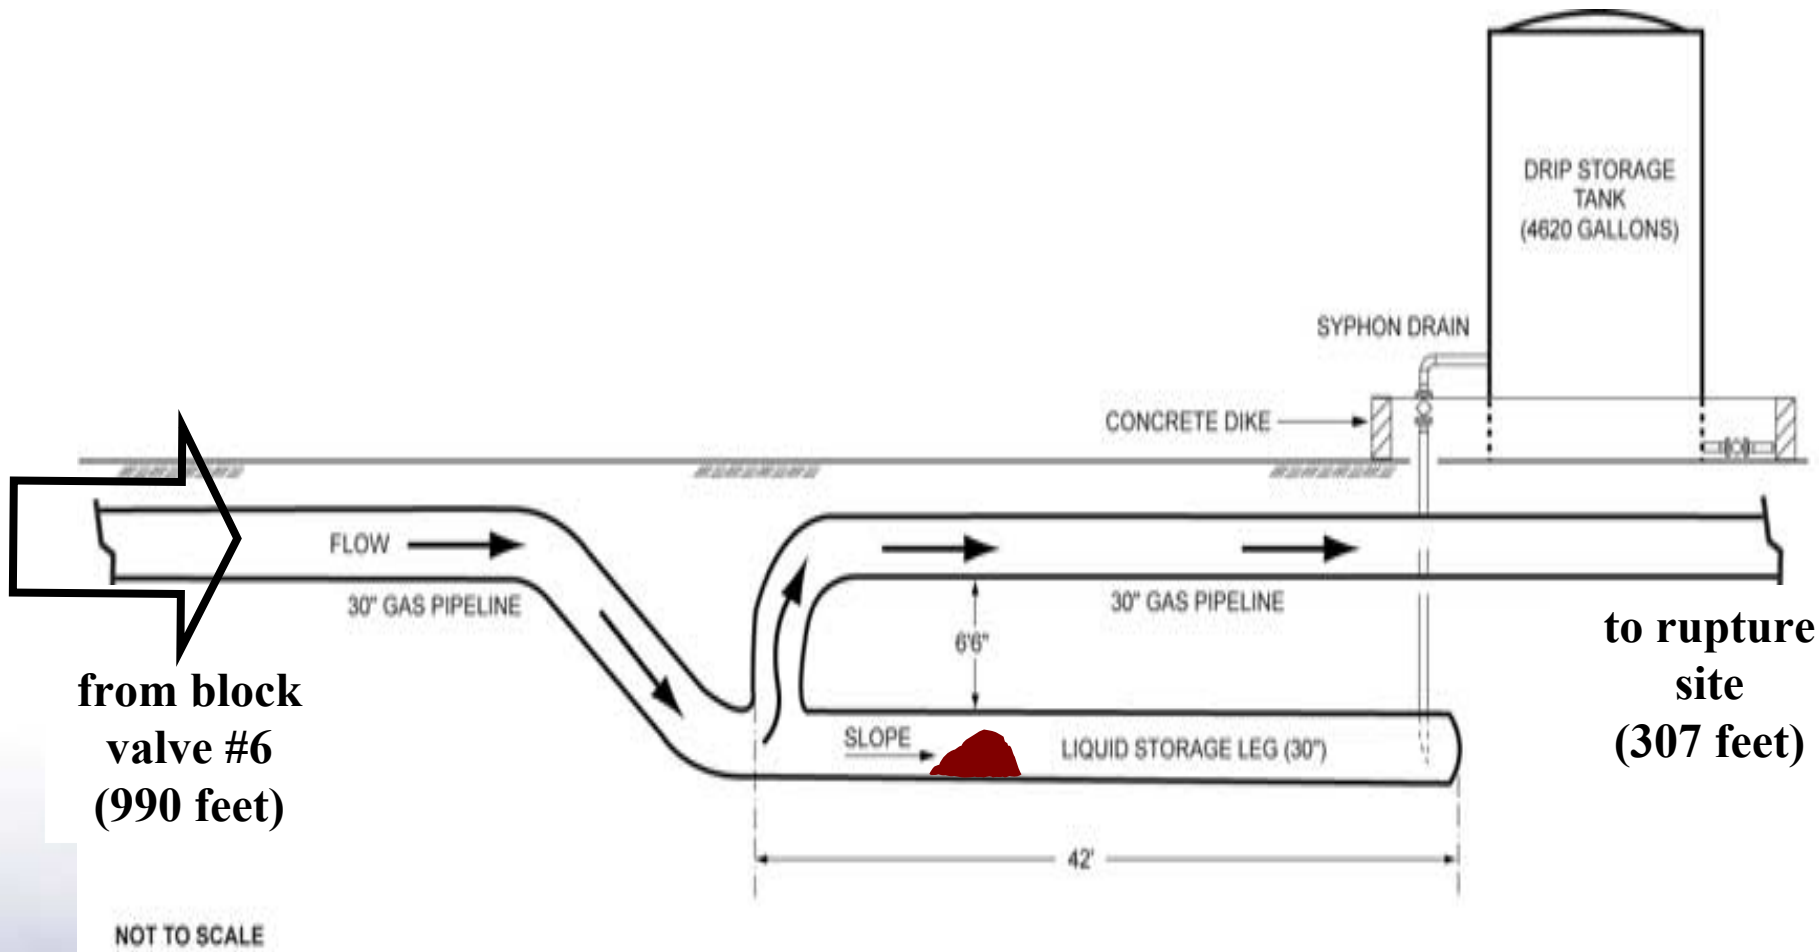
from block valve #6 (990 feet)

to rupture site (307 feet)
