**NATIONAL TRANSPORTATION SAFETY BOARD
OFFICE OF AVIATION SAFETY
WASHINGTON, D.C. 20594**

**Powerplant Group Chairman's Factual Report – Addendum 1
Engine Starting System**

NTSB ID No.: DCA-07-MA-310

Aircraft: American Airlines McDonnell Douglas DC-9-82 (MD-82), N454AA, Flight 1400

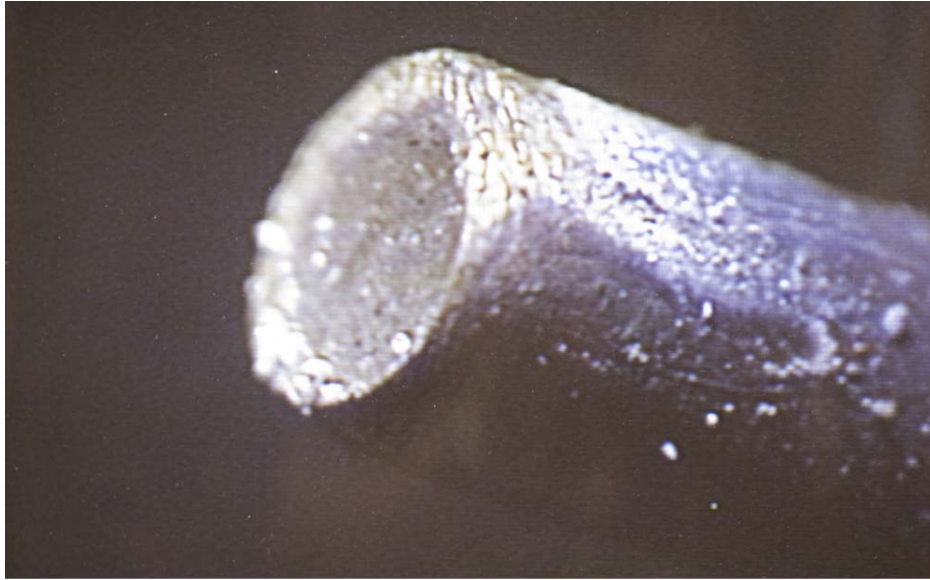
Photo 25 – Photomicrograph of tip of solenoid plunger rod

The solenoid housing mounting flange was deformed. The solenoid was disassembled to reveal the armature and the solenoid valve housing (Photo 24). The armature was free to move. There were no witness marks noted on the forward face of the armature. Additionally, there were no axial score marks noted on the plunger rod. The plunger rod face, which is in contact with the ball valve, was slightly worn with a spherical indentation (Photo 25). Based on the measurements of the deformation of the ball valve on the pin surface, the depth of wear was calculated to be 0.002-inches.

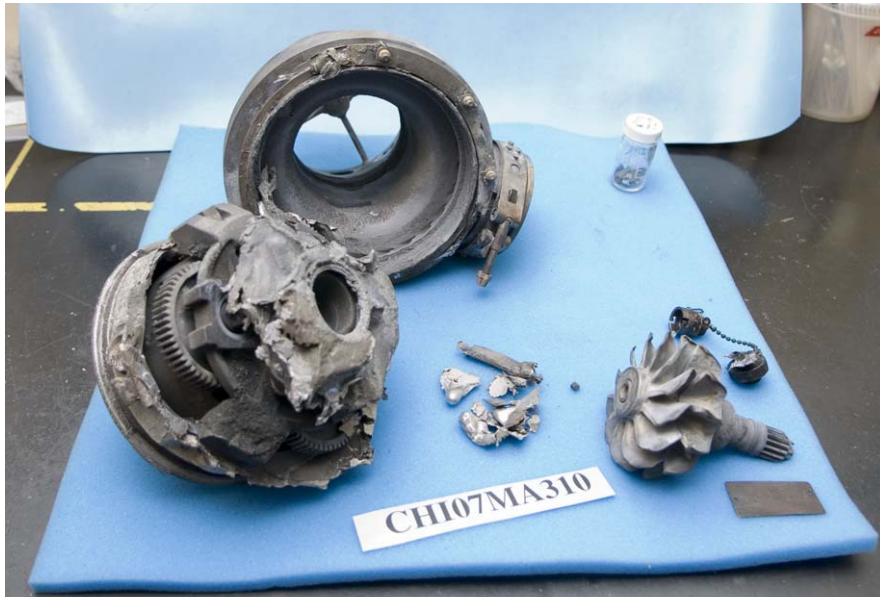
Photo 30 – Air turbine starter (ATS)

The ATS was in three pieces in the shipping container (Photo 30). The ATS was separated at the flange between the turbine housing and the planetary gearbox. The turbine wheel assembly was separate.

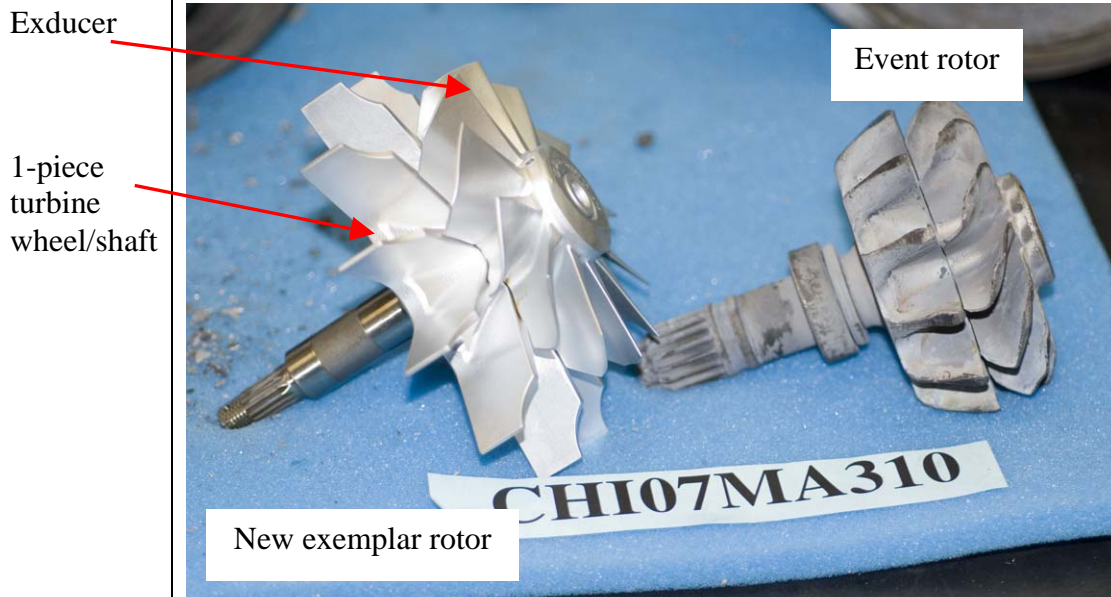
Photo 31 – Turbine rotor comparison

The rotor assembly is of a two-piece construction consisting of an aft side exducer and an integral turbine wheel/shaft. The rotor assembly exhibited an overall even matte gray-blue deposit. The assembling roll pin of the exducer was in place and intact. The aft face of the exducer hub exhibited rotational score marks. All the blades of the exducer were present. The blades tips exhibited deformation and were rolled in the direction opposite rotation. The leading edge and trailing edges of the blade tips were rounded off producing a 'spoon' shape. The average length of the blades at mid-chord was approximately 1-1/4 inch. The turbine blades were all present. All the tips were 'mushroomed' and exhibited circumferential scoring. The blades were worn down to the same height as the exducer blades on the trailing edge and tapered further inward moving forward along the blade chord (Photo 31).

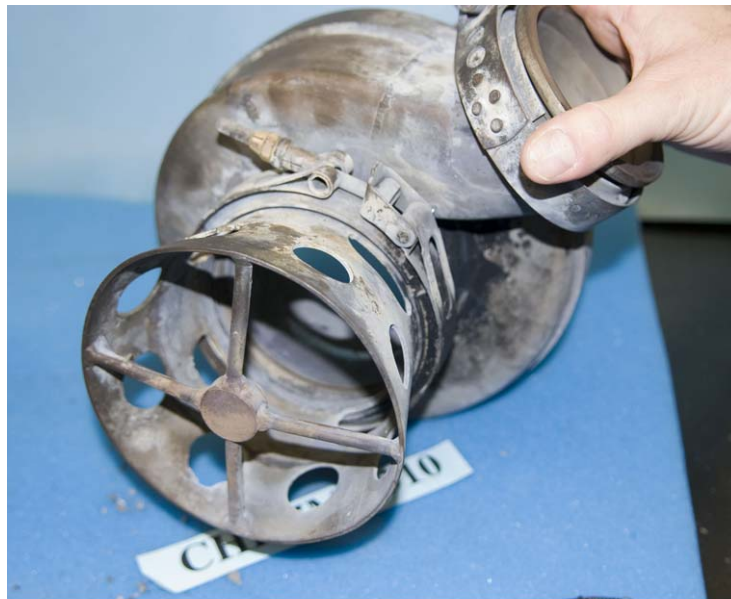
Photo 32 - Inlet/exhaust scroll housing

The inlet/exhaust scroll housing was intact (Photo 32). A small protected area just beneath the inlet flange was sooted from 12 to 3 o'clock. The remaining external surfaces were a gray color. The exhaust basket was intact and still connected to the housing with a v-band clamp. The inlet flange appeared to be undamaged and the v-band clamp was present.

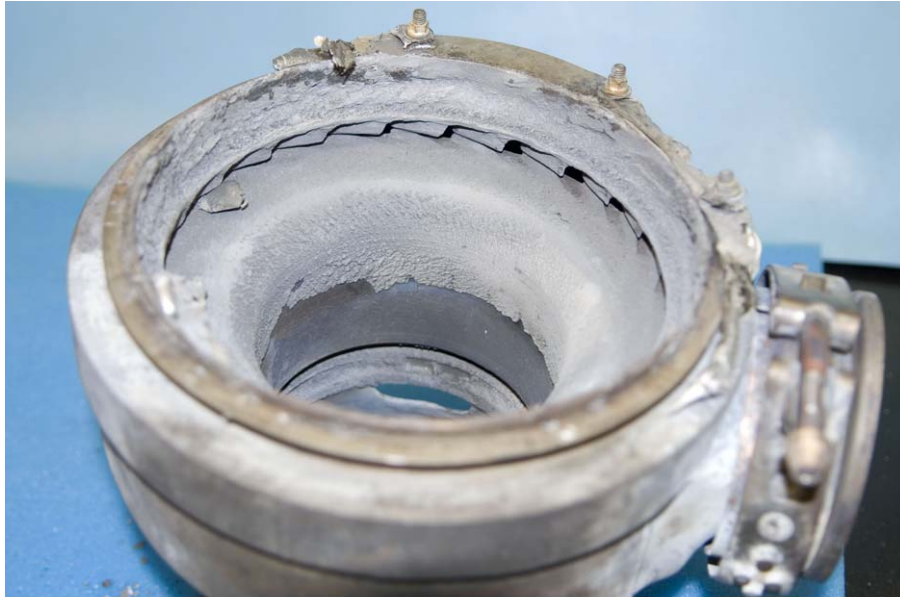
Photo 33 – Turbine inlet scroll

A small segment of the aluminum gearbox housing including 3 fasteners from the 12 to 4 o'clock position was still attached to the connecting flange. The outside of this flange exhibited melted flow condition. The vanes of the scroll were present but were coated with slag and circumferentially scored (Photo 33). The internal surfaces of the airflow path were all coated with a rough metallic deposit. The shroud was rotationally scored. The stop cruciform cage was present and the center puck was rotationally scored on the inside facing surface.

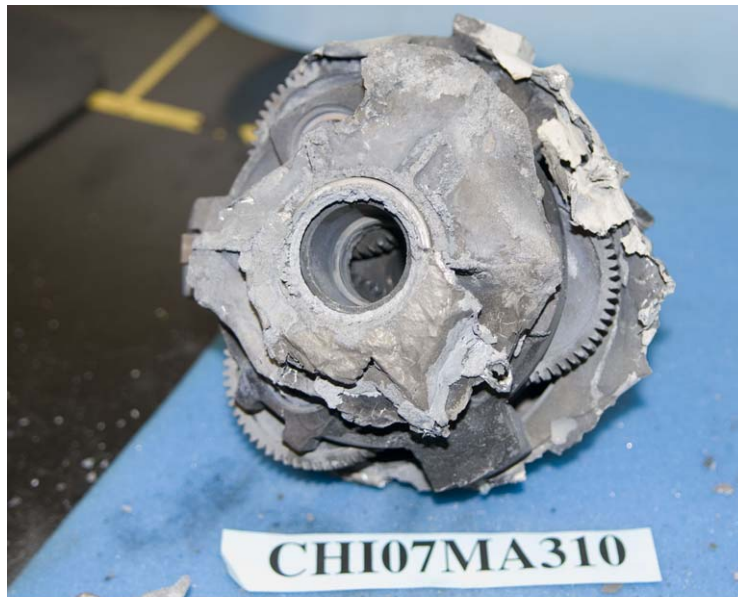
Photo 34 – Planetary gearbox

The planetary carrier assembly was intact and the planetary gears were present but could not be rotated (Photo 34). The assembly exhibited a general black sooty deposit. The planet gear carrier was intact; however, the corner of two of the three mounting lugs exhibited material loss with a rough eroded appearance. The planetary carrier was not disassembled. Most of the oil barrier was consumed in a manner consistent with heat distress and melting. The ring gear and ratchet assembly was intact and the ratchets appeared to be undamaged.

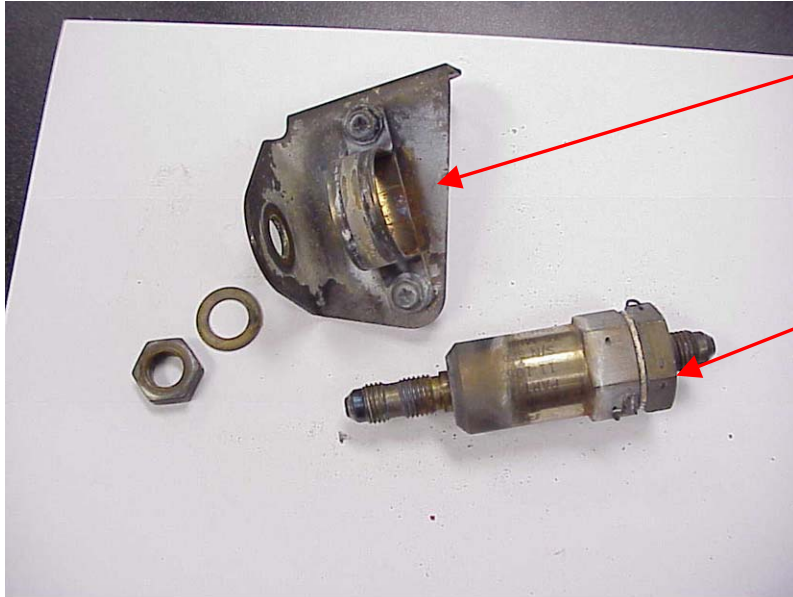
Photo 37 – Air turbine starter valve air filter (ATSV-AF)

The assembly appeared to be externally undamaged (Photo 37). The lock wire was still intact and was removed prior to disassembly. Although the removal torque value was not measured, it was considered to be within the normal range.

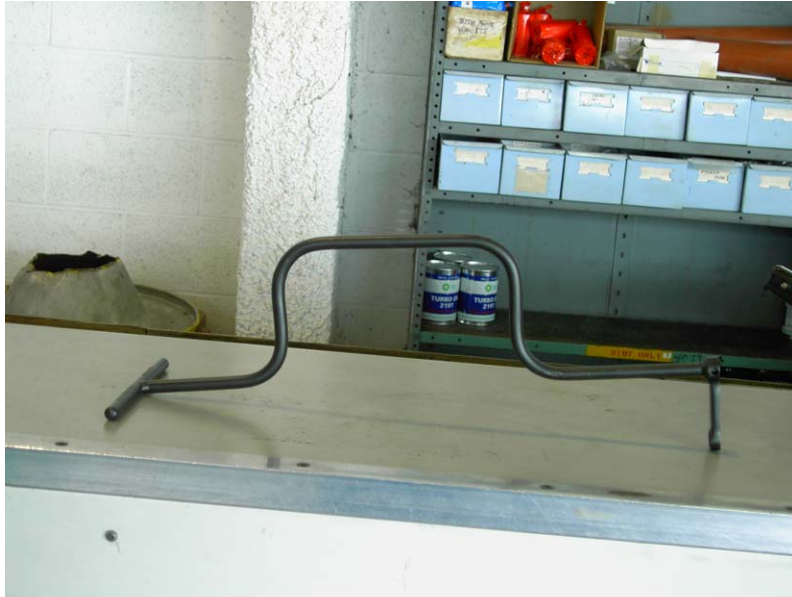
According to the AA engine start procedure manual MEL/CDL Maintenance Procedures Manual 80-2 (Attachment 1), when a manual engine start is to be done, the mechanic must use an approved specialized wrench, Boeing P/N DG16314-501 or AA P/N WRE9550 (Photo 43), to access and turn the wrenching flats on the upper end of the butterfly valve shaft. This manual override method directly turns the butterfly valve shaft (Photo 44) thus bypassing the manual override pin, ball valve and piston actuation system within the ATSV. Use of the approved butterfly override method using the specialized wrench requires that the entire forward lower nacelle cowl door be unlatched and opened because the wrench cannot fit through the small access panel (Photo 45).

Photo 43 – Specialized ATSV butterfly shaft tool

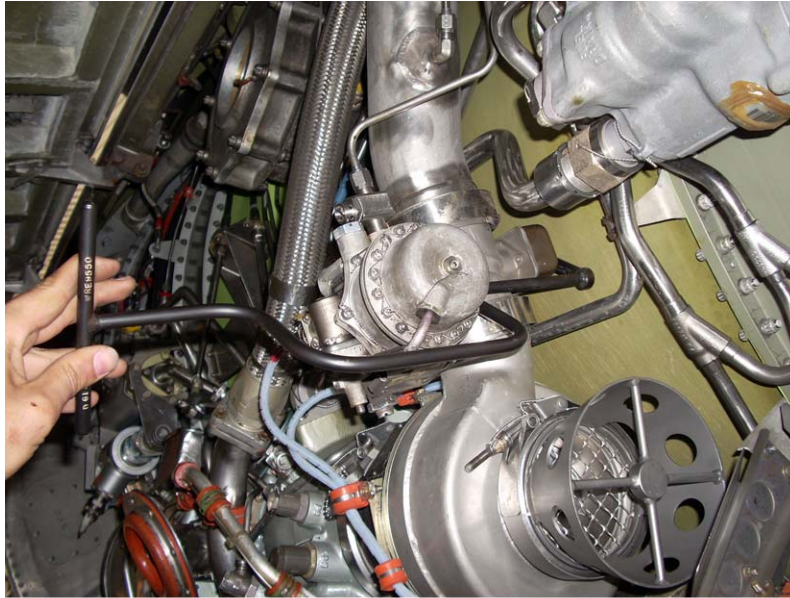
Photo 45 – Specialized ATSV butterfly shaft tool used on exemplar aircraft – Note: cowl door must be opened for access

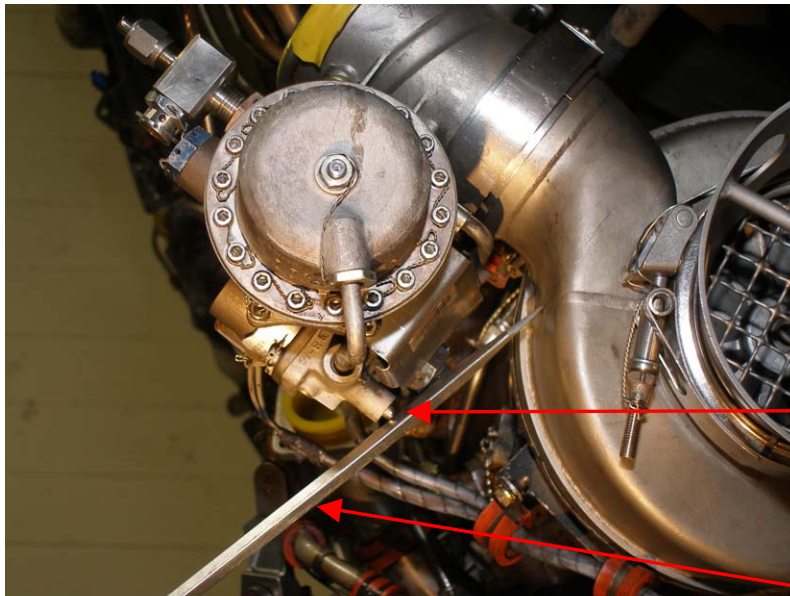
In order to alleviate these problems, a levering type tool can be used to actuate the manual override button by resting it against the open nacelle panel edge or ATS housing, using them as a fulcrum ([Photo 46](#) & [Photo 47](#)). The use of a levering technique is not approved in either the Boeing or AA maintenance manuals.

Photo 46 – Lever used to assist manual override button activation (For illustrative purposes only)

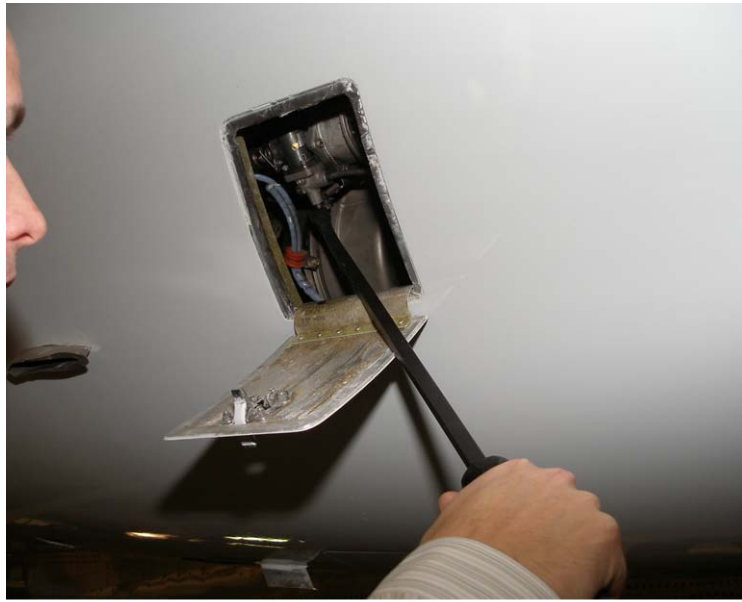
Photo 47 - Lever used to assist manual override button activation (For illustrative purposes only) – alternative levering method
