NATIONAL TRANSPORTATION SAFETY BOARD
Southwest Regional Office
Gardena, CA

Airworthiness Factual Report

Aircraft: N613TV (Ch 3), Eurocopter AS350B2
N215TV (Ch 15), Eurocopter AS350B2

NTSB Number: LAX07MA231A/B

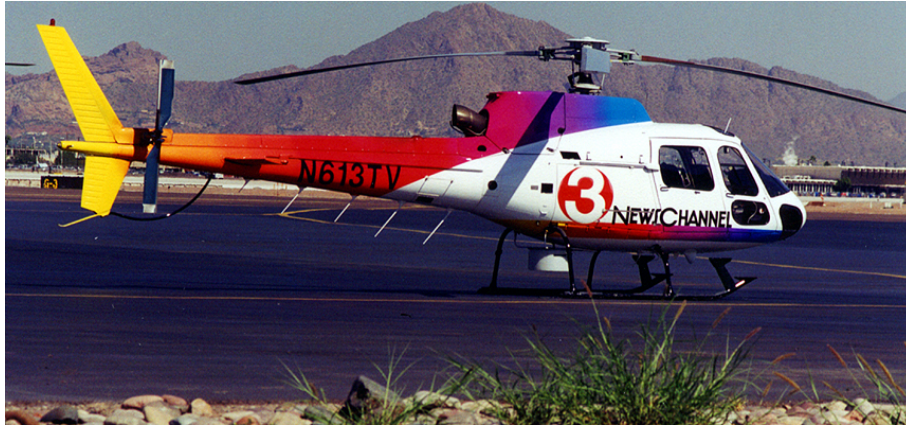
Figure 1. Ch 3

The helicopter, N613TV, was a Eurocopter model AS350B2, serial number 2883. The engine was a Turbomeca Arriel 1D1, serial number 9212. Ch 3 contracted their maintenance to Westcor Aviation. A review of the helicopter's logbooks³ revealed that it had a total airframe time of 11,817.7 hours. The logbooks contained an entry for F and S inspections dated July 24, 2007, which noted total times of 11,810.1 for the airframe and 8,946.3 for the engine. The records indicated completion of 10, 25, 30, 50, 100, 200, 250, 300, 400, 500, 550, and T-inspections on June 29, 2007. The helicopter logged about 168 hours in the previous 90 days.

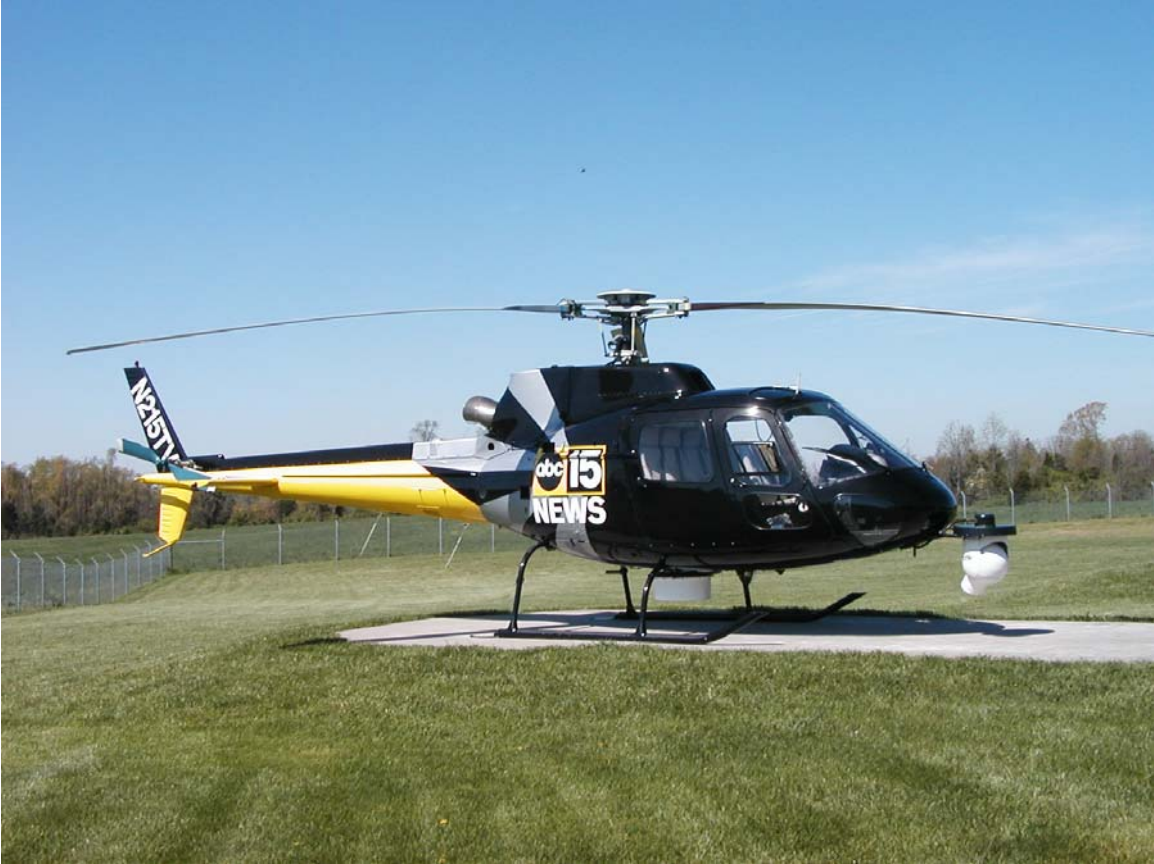
Figure 2. Ch 15

The helicopter, N215TV, was a Eurocopter model AS350B2, serial number 3167. It was imported from the Philippines in 2003. Ch 15 contracted their maintenance to Mustang Helicopter Services. The engine was a Turbomeca Arriel 1D1, serial number 9610. A review of the helicopter's logbooks⁴ indicated that airframe and engine total times were not consistent. An entry on June 5, 2007, noted a total airframe time of 5,041.0 hours and engine time of 4,804.0 hours. The next entry on June 10, 2007, noted an airframe time of 4,978 hours and an engine time of 4,741.4 hours. The last inspection recorded was a 100/30-hour inspection on July 15, 2007, at a total airframe time of 5,094.1 hours and total engine time of 4,857.4 hours. The last entry in the logbook on July 26, 2007, indicated a total airframe time of 5,124.6 hours and total engine time of 4,877.9 hours. The helicopter logged about 269 hours in the previous 90 days.

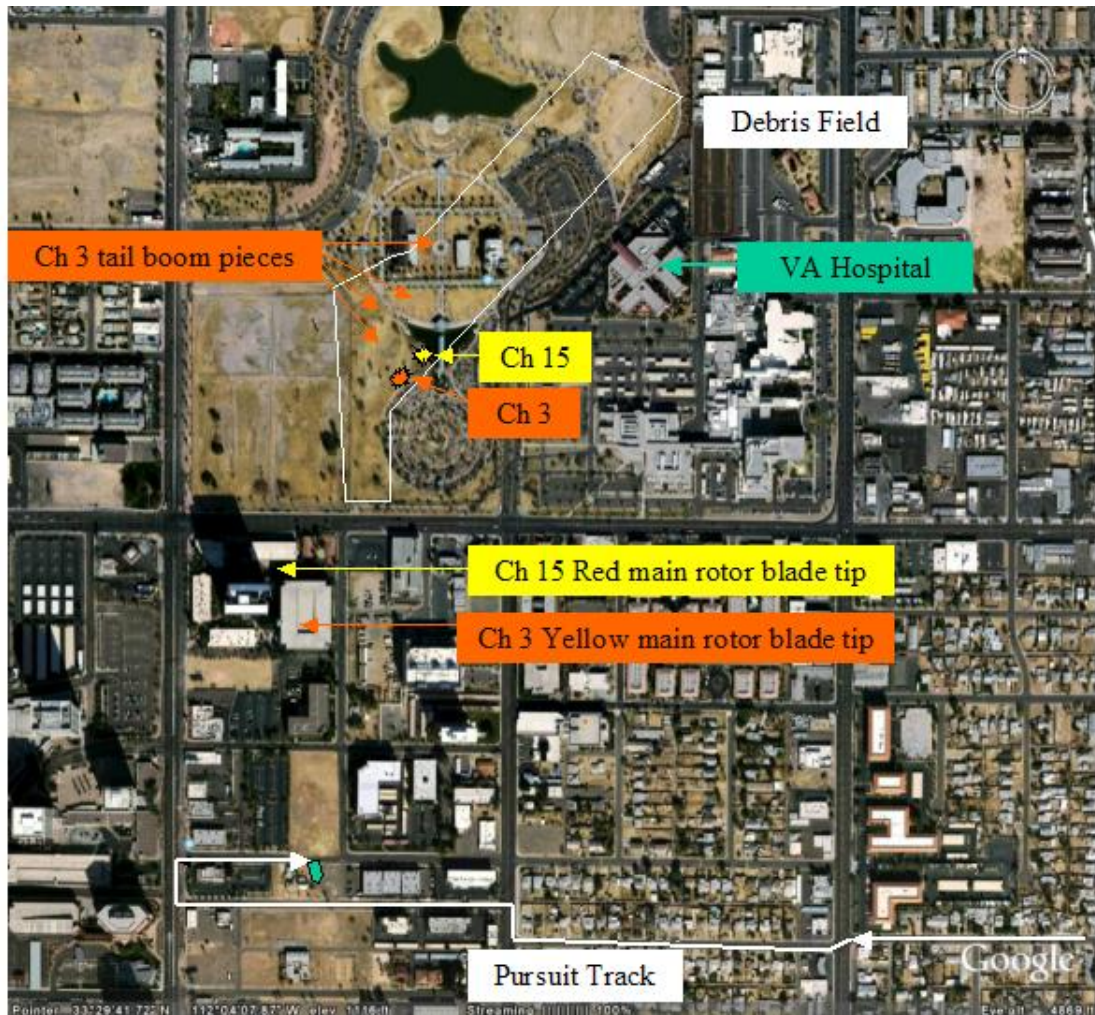
Figure 3. Overhead view of accident site

3.1 Investigators from the Safety Board, the FAA, American Eurocopter, and Turbomeca examined the wreckage at the accident scene. The main wreckage for each helicopter was in Steele Indian School Park, and they were about 160 feet apart⁵. Debris dented the roof of a nearby covered walkway. The main debris field, which encompassed components from both helicopters, was about 2,160 feet long and 560 feet wide, and north of Indian School Road. The only pieces of debris south of Indian School Road were an outboard segment of the yellow main rotor blade from the Ch 3 helicopter and an outboard segment of the red main rotor blade from the Ch 15 helicopter.

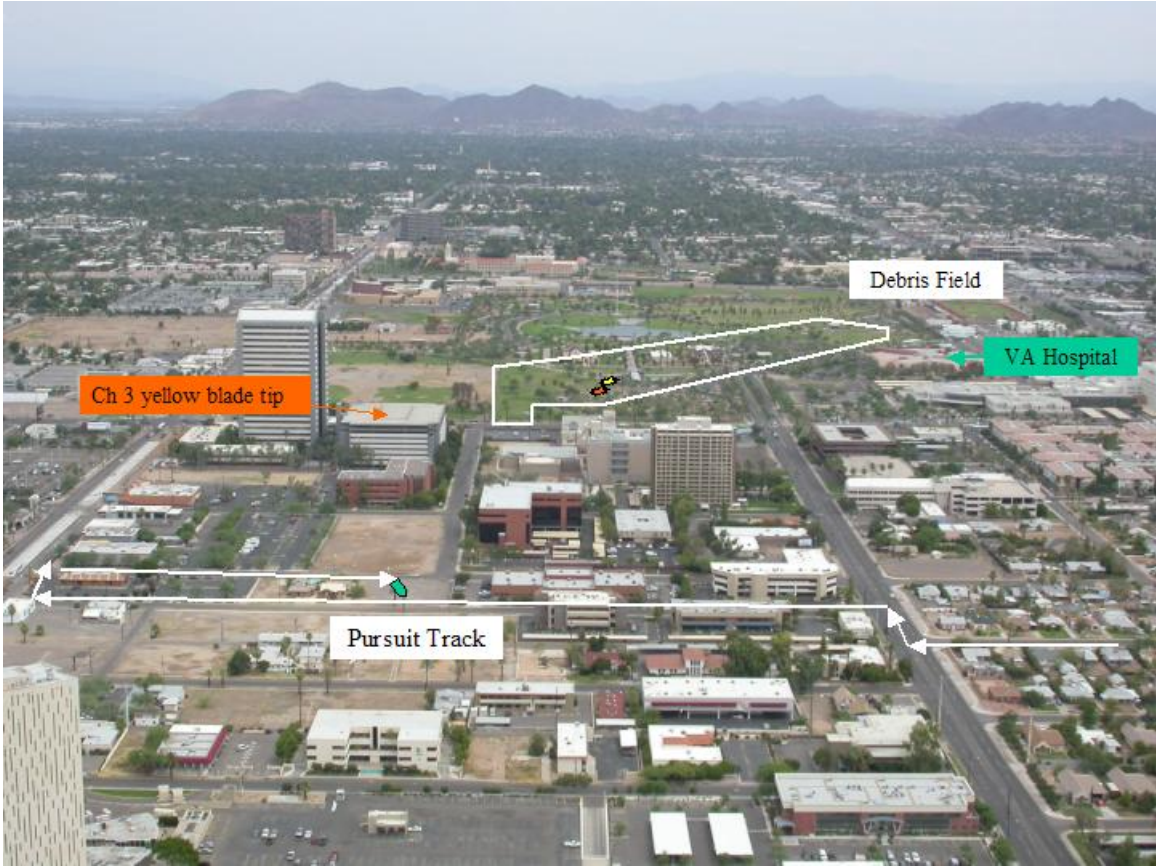
Figure 4. Aerial view from south

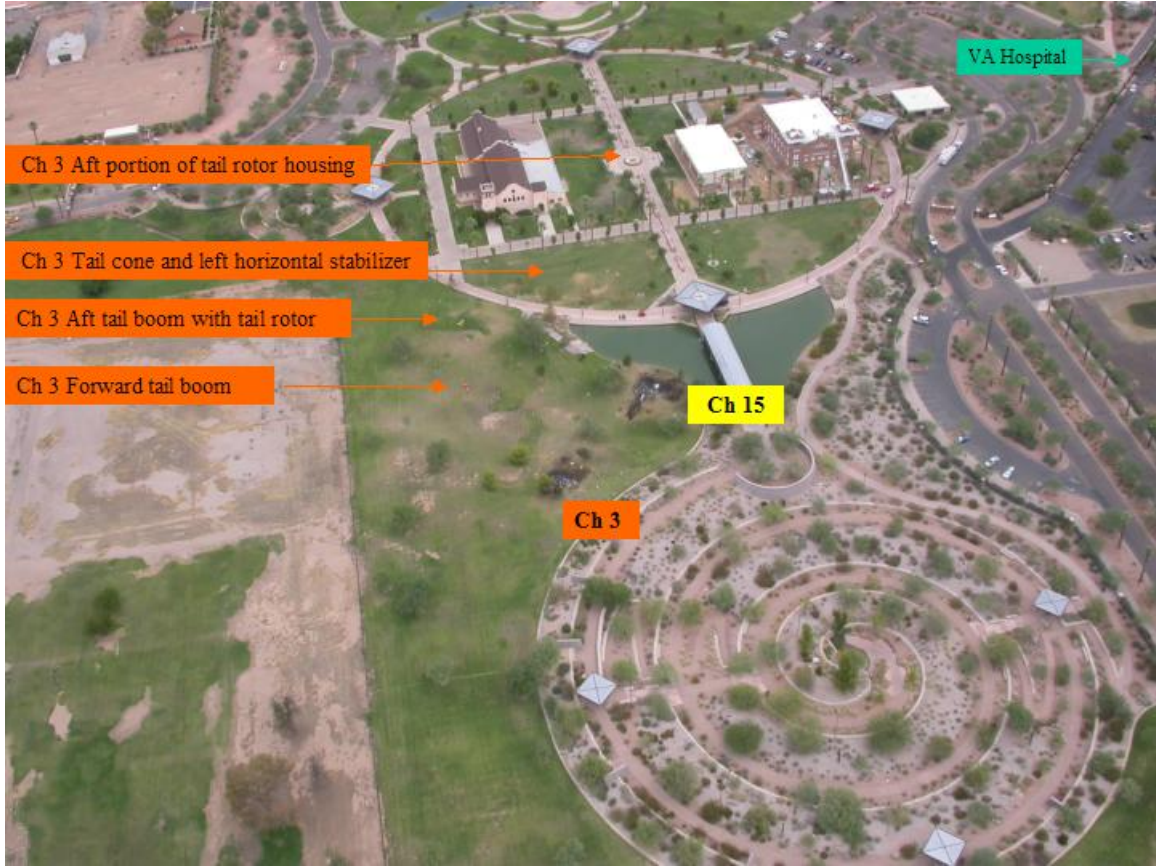
Figure 5. Aerial View of Park
