NATIONAL TRANSPORTATION SAFETY BOARD

COLLISION OF TRACTOR/CARGO TANK
SEMITRAILER AND PASSENGER VEHICLE AND
SUBSEQUENT FIRE, YONKERS, NEW YORK,
OCTOBER 9, 1997

NTSB/HAR-98/02/SUM (PB98-916202)

Accident Number: HWY-98-F-H002
Accident Type: Collision and fire
Location: Yonkers, New York
Motor Carrier: Mystic Bulk Carriers, Inc.
Vehicle 1: 1994 Mack tractor and MC-306 cargo tank semitrailer
Vehicle 2: 1990 Eagle Premier sedan
Date: October 9, 1997
Time: 12:10 a.m.
Damage: Vehicles and overpass destroyed
Injuries: One fatality

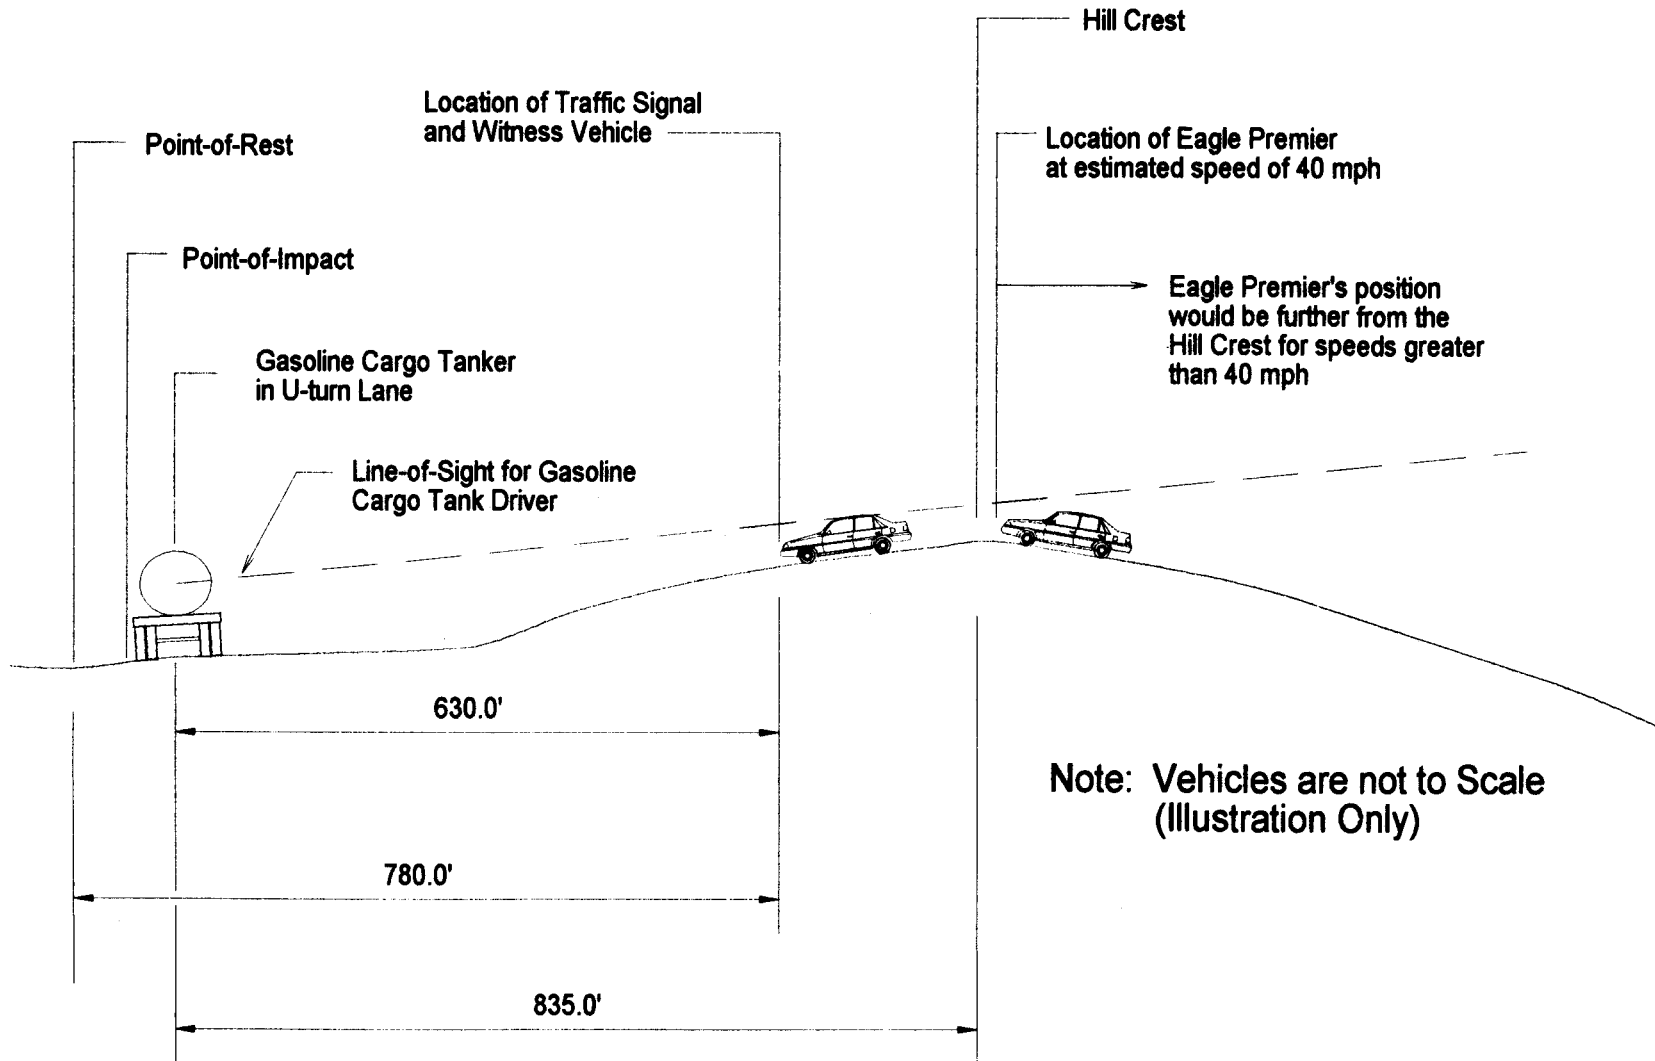
Calculations were made to determine where the Eagle Premier would have been 14.6 seconds before the accident and whether it would have been visible to the truckdriver. Several factors were considered in arriving at appropriate speed estimates. First, the witness estimated the speed of the Eagle Premier as between 40 to 45 mph; second, the speed limit on Central Park Avenue is 40 mph; and third, the Eagle Premier driver was late for work. Given this information, speed estimates ranging from of 35 mph to 50 mph were used.
