## RAILROAD ACCIDENT REPORT

COLLISION BETWEEN UNION PACIFIC  
FREIGHT TRAINS MKSNP-01 AND ZSEME-29  
NEAR DELIA, KANSAS  
JULY 2, 1997

NTSB/RAR-99/04  
PB99-916304  
Notation 6899B  
Adopted: August 31, 1999

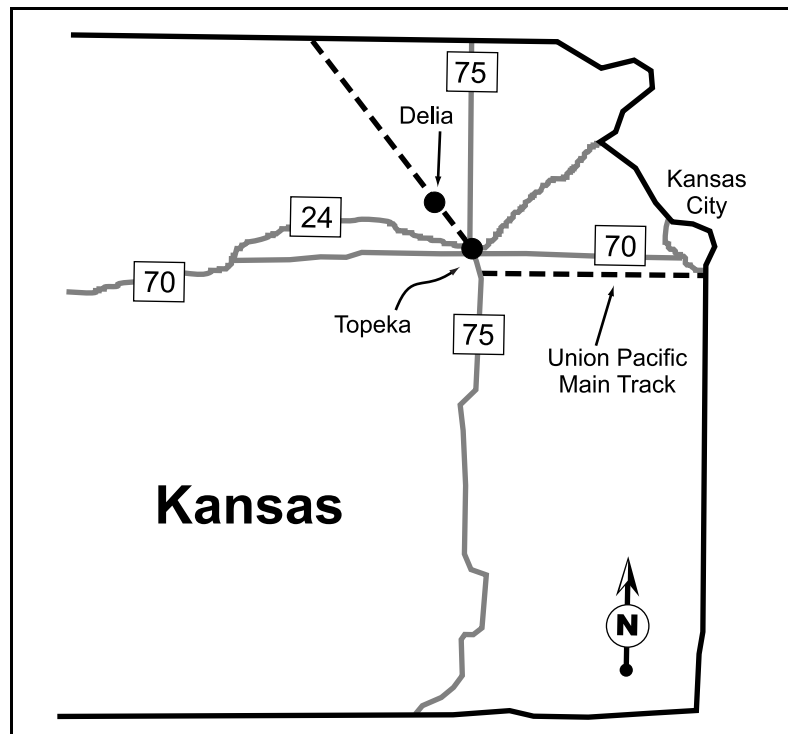
On July 2, 1997, about 2:15 a.m., westbound Union Pacific (UP) freight train MKSNP-01 (NP-01) collided with the side of eastbound UP freight train ZSEME-29 (ME-29) where the Kenefick siding track merges with the main track on the UP railroad near Delia, Kansas, (figure 1). Each train was staffed by an engineer and a conductor. The NP-01 train engineer was killed, and the NP-01 train conductor sustained minor injuries.

Figure 1. Collision occurred near Delia, Kansas.

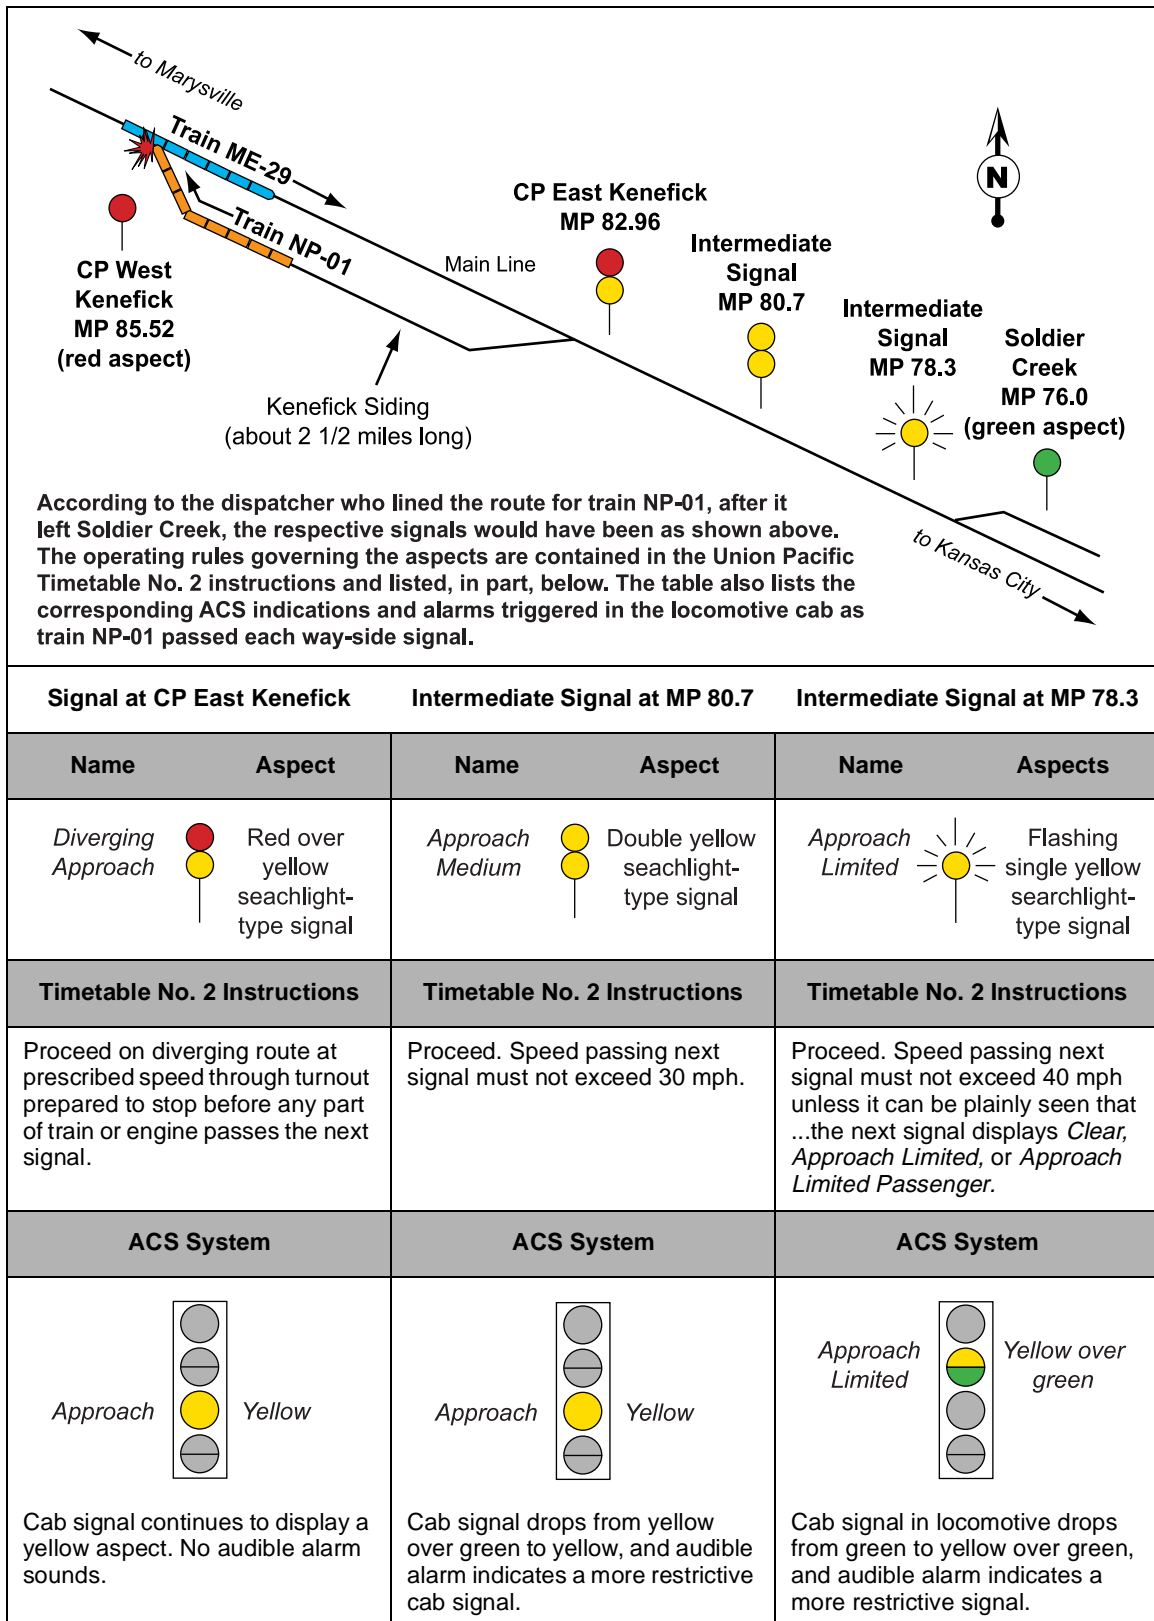
According to the Marysville Subdivision train dispatcher, he routed eastbound train ME-29 to move on the main track because it was a higher priority train than train NP-01. He routed westbound train NP-01 into the Kenefick siding and had a stop signal displayed at the west end of the siding. Before reaching the siding, train NP-01 passed two intermediate signals, which displayed the aspects shown in figure 2.

**Figure 2.** Wayside signals and locomotive cab signals for train NP-01 from Soldier Creek to the entry of the Kenefick siding.
