Hazardous Materials Accident Report

Release and Ignition of Hydrogen Following Collision of a Tractor-Semitrailer with Horizontally Mounted Cylinders and a Pickup Truck near Ramona, Oklahoma May 1, 2001

**NTSB/HZM-02/02
PB2002-917003
Notation 7371A
Adopted September 17, 2002**

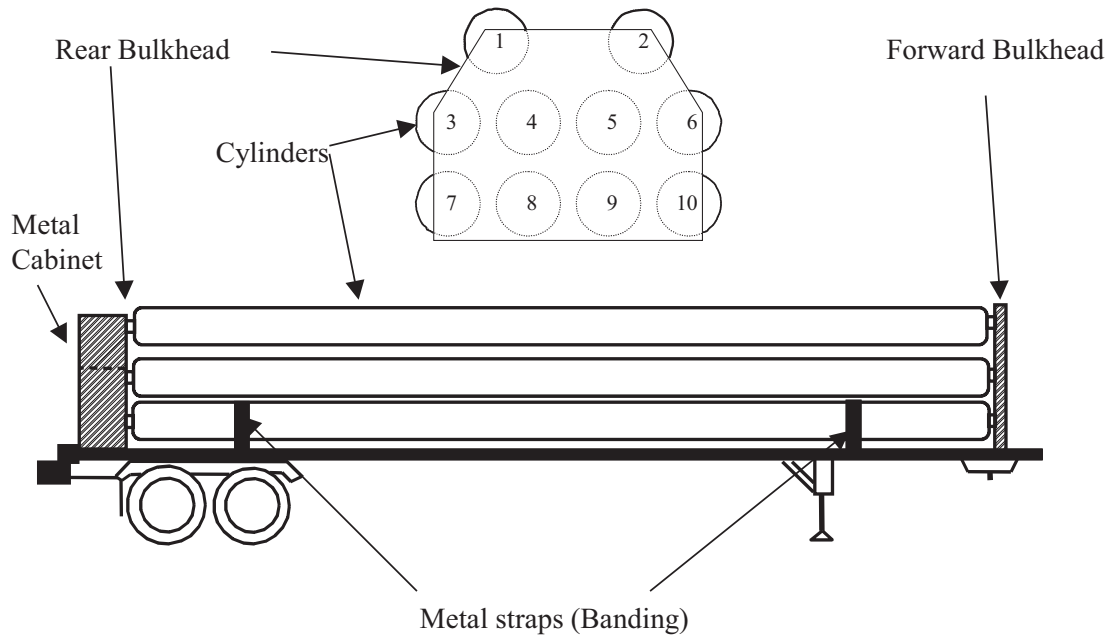
The tractor-semi-trailer was operated by Airgas Mid-South, headquartered in Tulsa, Oklahoma. The semitrailer carried 10 horizontally mounted cylinders (see figure 1) loaded with compressed hydrogen. Each cylinder was about 22 inches in diameter and about 37 1/2 feet long. Combined, the cylinders contained a total of approximately 141,365 cubic feet² of hydrogen; each cylinder was pressurized to about 2,500 pounds per square inch, gauge (psig). The cylinders were secured between two bulkheads and arranged in three rows; the first (bottom) and second rows each had four cylinders, and the third (top row) had two cylinders. The cylinders had been filled with hydrogen on April 30, 2001, at the Airgas Mid-South facility in Tulsa.

Figure 1. Mounting and cylinder configuration of the accident semitrailer.

The metallurgical examination of the fracture of cylinder 3 showed that the fracture was caused by overstress that resulted from forces acting on the cylinder during the rollover. The fracture was consistent with the impact of the front of the cylinder with the roadway and/or terrain. Because the outermost cylinders extended beyond the top and side edges of the bulkheads, the cylinders were exposed and vulnerable to absorbing the initial impact during a rollover. (See figure 1.)

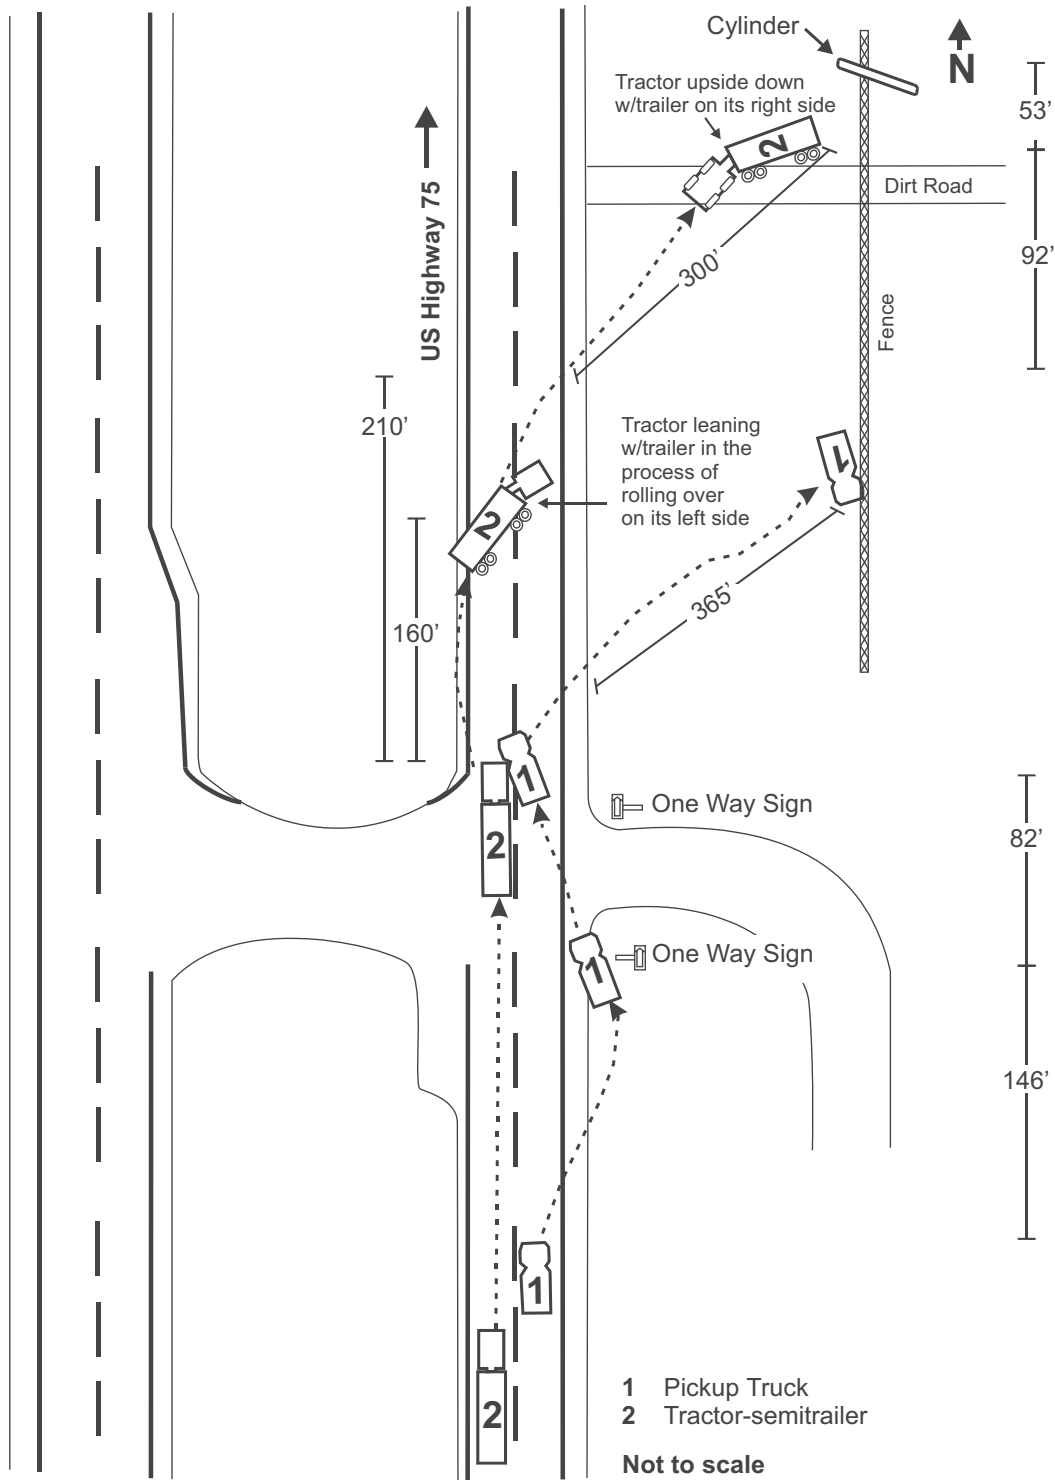
Witnesses said the pickup truck next swerved from the left lane, through the right lane, and onto the right shoulder of the highway, where it struck a one-way traffic sign. (See figure 3.) After striking the sign, the pickup truck veered back onto the highway, into the left lane and into the path of the tractor-semitrailer. The right front of the tractor struck the front left axle of the pickup truck.

After the collision, the pickup truck traveled about 365 feet before coming to rest against a fence and facing south. The tractor-semitrailer remained coupled and traveled about 210 feet along the roadway beyond the point where it had hit the pickup truck. The tractor-semitrailer rolled over onto its left side before leaving the roadway. The tractor-semitrailer left the road and traveled about 300 feet on the embankment before coming to rest. The tractor and the semitrailer remained coupled with the tractor upside down and the semitrailer on its right side (the tractor had rolled about 180 degrees, and the semitrailer had rolled about 270 degrees). One cylinder, cylinder 3, had separated from the semitrailer and came to rest about 53 feet away.

Figure 3. Accident diagram.

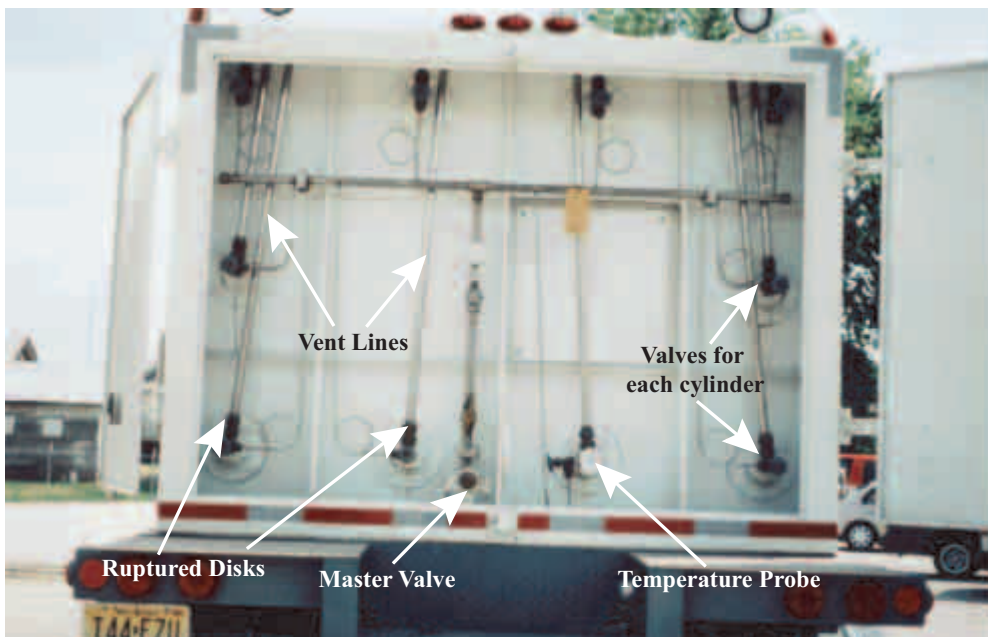
The cabinet, which enclosed the valves, piping, and fittings for the cylinders, had separated from the rear bulkhead and was crushed inward from the passenger side of the semitrailer toward the driver's side. (See figure 4a. Figure 4b shows the rear view of a similar vehicle configuration without damage.) The master valve and the shutoff valves, piping, and fittings for eight of the cylinders had been sheared off. The valves for the other two cylinders were intact but broken away from their piping. Both valves were bent in a direction consistent with the application of a force applied from the right side of the trailer.

Figure 4b. Rear view of a typical semitrailer's cabinet without damage.

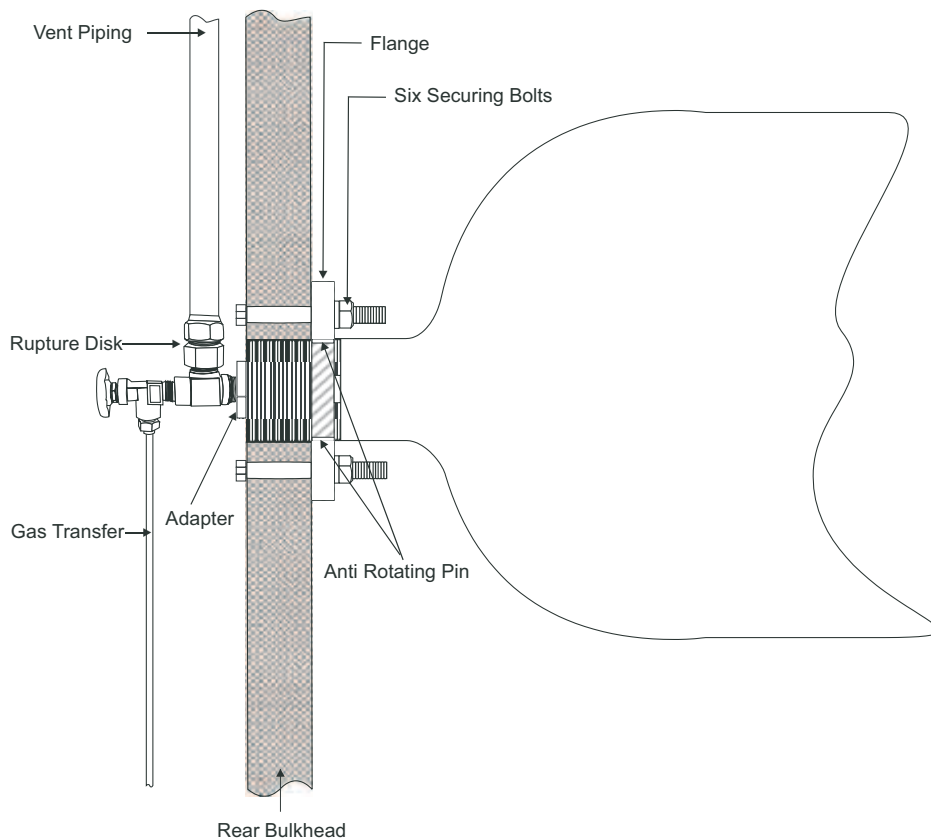
Both necks of each cylinder on the accident semitrailer had inside and outside threads. The outside threads were screwed into six-bolt flanges that secured the cylinder to the bulkheads. Anti-rotation pins were inserted between the flange and the outside threads of the cylinder. (See figure 8.) Adaptors were screwed into the inside threads of each neck of each cylinder. The front-end adaptor held a rupture disk,¹⁶ whereas the rear-end adapter held a rupture disk and the shutoff valve for the cylinder. The valves, piping, and fittings at the rear of the semitrailer allowed the contents of all 10 cylinders to be loaded or unloaded simultaneously or in a series of one or more. The valves and piping from each cylinder joined at a master shutoff valve.¹⁷ Piping used to release pressure and vent each cylinder was installed on the front and rear of the semitrailer.

Figure 8. Diagram of the rear end of a cylinder, showing how it is secured into a flange, which is then secured with bolts to the bulkhead. The valve is screwed into an adapter, which is inserted into the end of the cylinder.
