**Nurse Tank Failure With Release of Hazardous Materials
Near Calamus, Iowa
April 15, 2003**

**Hazardous Materials
Accident Report**

NTSB/HZM-04/01

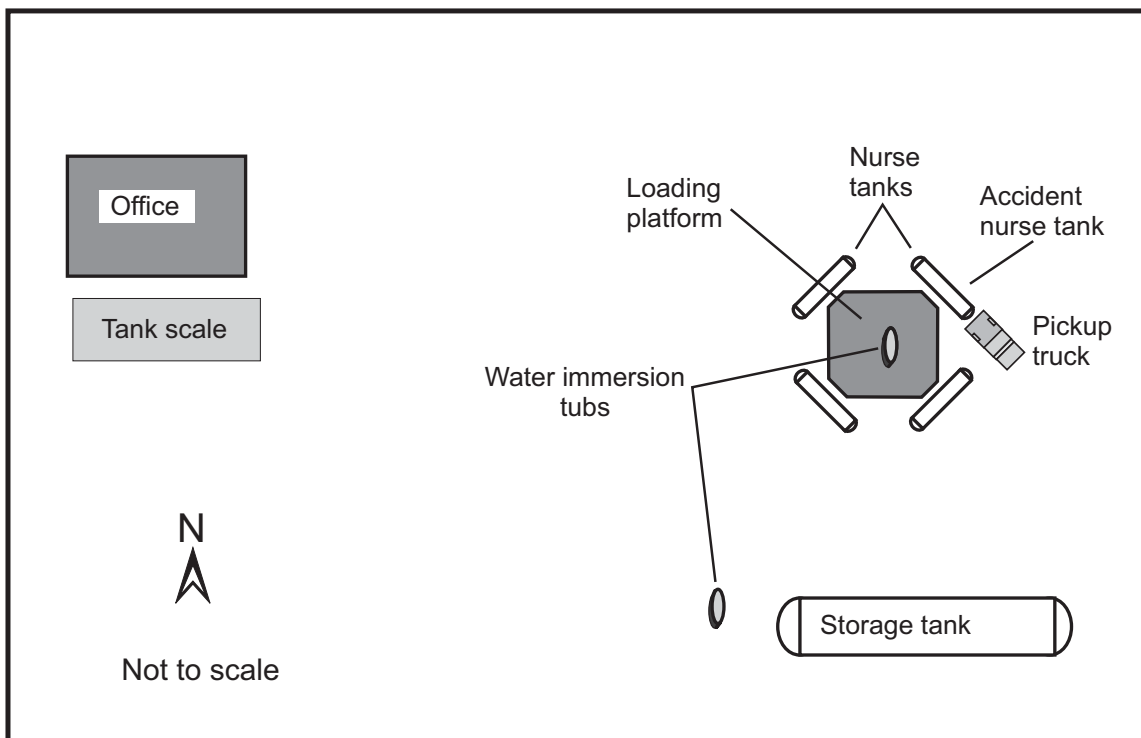
The loader who had been on the loading platform could not tell investigators what occurred immediately following the sudden release of anhydrous ammonia because the injuries he sustained during the accident were so severe that he could not be interviewed by investigators before he died 9 days after the accident. This loader did tell a witness that he had activated the emergency shutoff button for the anhydrous ammonia pump to the other three nurse tanks on the platform. (See figure 3 for layout of Calamus filling facility.)

Figure 3. Layout of Calamus anhydrous ammonia filling facility.

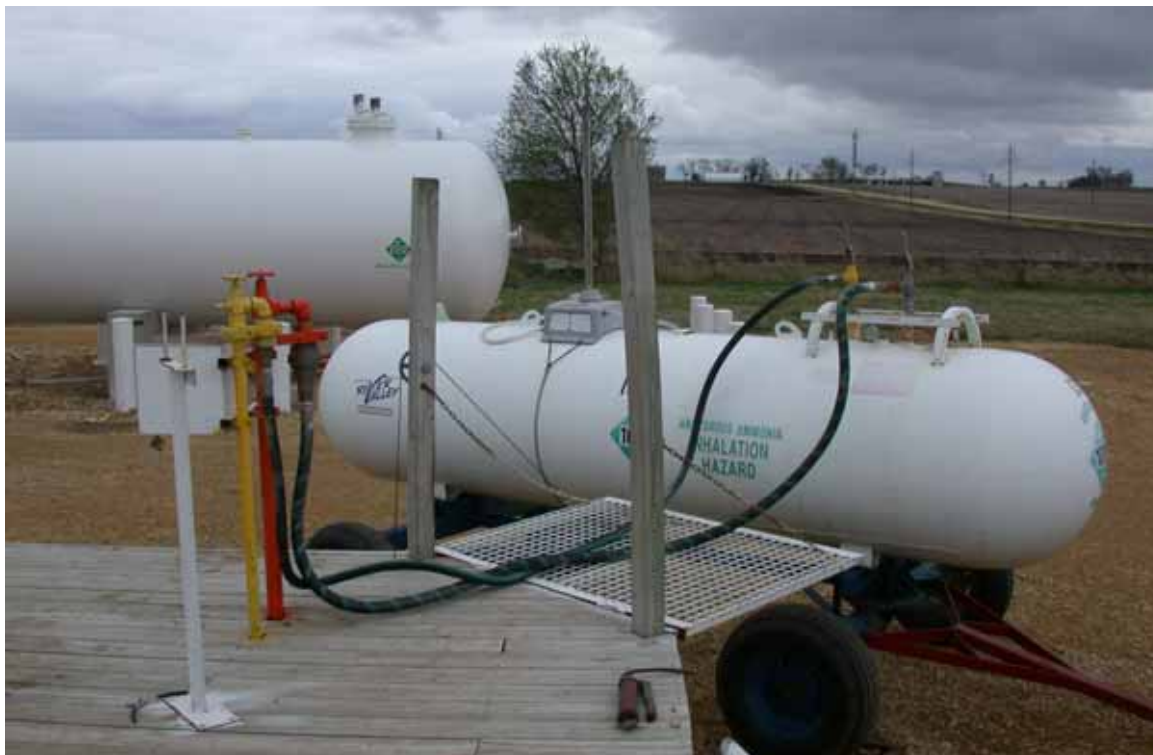
- Hook up the hoses. (The loaders were to attach the red fitting to the red valve for the liquid line and the yellow fitting to the yellow valve for the vapor return line.) (See figure 7.)

Figure 7. A nurse tank hooked to loading hoses.
