**Hard Landing, Gear Collapse
Federal Express Flight 647
Boeing MD-10-10F, N364FE
Memphis, Tennessee
December 18, 2003**

NTSB/AAR-05/01

**NTSB/AAR-05/01
PB2005-910401
Notation 7632A
Adopted May 17, 2005**

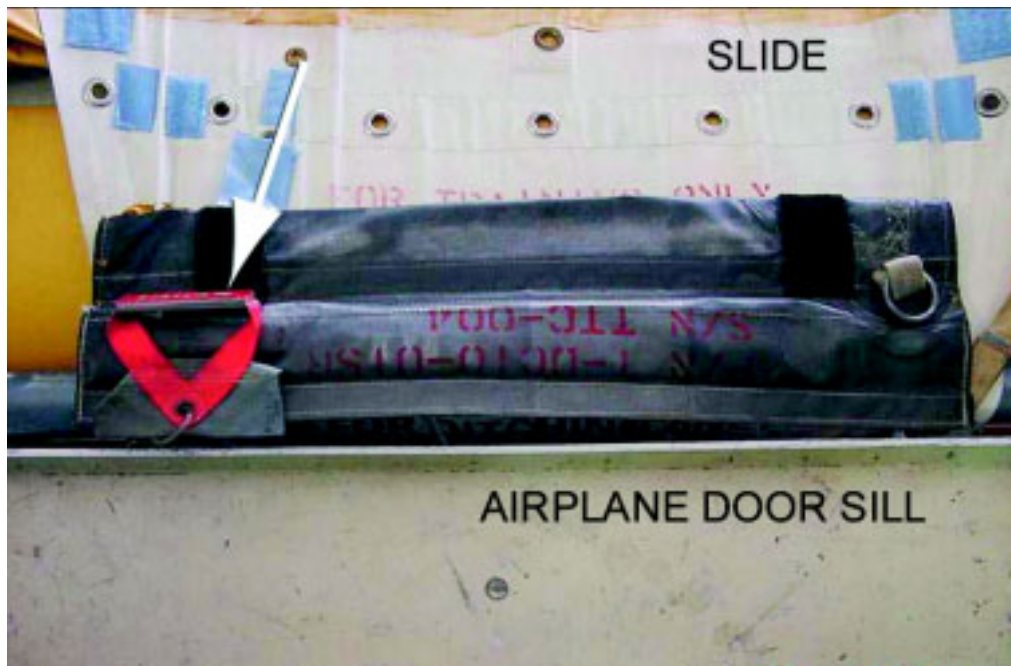
cylinder. The slide/raft disengage handle is webbed and has the word PULL stenciled in red lettering; it is normally attached by Velcro at the base of the upper girt assembly under the girt cover flap. The slide/raft disengage handle is normally used only during emergency evacuations after a water landing (ditching). (Figure 3 shows FedEx's MD-11/-10 emergency evacuation door trainer, with the girt flap assembly in place. Figure 4 shows FedEx's MD-11/-10 emergency evacuation door trainer, with the girt flap assembly lifted.)³⁴ The distance from the accident airplane's L1 doorsill to the ground was 16 feet 10 inches instead of the usual distance of 16 feet 3 inches because of the failed right main landing gear.

Figure 3. FedEx's MD-11/-10 emergency evacuation door trainer, with the girt flap assembly in place, as it would appear when the door/slide is opened. The arrow indicates the manual inflation handle.

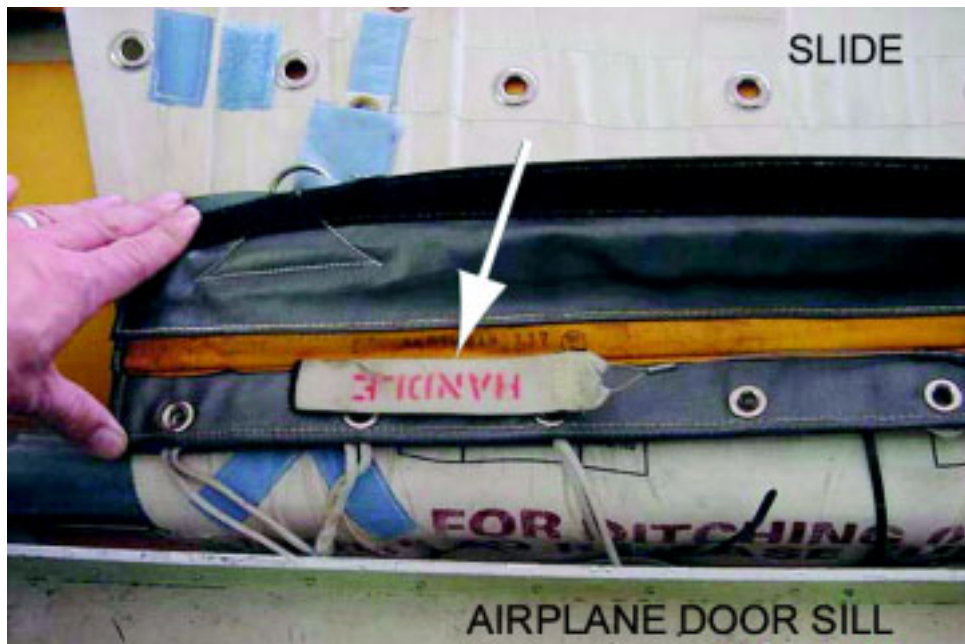
Figure 4. FedEx's MD-11/-10 emergency evacuation door trainer, with the girt flap assembly lifted. The arrow indicates the slide/raft disengage handle.
