# Biennial Report<sup>1</sup> on Occupational Safety and Health Inspections

Conducted in the legislative branch during the 109<sup>th</sup> Congress pursuant to the Congressional Accountability Act of 1995

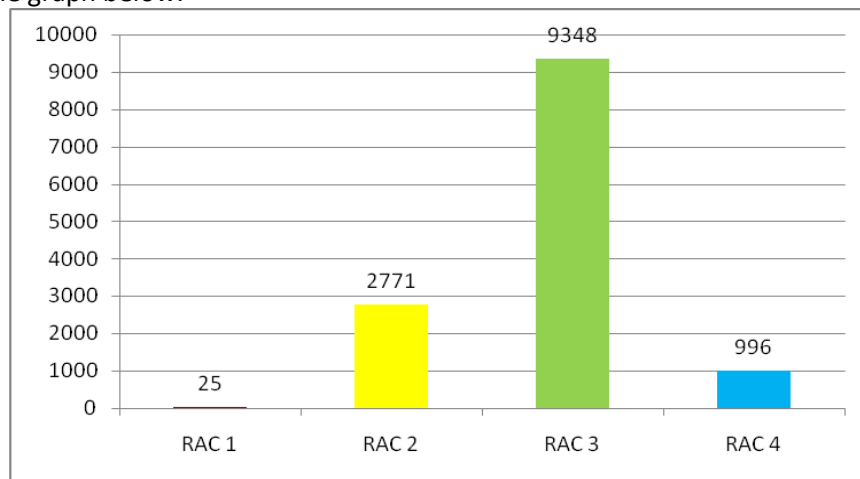
**Figure 1 RAC Distribution in the 109th Congress Inspection**

Approximately 15.3 million square feet were inspected during the 109<sup>th</sup> Congress, which was approximately four times the area inspected during the 108<sup>th</sup> Congress. During this inspection cycle, the OGC inspection team was able to access most of the spaces within each building. In contrast, during the 108<sup>th</sup> Congressional inspections, the OGC inspection team was unable to gain access to many offices. The OGC inspection team documented 13,147 findings during this Biennial inspection, approximately five times the number of findings during the 108<sup>th</sup> Congress. As of August 1, 2007, there were 5,715 findings unabated (43.5%). The distribution of findings by RAC levels is shown in the graph below:

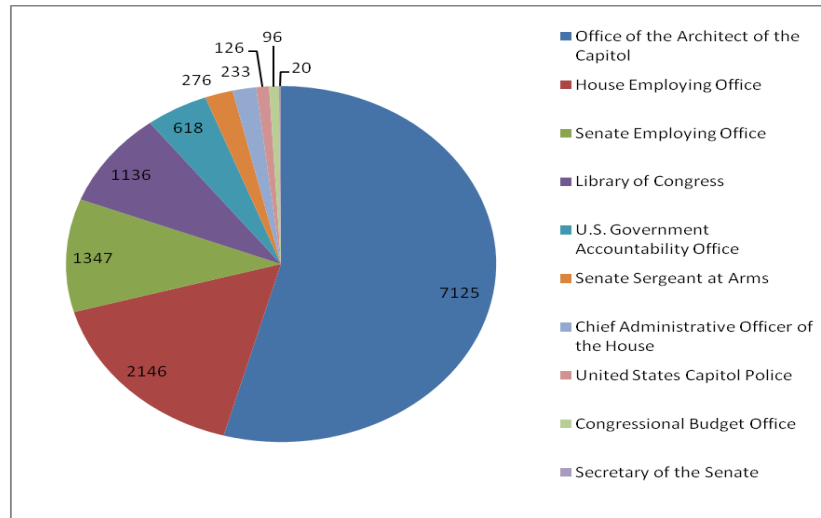
**Figure 2 Organizations with highest number of findings**

The AOC is principally responsible for the maintenance of the structure of most of these legislative branch buildings occupied by legislative branch entities as well as the mechanical and electrical systems and the Capitol Hill grounds. The following chart illustrates the number of hazard findings by the organization responsible for their abatement:

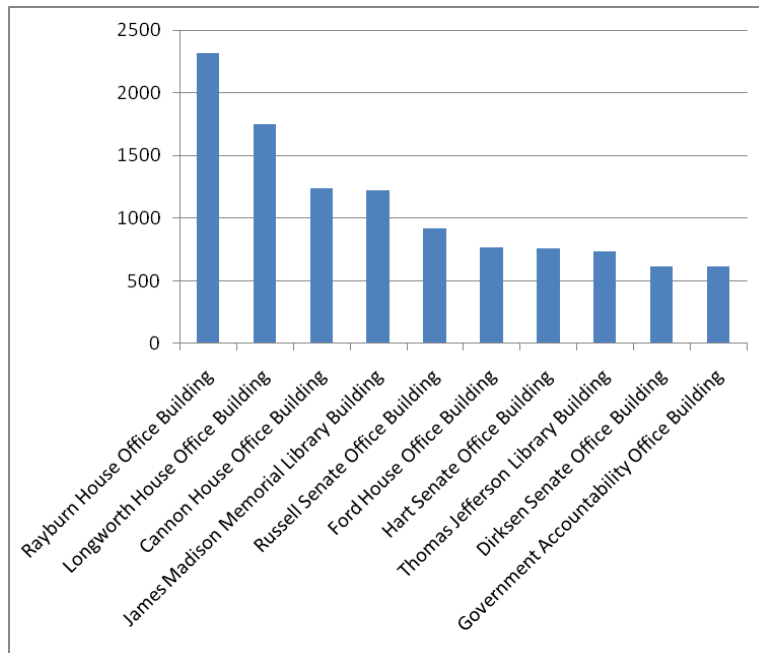
**Figure 3 Facilities with the Highest Number of Findings**

The ten facilities with the highest total number of findings are listed below. The findings for these individual buildings are presented in the jurisdictional findings sections of this Report discussed below.

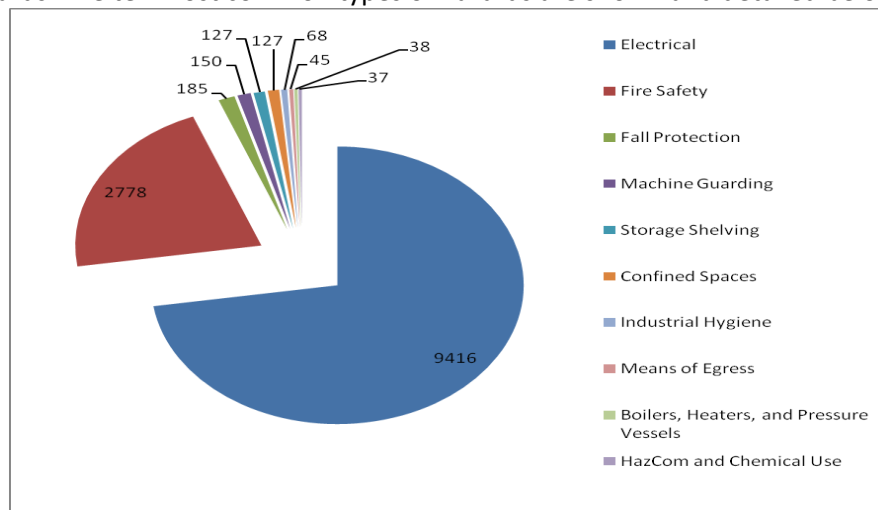
**Figure 4 Most Common Types of Hazards Cited in 109th Congress Inspection**

The most common findings of the 109<sup>th</sup> Congressional inspections are very similar to the past Congressional inspections. Electrical hazards were the most common findings, representing 9,416 of the total. There were 2,778 fire safety hazards, 195 fall protection (potential slip and fall) findings, 150 improper or missing machine guarding findings, 127 instances of unsecured storage shelving, and 127 confined space hazards. Other miscellaneous findings included industrial hygiene issues; means of egress; hazards regarding boilers, heaters, and pressure vessels; and hazard communication and chemical use issues. Even though some of the latter issues

were not as prevalent, in many cases they pose a more serious hazard than some of the more common electrical and fire safety hazards. The ten most common types of hazards are shown and detailed below:

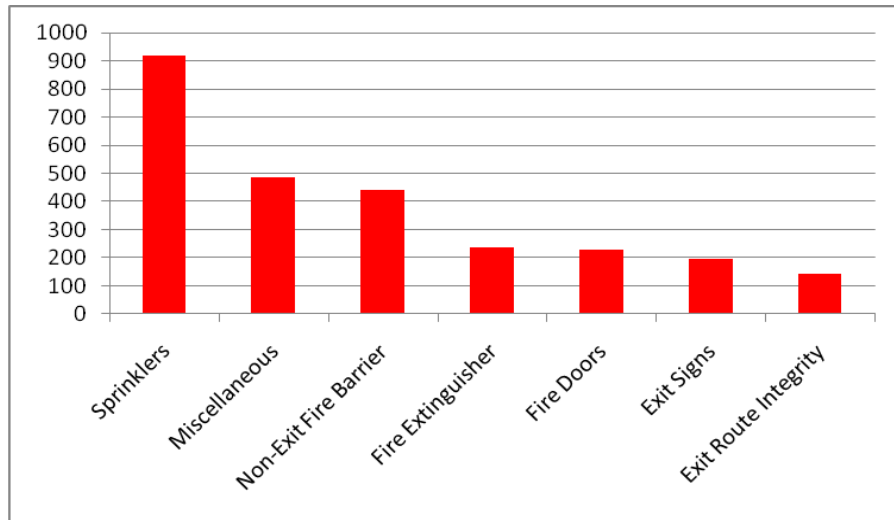
**Figure 5 Most Prevalent Fire Safety Hazards Cited in the 109th Congress Inspection**

**Sprinkler systems:** Deficiencies involving sprinkler systems were the most common fire safety hazard. The inspection team noted at over 300 locations where high storage of materials either blocked water distribution from the sprinkler heads, or were stacked above the sprinkler heads, thereby impeding their ability to extinguish fires. Storage must be kept at least 18 inches below the plane of the sprinkler heads to ensure proper water dispersion. Additionally, ceiling tiles were missing in approximately 190 locations within legislative branch facilities, potentially delaying activation of smoke or heat detection devices in those areas. Other sprinkler deficiencies include damaged, incomplete coverage, and recalled Omega sprinkler heads.

**Portable space heaters:** A significant number of employees throughout the legislative branch use portable space heaters to provide comfort during cold weather to supplement building heating systems. Some consumer models of portable space heaters lack a “tip switch” - a mechanism that automatically turns off the heating element if the device tipped over. Although testing laboratories may approve models that lack this feature for home use, they are not approved for use in the workplace. Some space heaters have components which have become damaged or inoperable, voiding their laboratory approval. Clearly, the use of unapproved space heaters or improperly placing them too close to combustible materials is one of the most significant fire hazards identified during the 109<sup>th</sup> inspections. The OGC inspection team identified 225 space heaters that did not have tip switches or were not in proper working order.

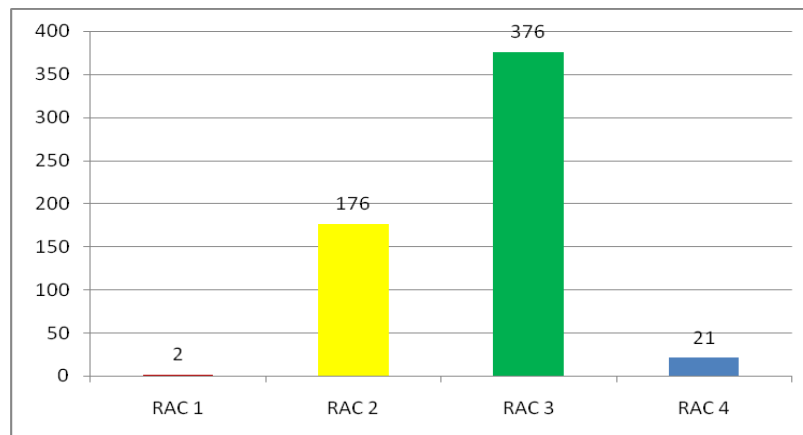
**Figure 6 Proportion of Capitol Building Hazards by Risk Assessment Code**

The inspection team identified 575 findings during its inspection. Two findings were ranked as RAC 1's, and 179 were ranked as RAC 2's. Of the 575 findings identified, 416 findings were electrical hazards; 120 fire safety hazards; fifteen fall protection hazards; five machine guarding; five for unsecured storage shelving. Other findings include tripping hazards, failure to comply with the Methylene Chloride Standard and hazardous communications requirements for hazardous materials, and several confined spaces were not posted with proper warning signage. As of August 1, 2007, 449 of the findings were reported to the OOC as having been abated; 126 remain open (unabated). The following charts show the distribution of findings with corresponding RAC levels and number of findings by responsible office.

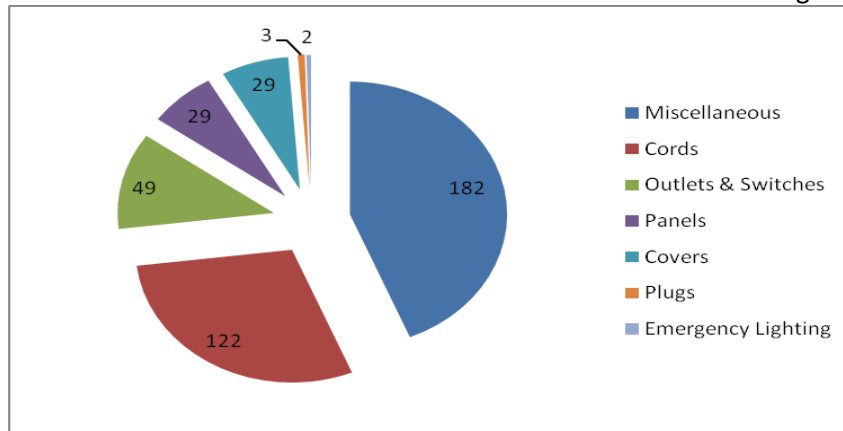
**Figure 8 Electrical Hazards Cited in the U.S. Capitol Building**

During the inspections, access to seven electrical circuit breaker panels were obstructed, potentially impeding access by either fire or security personnel in an emergency situation. OSHA and the National Electrical Code prohibit this condition. Eleven electrical panels were found to lack or had inadequately completed directories indicating the service controlled by individual circuit breaker. This condition could also delay shutting off power in an emergency.

Electrical junction boxes, pieces of the electrical system where electrical wires are spliced together, are required to have a firmly affixed cover. Twenty-nine of these were found to be without covers, exposing energized wires that could result in an electric shock. It was also noted that twenty-one electrical outlets had high ground impedance or reversed polarity, conditions which could result in an electrical shock or malfunction of electrical appliances.

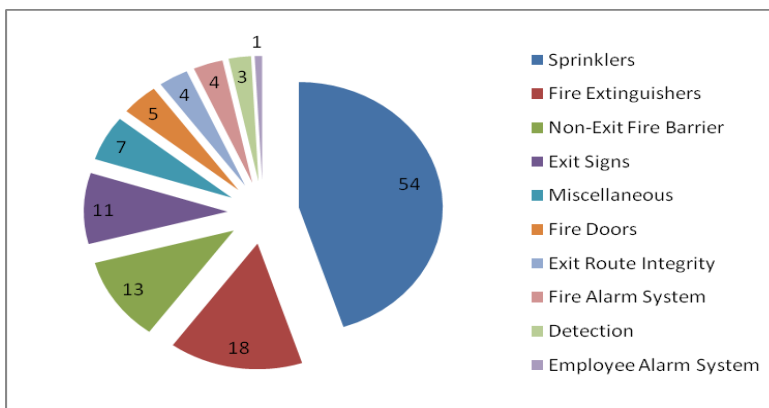
**Figure 9 Fire Safety Hazards Cited in the U.S. Capitol Building**

Most significantly, the Capitol continues to have open exit stairways, lacking protection from fire, smoke, and toxic gases. Prior inspections have noted these serious RAC 1 hazards, for which Citation 16 was issued to the AOC in 2000. The stairways' inability to protect evacuees by limiting the spread of fire and smoke is of particular concern in a building that is widely recognized as a potential terrorist target. The OGC continues to urge that protective actions be taken as soon as possible.

As of the time of the inspection, approximately 80% of the Capitol Building lacked sprinkler coverage, the highest deficit of all buildings on Capitol Hill.<sup>32</sup> Within the spaces having sprinkler coverage, four isolated areas were found to use a mode of sprinkler head that was recalled in 1998 by the U.S. Consumer Product Safety Commission (CPSC) because it too frequently fails to activate.

The National Fire Code requires that portable fire extinguishers be mounted on a wall or stored in an accessible case. These rules also require that portable fire extinguishers be inspected monthly for damage and charge, and inspected yearly by a company certified to conduct inspections and repairs by the manufacturer. These monthly and annual inspections are usually documented using tags attached to each fire extinguisher. The inspection team found that at least eighteen fire extinguishers were not properly mounted or tagged, or both, making them susceptible to damage. The dates and frequency of inspection of the units without tags could also not be verified. Without proper documentation, the functionality of the individual fire extinguisher in an emergency is suspect.

The inspection team noted three locations that lacked exit signage. Seven exit routes were found to lack adequate emergency lighting, either due to failure to install emergency lighting, failure to keep backup batteries charged, or failure to replace burnt out light bulbs.

Penetrations in critical fire barriers were identified in thirteen locations, and five areas were found to have missing ceiling tiles. These openings enable smoke and fire to travel rapidly to other areas of the building, and prevent the smoke detection system from working properly.

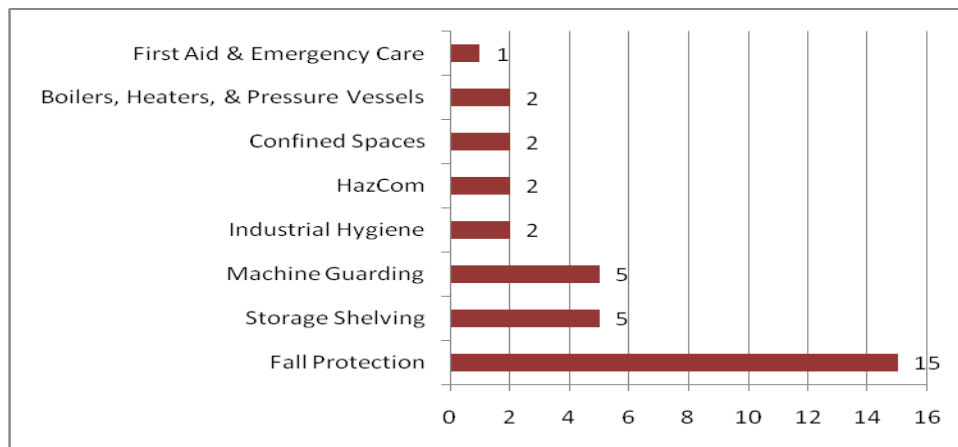
**Figure 10 Additional Hazards Cited in the U.S. Capitol Building**

As the chart above shows, hazards other than electrical or fire safety hazards were also identified in the Capitol Building. These findings are discussed below.

Trip and fall hazards are created by the presence of unguarded obstructions in walkways or work areas and missing handrails and guardrails. Nine locations had walkways with power cords or telephone cords crossing them, buckled carpet, or protruding furniture that could cause people to trip. OSHA regulations require that walkways, particularly those used as routes of egress, remain clear and free from obstructions. The inspection team noted six locations where stairs did not have handrails or the guardrails were inadequate or lacking.

Storage shelving was found unsecured and capable of toppling over trapping or injuring an individual. As well, mechanical devices were identified lacking the proper machine guarding to prevent contact with motorized parts.

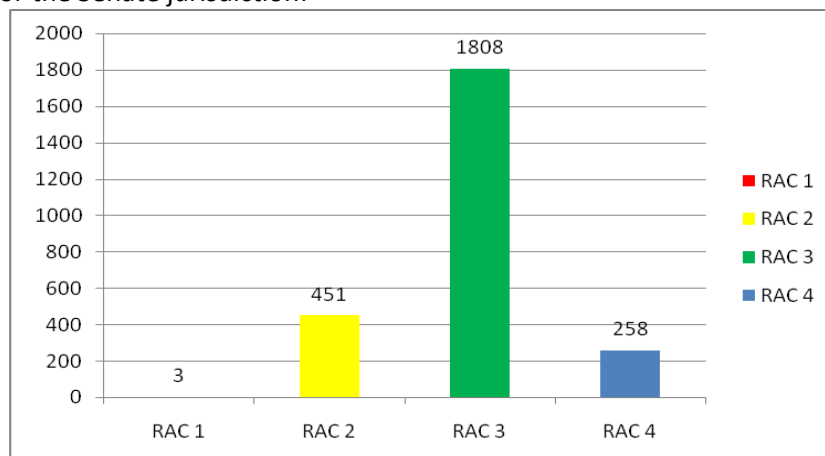
**Figure 11 Proportion of Senate Building Hazards by Risk Assessment Code**

The OGC inspection team identified 2,520 findings during the inspection of the Senate facilities. Three findings were assigned a hazard rating of RAC 1, and 451 were rated as RAC 2. Of the 2,520 findings, 1,911 were electrical hazards, 519 were fire safety hazards; twenty-three related to slip, trip or fall hazards, fourteen involved machine guarding, and thirteen findings involved unstable or unsecured storage furniture. Other findings involved inadequate means of egress: the presence of products containing a regulated carcinogenic chemical, like methylene chloride without compliance with OSHA’s Methylene Chloride Standard and Hazard Communication Standard, and several confined spaces that were not posted with proper hazard signage. Fortunately, many electrical violations were corrected during the inspection or within 24-hours of discovery. As of August 1, 2007, 1,675 of the findings were reported to the OOC as having been abated; 845 (approximately 1/3 of the total findings) were not.<sup>33</sup>

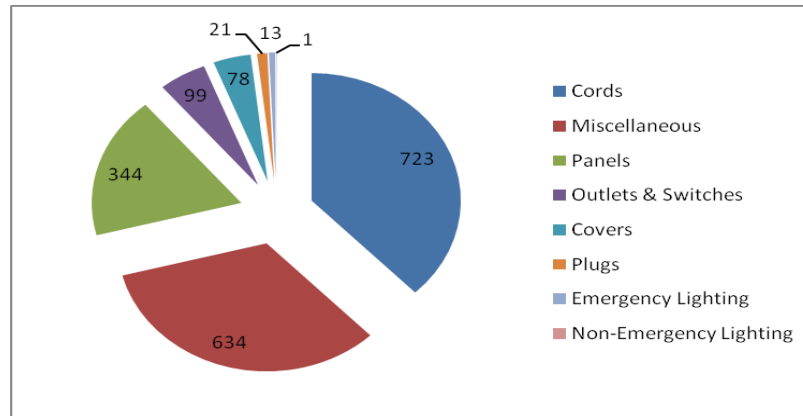
**Figure 14 Electrical Hazards Cited in the Senate Jurisdiction**

During the 109<sup>th</sup> inspection cycle, access to 159 electrical panels housing circuit breakers were obstructed. Impeding an electrician or fire or security professional’s access to a breaker in an emergency situation creates unnecessary delay in emergency response.

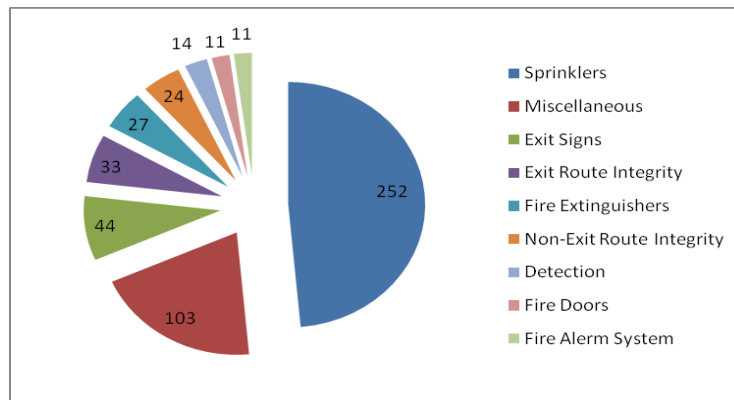
**Figure 15 Fire Safety Hazards Cited in the Senate Jurisdiction**

Most of the storage closets in the Member and Committee offices had no fire sprinkler coverage. Many of those having coverage had sprinkler heads that were not suspended low enough below the ceiling tiles to properly disperse water, or stored materials were stacked too high, impeding the ability of the sprinkler to extinguish a fire. Storage must be kept at least 18 inches below the plane of the sprinkler heads to ensure proper water

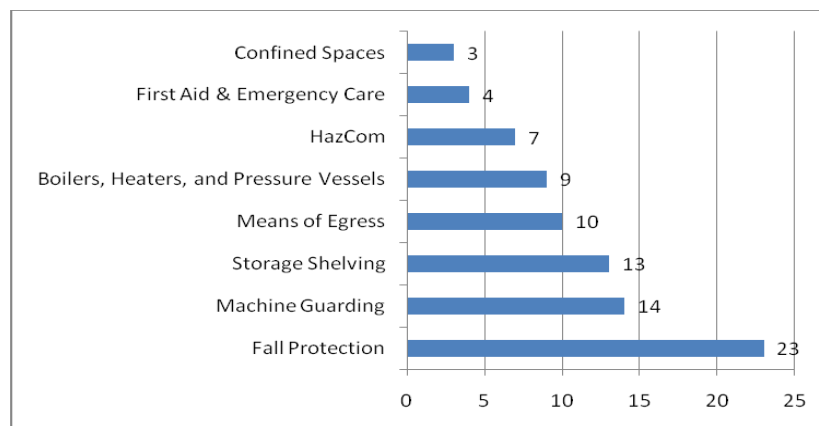
**Figure 16 Other Hazards Cited in the Senate Jurisdiction**

The inspection team noted eighty-one findings that were neither electrical nor fire safety hazards. These findings are discussed below:

Observed fall hazards include hazardous conditions that result in trip hazards, as well as missing handrails and guardrails, and unguarded obstructions in the walkways. Fall hazards include wires strung across walkways,

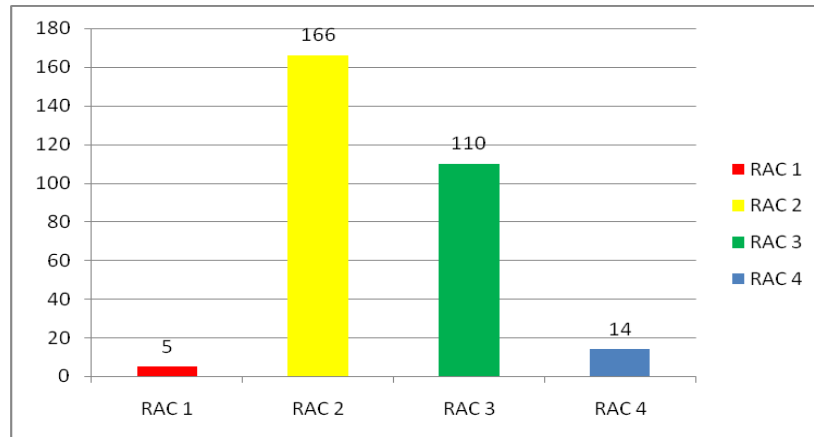
**Figure 17 Proportion of Hazards at the Capitol Power Plant and Utility Tunnels by Risk Assessment Code**

The OGC's inspection team identified 295 hazards during the inspection. Five were rated as RAC 1 hazards, and 166 were rated as RAC 2 hazards. Of the 295 findings, eighty-two were electrical, seventy-two were confined space, forty-two were related to fire safety, and thirty-nine involved industrial hygiene hazards. The remaining sixty findings include boiler and pressure vessel hazards, improper machine guarding, fall protection hazards, health and chemical hazards associated with inadequate implementation of the site's Hazardous Communication Program. The following chart shows the distribution of findings by RAC level:

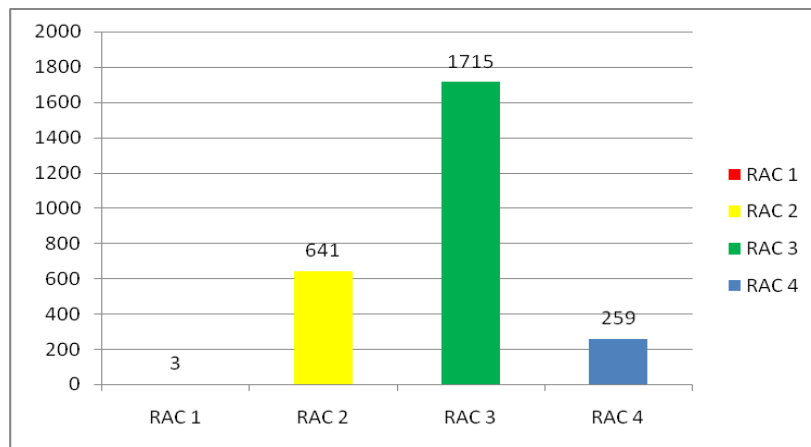
**Figure 18 Proportion of Hazards in the Library of Congress Jurisdiction by Risk Assessment Code**

The inspection team identified 2,618 findings during inspection of the LOC facilities identified above. Three findings were ranked as RAC 1 hazards, and 641 were ranked as RAC 2 hazards. Of the 2,618 total findings, 1,498 involved electrical hazards, 825 were fire safety violations, sixty-five involved fall protection hazards, fifty-eight findings were related to unsecured storage shelving, and fifty were associated with improper machine guarding. Other findings include several permit-required confined spaces that were not posted with proper hazard signage and the presence of hazardous chemical products without compliance with chemical-specific standards and lacking proper hazard communication procedures. As of August 1, 2007, 1,239 of the findings were abated, leaving 1,379 findings open (unabated). Therefore, approximately 52.6% of the total violations were not abated as of that date.

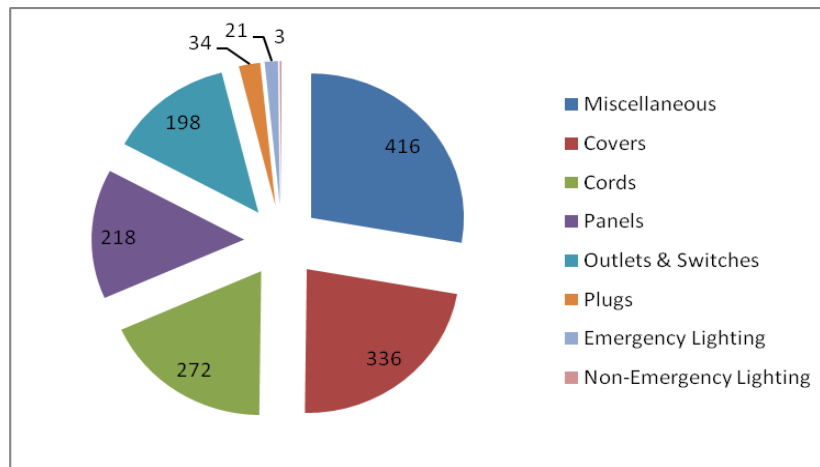
**Figure 21 Electrical Hazards Cited in the Library of Congress Jurisdiction**

In over fifty-three instances, access to electrical panels housing circuit breakers was obstructed. Additionally, 144 electrical panels were found not to have a directory or were not otherwise labeled to indicate which circuit or piece of machinery is shut off by which breaker.

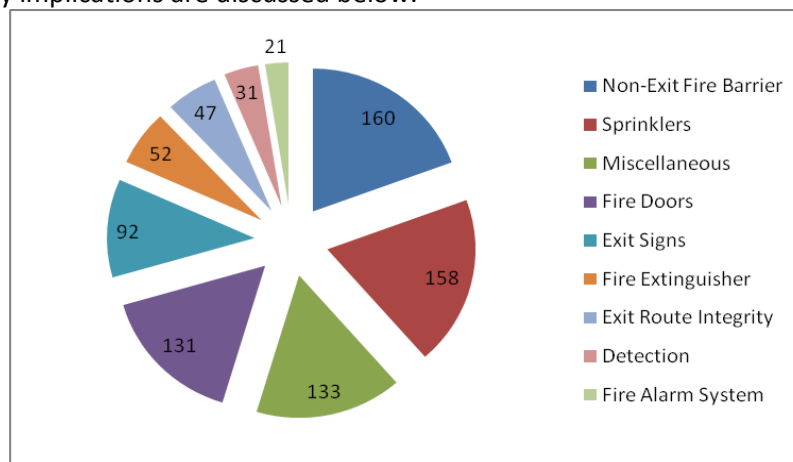
**Figure 22 Fire Safety Hazards Cited in the Library of Congress Jurisdiction**

The inspection team noted at least thirty locations where high storage of materials either blocked some of the potential water distribution from the sprinkler heads, or was stacked above the sprinkler heads, severely impeding their ability to extinguish fires. Storage must be kept at least 18 inches below the place of the sprinkler heads to ensure proper water dispersion. Seventeen sprinkler heads in the Jefferson Building were damaged or improperly installed. Attempting to store materials near a sprinkler head can result in the accidental damage of the sprinkler head, preventing it from functioning as intended.

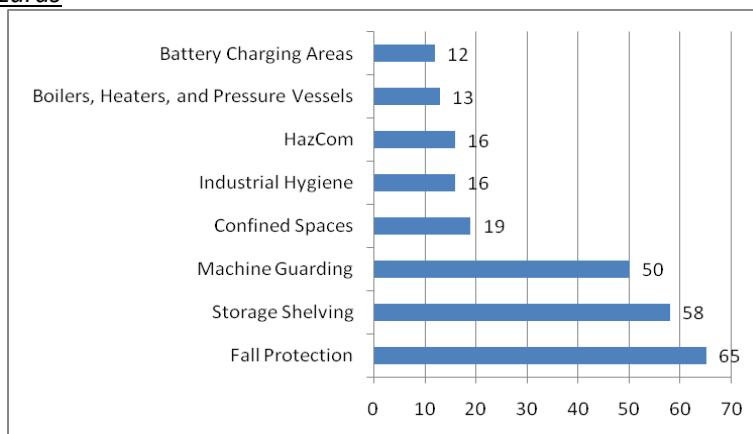
**Figure 23 Miscellaneous Hazards Cited in the Library of Congress Jurisdiction**

Electrical and fire safety hazards were the most common types of hazards found in the 109<sup>th</sup> Congress Biennial Inspection of the Library of Congress facilities. The chart above identifies the eight most common other types of

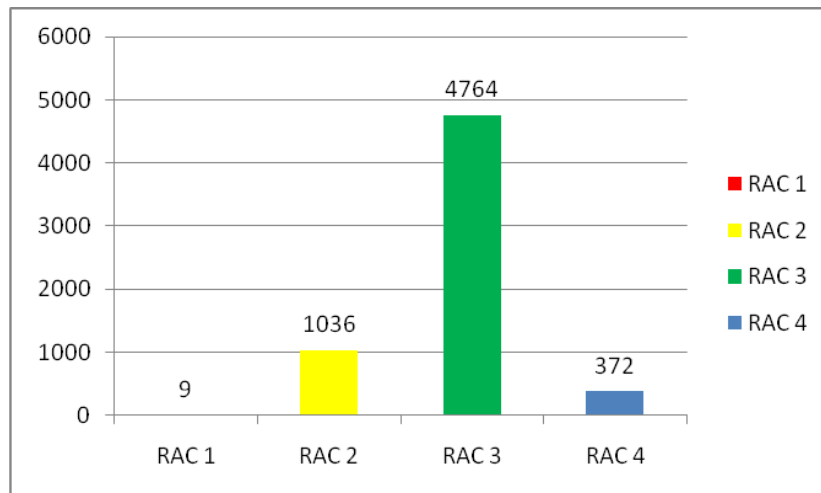
The inspection team identified 6,181 findings during its inspection of these House of Representatives facilities. Nine of these findings were ranked as RAC 1, and 1,036 were ranked as RAC 2. Of the 6,181 findings, 4,944 involved electrical hazards, 991 involved fire safety hazards, sixty-five involved inadequate fall protection, forty-four findings involved unsecured storage shelving, and forty involved machine guarding. Other findings include inadequate means of egress, the presence of products containing a regulated carcinogenic chemical, specifically methylene chloride without complying with the Methylene Chloride Standard and Hazard Communication Standard, and several permit entry confined spaces that were not posted with proper hazard signage. As of August 1, 2007, 3,183 of the findings were abated, with 2,998 findings (approximately 48.5% of the total) not reported as being abated.

Figure 24 Proportion of Hazards in the House Jurisdiction by Risk Assessment Code

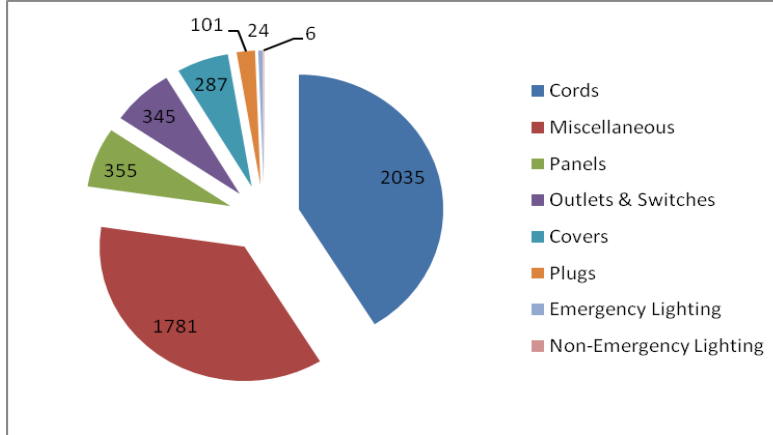
**Figure 27 Electrical Hazards Cited in the House Jurisdiction**

In over 300 instances, access to electrical panels housing circuit breakers were obstructed impeding an electrician or fire or security professional’s access to a breaker in an emergency situation creates unnecessary delay in emergency response. Additionally, many of the electrical fuse panels did not have a directory or were not otherwise labeled to indicate which circuit or piece of machinery were shut off by which breaker. The absence of complete labeling can increase response time in an emergency situation.

Many electrical junction boxes were found to lack covers, exposing energized wires that could provide an electrical shock or possible fire hazard. Several electrical outlets had high ground impedance or reversed polarity, which could result in electrical shock or damage electrical appliances, possibly resulting in a fire.

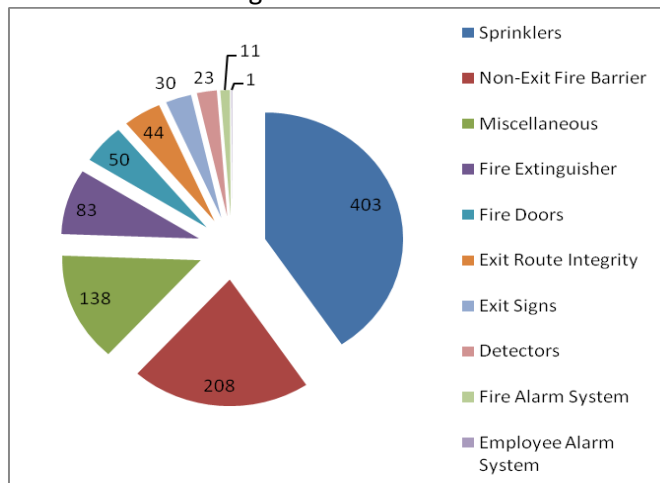
**Figure 28 Fire Safety Hazards Cited in the House Jurisdiction**

Deficiencies involving sprinkler systems were the most common fire safety hazard. The inspection team noted at least 160 locations where high storage of materials either blocked water distribution from the sprinkler heads, or were stacked above the sprinkler heads, thereby impeding their ability to extinguish fires. Storage must be kept at least eighteen inches below the plane of the sprinkler heads to ensure proper water dispersion.

The National Fire Code requires that portable fire extinguishers must be inspected monthly for damage and charge, and inspected yearly by a company certified to conduct inspections and repairs by the manufacturer. The inspection team found fifty-eight fire extinguishers to be beyond their monthly inspection date. Fire extinguishers that are not checked on a regularly scheduled basis may lose their charge and may not work as intended in an emergency situation.

The inspection team identified seventeen locations within the House jurisdiction that lacked an exit sign where one was needed. In three instances, exit signs were present but lacked or had incorrect directional markers. Four exit routes were found to lack adequate emergency lighting during the survey, either due to the failure to install proper emergency lighting or failure to maintain charged back-up batteries or functional light bulbs.

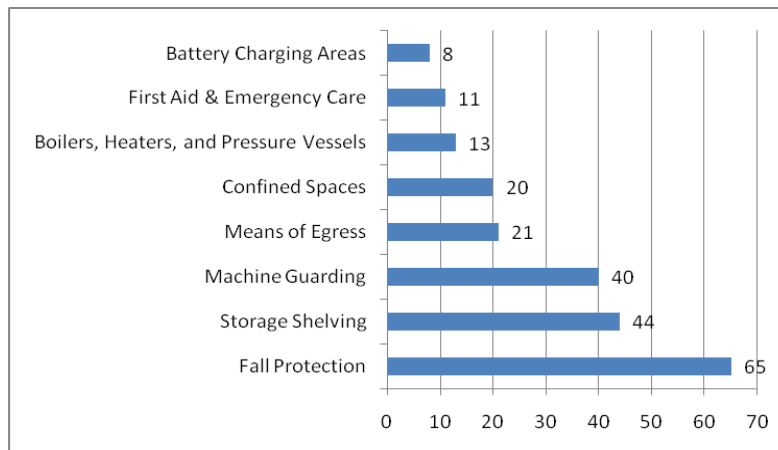
**Figure 29 Miscellaneous Hazards Cited in the House Jurisdiction**

Most frequent fall protection hazards found (forty-five) were wires strung across walkways, loose carpeting, or protruding furniture within walkways, or other items within a walking path that can cause employees to trip and fall. OSHA regulations require that walkways, particularly those used as routes of egress in an emergency, remain clear and free of obstructions. In addition, the OOC inspection team identified open side platforms with greater than a four foot drop and floor holes that could cause a person to trip and fall. Also, deficient ladders were identified that could break and cause someone to fall from an elevated position.

OSHA regulations require that storage shelving either be attached to a wall or be bolted together in a manner that provides stability, preventing it from tipping over. The inspection team noted forty-four instances where unstable shelving was not properly secured. Of that total, twenty-three are in the Rayburn House Office Building. Machine guarding issues were also noted in the House Office Buildings.

In a few of the buildings, the inspection team noted that seventeen egress routes within offices had a width of less than 36 inches. This can impede the ability of a physically disabled person in a wheelchair or a crowd of people from being able to promptly vacate the building during an emergency. The inspection team also found two instances in which exit routes were not properly marked or labeled. The House Employing Offices have represented that they are making abatement efforts which the OOC will verify during the 110<sup>th</sup> Congress.

The inspection team noted nineteen permit entry confined spaces that were not properly marked at the time of the inspections. AOC is actively working on identifying and labeling all confined spaces and has made great progress in some of the House buildings since the biennial inspection conducted for the 108<sup>th</sup> Congress.

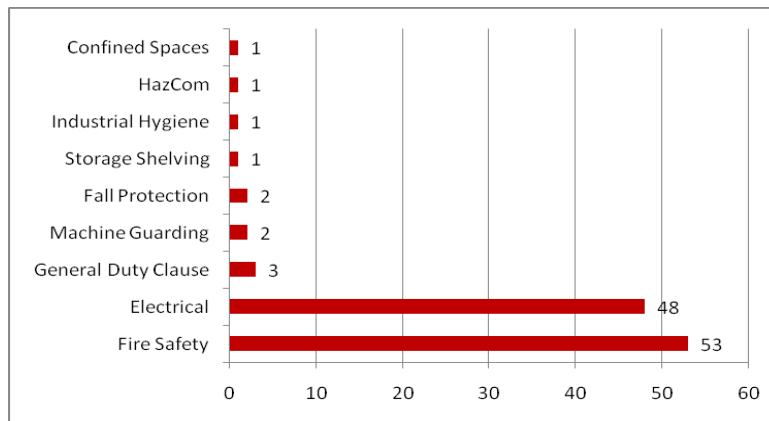
The most common findings in the USCP occupied facilities were fire safety or electrical issues. The other findings included General Duty clause findings (discussed below), slip, trip, and fall hazards, unsecured storage shelving, products containing methylene chloride (a regulated carcinogenic chemical) without compliance with OSHA’s Methylene Chloride Standard and Hazard Communication Standard and several confined spaces that were not posted with proper hazard signage. Many of the findings were abated within 24-hours of the inspection. As of August 1, 2007, ninety-one of the 112 findings (81.3% of the total findings) in the USCP-occupied buildings were reported as abated. The distributions of findings are show and discussed below:

**Figure 32 Types of Hazards Cited in the USCP Jurisdiction**

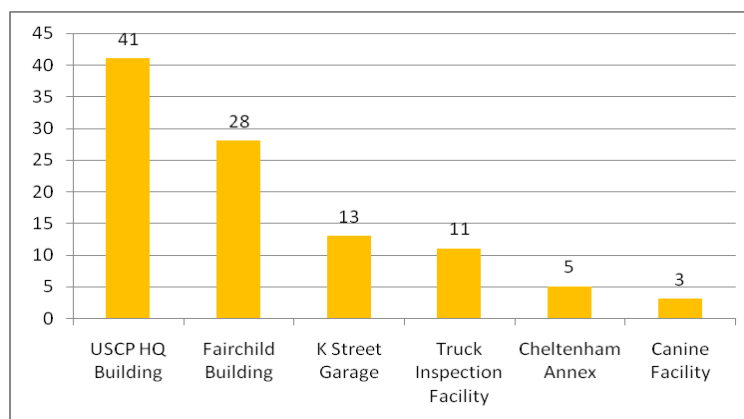
The USCP leases a training building and firing range space at a Federal Law Enforcement Training Center in Cheltenham, Maryland. This biennial inspection included the training building, but not the firing ranges; however, a limited inspection of the firing range was conducted as part of a subsequently filed Requestor-Initiated Inspection. Of the five findings recorded at this site, three involved the lack of sprinkler coverage. All of the findings were either a RAC 3 or RAC 4 hazard.

**Figure 33 Hazards Cited per Building in the USCP Jurisdiction**

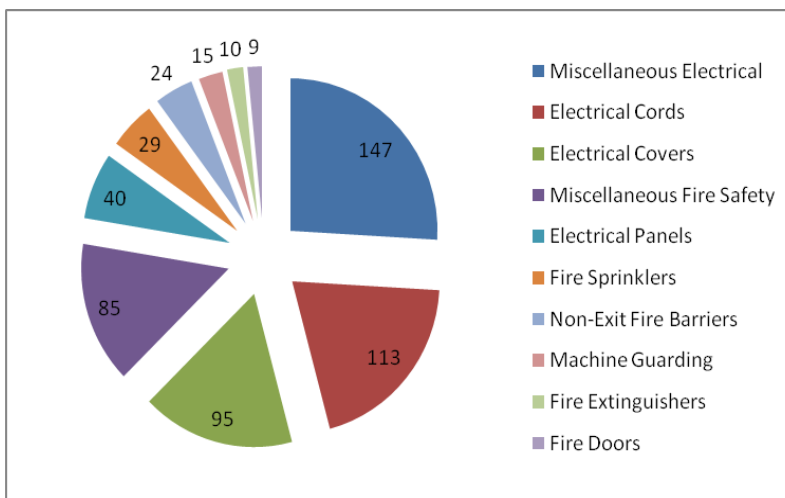
**Figure 35 Common Types of Hazards Identified in the GAO Building**

The chart above expresses 567 of the 618 hazards identified in the building. The distribution of findings are very similar to the other legislative branch jurisdictions in that general electrical hazards are the most common hazards identified. The use of non-permanent cords in lieu of permanent wiring, daisy chains, and unapproved portable space heaters were all common findings in the GAO building.
