U.S. Department  
of Transportation

Federal Railroad  
Administration

# Repair of Budd Pioneer Coach Car Crush Zones

## Rail Passenger Equipment Impact Tests

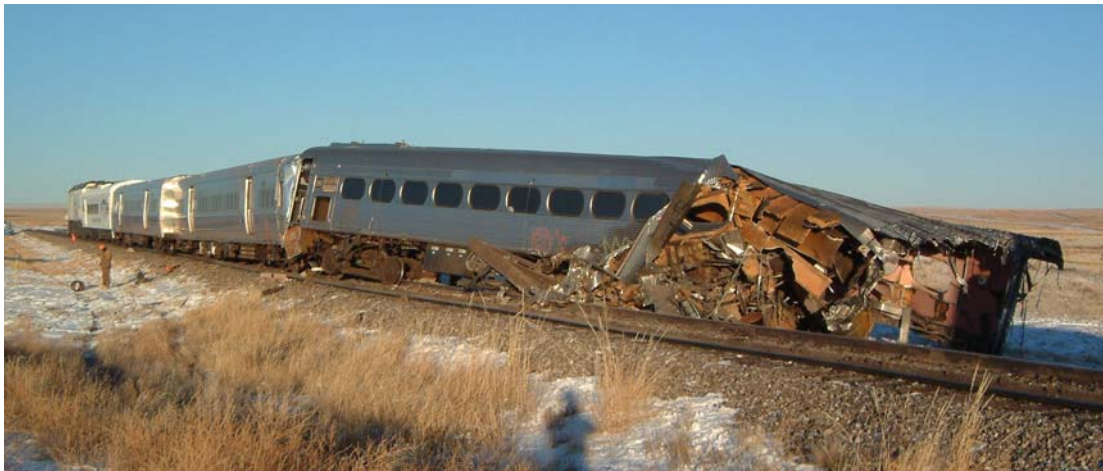
**Figure 1. Cab Car Crush in the Train-to-Train Test**

The baseline train-to-train test consisted of a train moving at about 30 mph (48 km/h), with the cab car leading, colliding with a standing train in which the locomotive was the lead (impacted) vehicle. The cab car leading train included the cab car, followed by the equivalent of four coach cars and, at its aft end, a passenger locomotive. The cab car experienced about 22 ft (6.7 m) of crush in the test. Figure 1 shows the visible damage to the cab car after the test. Implementation of CEM will greatly mitigate the amount of crush in such a collision, isolating deformation to unoccupied areas and preventing override and lateral buckling.

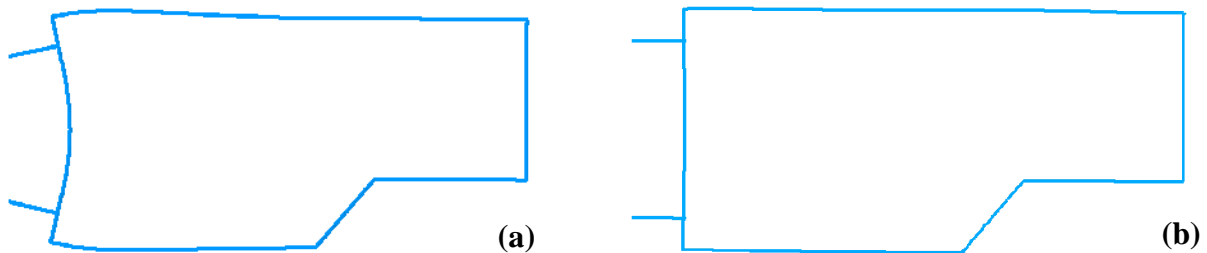
**Figure 19. Finite Element Results Comparing the Calculated Deformation of the End Beam Due to the Loads from the Primary Energy Absorber During Crush (Cross Section Ahead of Primary Energy Absorbers): (a) Original Configuration and (b) Repaired Configuration**

Researchers conducted a finite element analysis to demonstrate the ability of this repair to prevent distortion of the end beam. Figure 19 shows images of the calculated deformation (in section) of the end beams for the original and repaired configurations.

The primary repair on the end frame was the stiffening of the end beam's rear face at the locations at which the primary energy absorbers contact. The collar on the back of the end beam into which the primary energy absorbers protrude was first removed on each side. The end beam surface was then built up with weld metal and ground as flat as possible. A 0.75 in (19 mm), A572-50 plate (or A36 in some cases), whose area was larger than the area originally bounded by the collar, was then welded onto the rear of the end beam; the rear thickness of the A710 (minimum yield strength, 75 ksi [517 MPa]) end beam is 0.375 in (9.5 mm). The decreased length of the primary energy absorber accounted for this added plate (see below). Figure 18 shows a photograph of this region, together with the new retention device and the primary energy absorber.

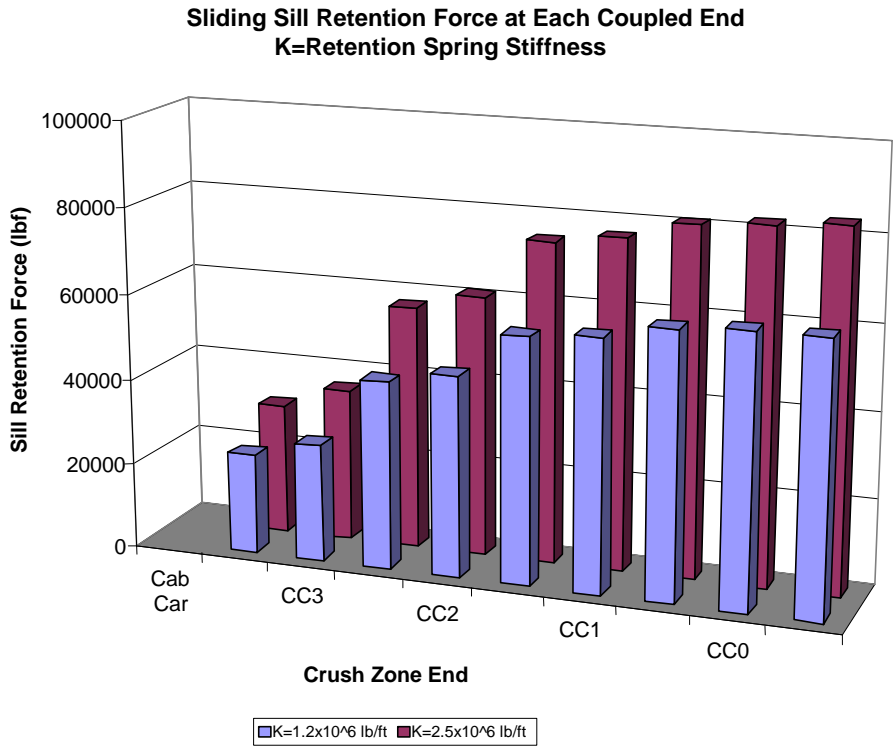
**Figure 23. Results of Collision Dynamics Model for the Effect of Retention Device Stiffness on Calculated Maximum Load on the Device**

Researchers conducted both collision dynamics and finite element analyses to select and demonstrate that the strength of the retention device is adequate. The collision dynamics model simulates the upcoming train-to-train test with CEM equipment. The model of each vehicle end with a crush zone was modified to allow the end of the car to slide outward. A spring element represented the retention device. (The original model includes coupler elastic response.) Calculations for a 30 mph (48 km/h) collision included different values of the retention spring stiffness. Figure 23 shows the calculated maximum force on the retention device as a function of device stiffness for the various coupled interfaces in the train. The force, and therefore the required strength, decrease as the stiffness decreases. This occurs because, with a lower stiffness, the retention force is applied over a longer time. Lower stiffness requires a greater device displacement.

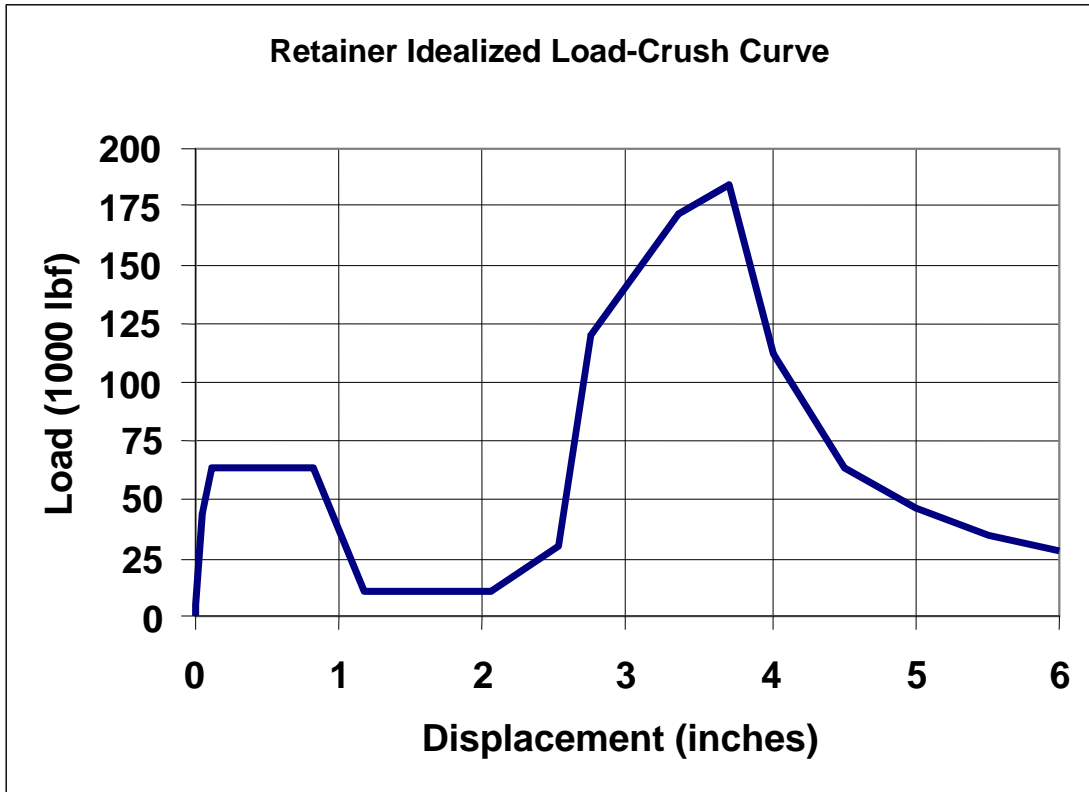
Figure 24. Calculated Load-Deformation Response for the Sliding Sill Retention Device

Figure 24 shows the calculated load-displacement response of the retention device that was installed on the cars, and Figure 25 shows the calculated deformation. These results are from a finite element analysis in which the back of the primary energy absorber was held and a rigid plate representing the end beam was displaced away from it at a speed of 30 mph (48 km/h).
