JRC2008-63053

POST TEST REVIEW OF A SINGLE CAR TEST OF MULTI-LEVEL PASSENGER EQUIPMENT

Michelle Priante
US Department of Transportation
Volpe Center
Cambridge, MA

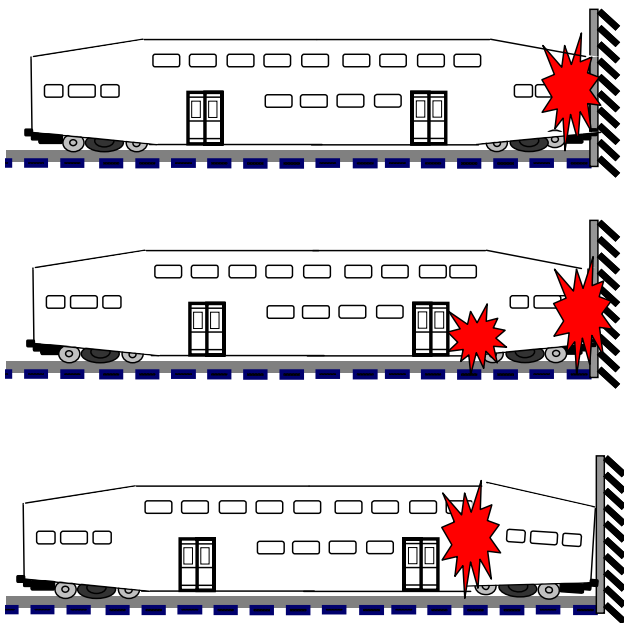
Figure 6. Three Potential Failure Modes for Single Car Test

In the single car test of single level conventional equipment, the leading end of the car crushed 5 feet [7]. Those results suggest that in a single car test, the leading end will crush. This test prediction is shown first in Figure 6.

Both single car and full train engineering models have been used to evaluate the crash performance of multi-level cars. The finite element models suggest crush at two locations, both the leading end and the gooseneck [5]. Collision dynamics modeling suggests that the leading end or a combination of the leading end and the gooseneck will crush during the test [6,8]. From these results, a second prediction for the test is that crush would occur in two places. This is the second prediction in Figure 6.

The collisions in Placentia and Glendale, California involving multi-level cars suggest that the gooseneck will crush while the leading end remains intact. Figure 6 shows this prediction last.

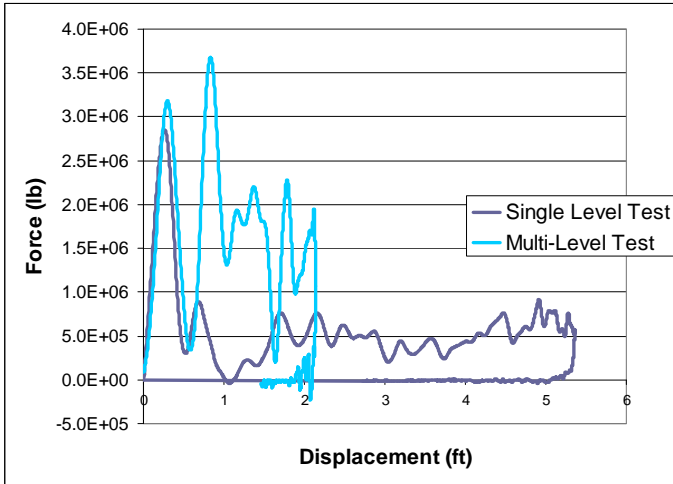
Figure 18. Force vs. Displacement for a Single Level and a Multi-Level Car

Figure 18 shows that the multi-level car and the single level car have a similar initial peak force of approximately 3×10^6 lbf at a displacement of 3 inches. After the initial peak in force, the single level car crushes at a relatively low force of 5×10^6 lbf. The multi-level car peaks in force a second time and then crushes at a high force of 2×10^6 lbf. For this collision scenario, a multi-level car is much stronger than a single level car. In a different collision scenario, the cars may behave another way.

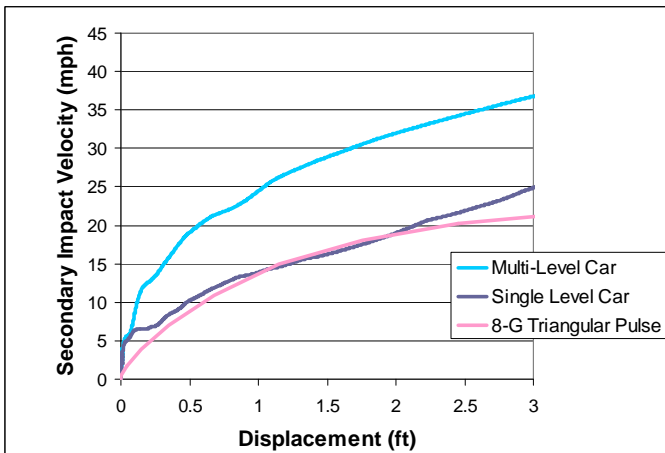
Figure 19. Secondary Impact Velocity Comparison

Another area of study from the test data is the interior environment, an important indicator of passenger survivability. The secondary impact velocity is a measure of the speed at which a person would hit the interior of the car after traveling the distance to the object in front of them. In Figure 19, data is taken from the single car test of multi-level equipment, the single car test of single level equipment, and an 8G triangular pulse. The 8G triangular pulse is standard for evaluating interior configurations. Figure 19 shows that for any distance, the multi-level car has a much higher secondary impact velocity, and, therefore, a more severe interior environment than the single level car or the 8G triangular pulse. This is due to the high force levels over a short crush distance for the multi-level car.
