FIRE ISLAND LIGHTHOUSE AND KEEPER'S DWELLING

Fire Island National Seashore
Patchogue, New York

Historic Structure Report
Volume 2

**THE KEEPER'S DWELLING:
CURRENT APPEARANCE AND CONDITION**

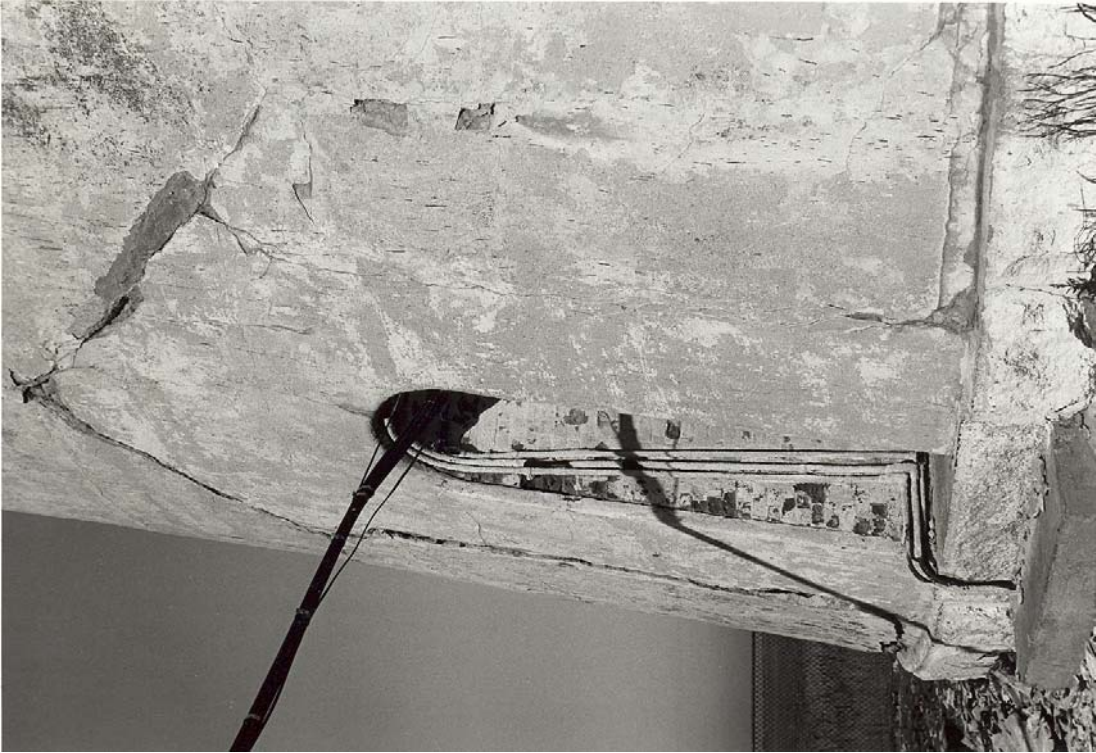
Figure 215. Tower exterior: evidence for former covered passageway.

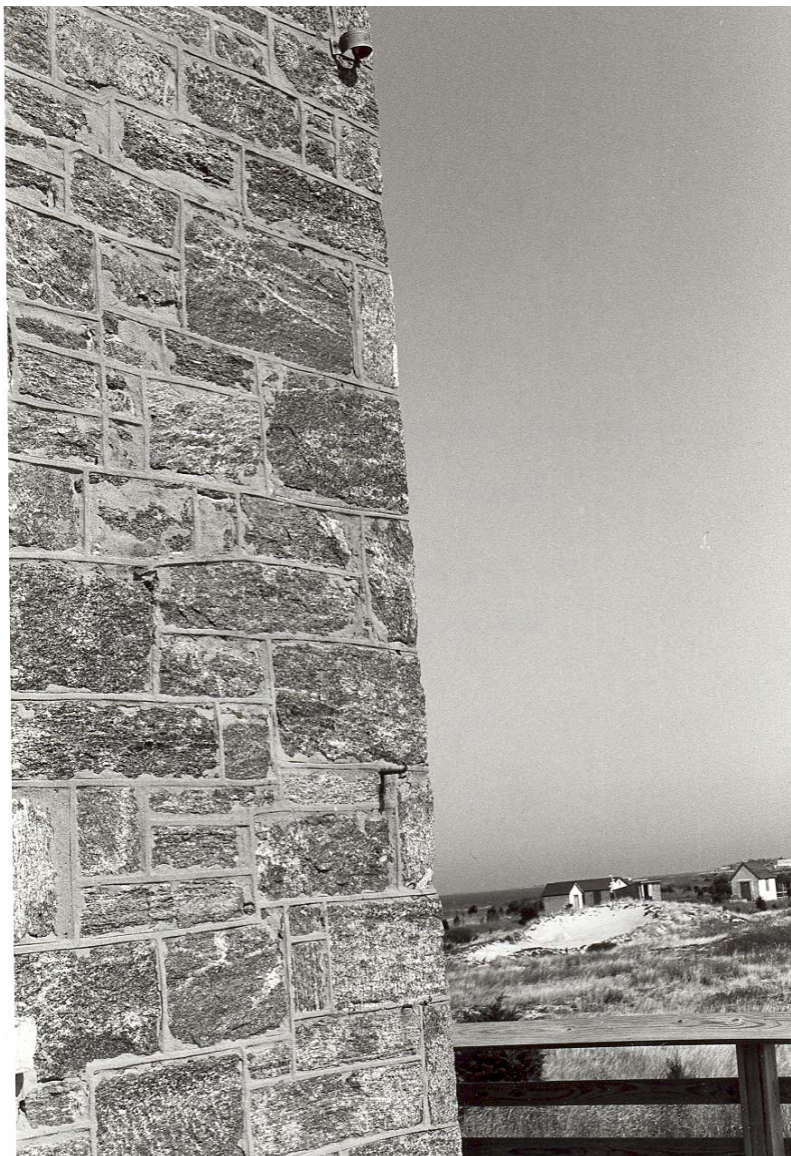
Figure 242. Dwelling exterior: east end of south wall, evidence for former downspout (1983).

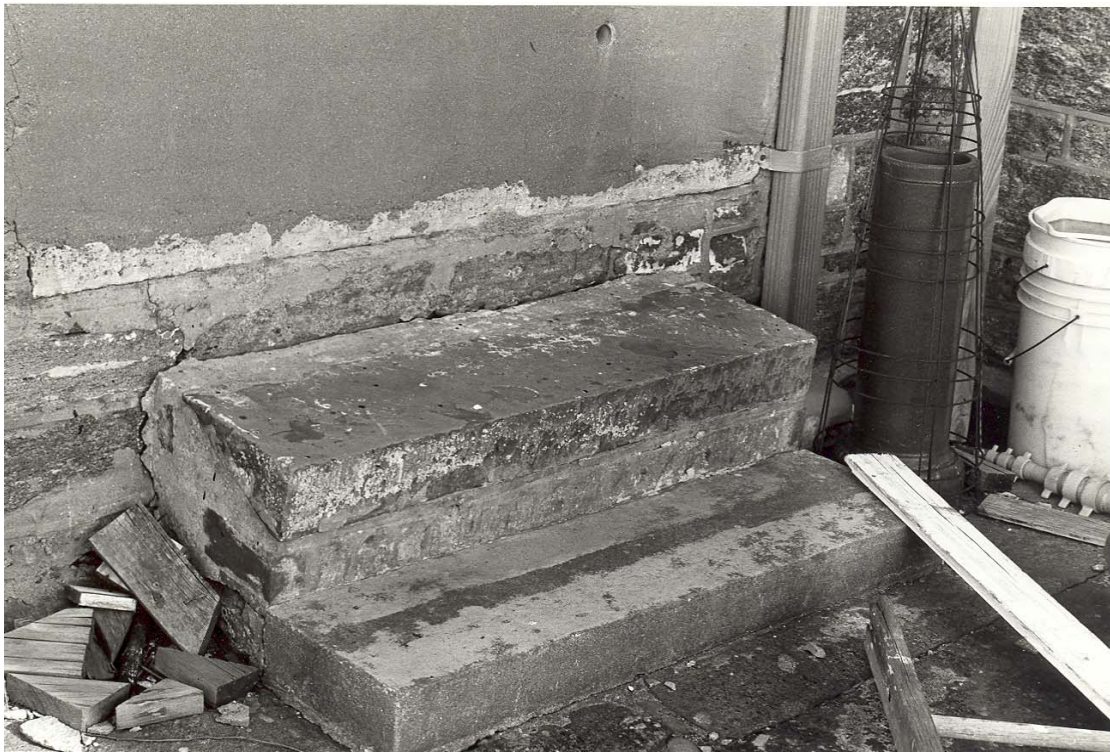
Figure 248. Dwelling exterior: north pavilion, steps for former west doorway (1983).

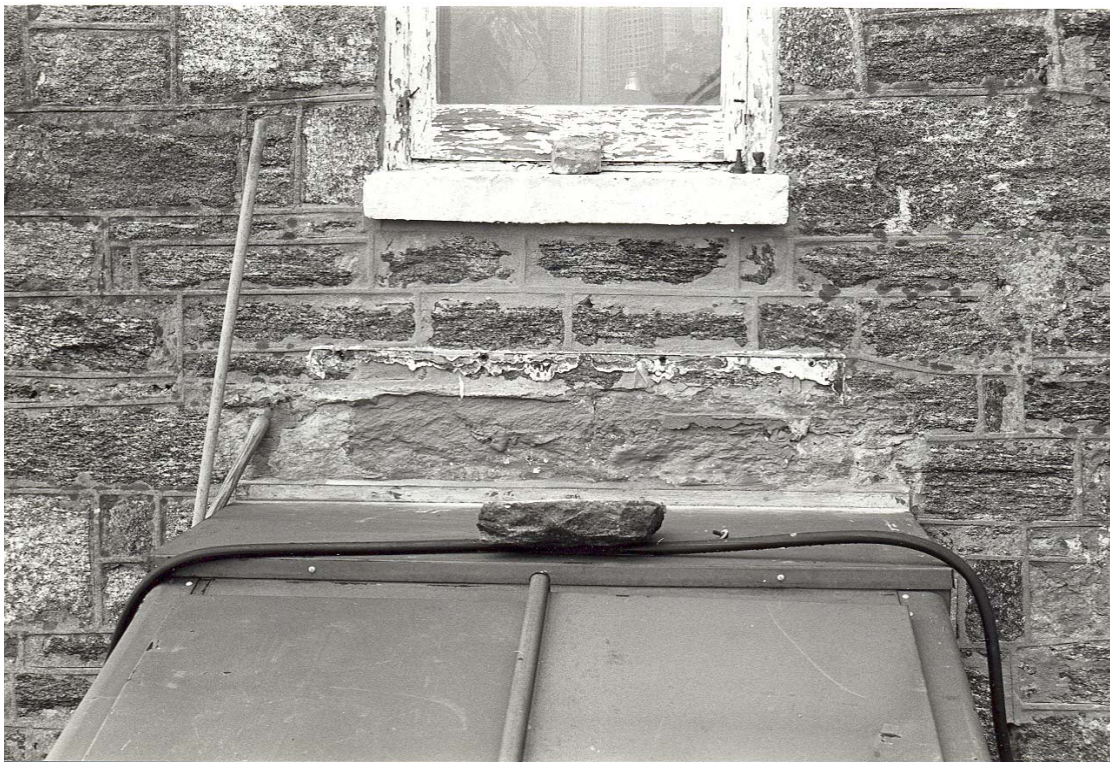
Figure 249. Dwelling exterior: north wall of east apartment, bulkhead and evidence for earlier bulkhead (1982).
