# STATE FIRE MARSHAL'S OFFICE

## Line of Duty Death Investigation

**Investigation Number 02-251-02**

**Fire-Rescue Officer Vincent Davis**

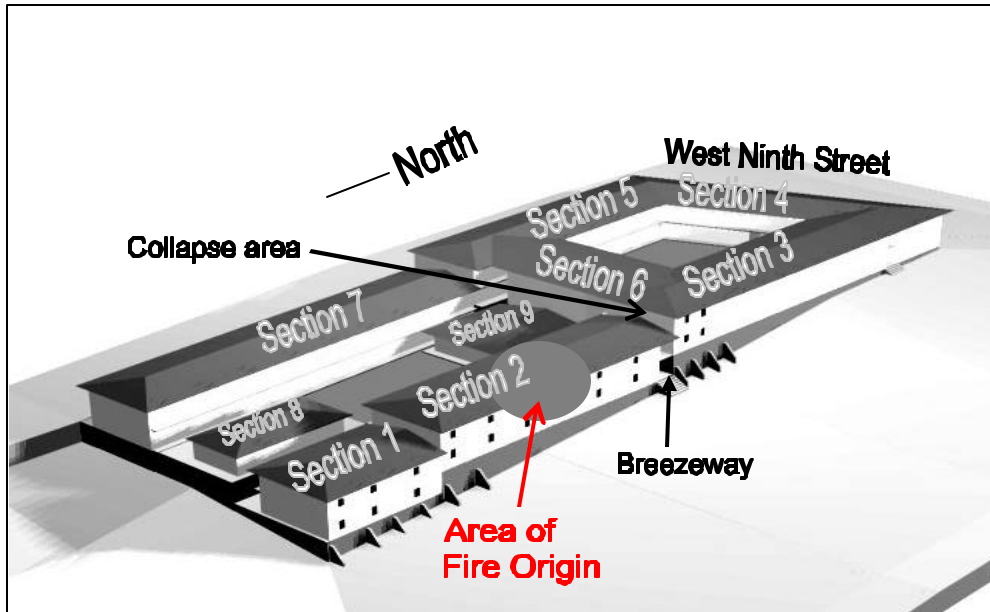
**Figure One. Rendering of apartment complex.  
Courtesy of Dallas Fire-Rescue.  
Notations by SFMO.**

The apartment complex is located on sloping ground (14.2% to 16.6% grade) with the north side being the lowest side. For report purposes, the building has been divided into nine sections. This roughly "figure 8" shaped building has both enclosed and open courtyards. **(Figure One)**
