# STATE FIRE MARSHAL'S OFFICE

## Line of Duty Death Investigation

**Investigation Number 03-262-03**

**Lieutenant Charles Lance Mathew**  
**LaBelle-Fannett Volunteer Fire Department**  
March 18, 2003

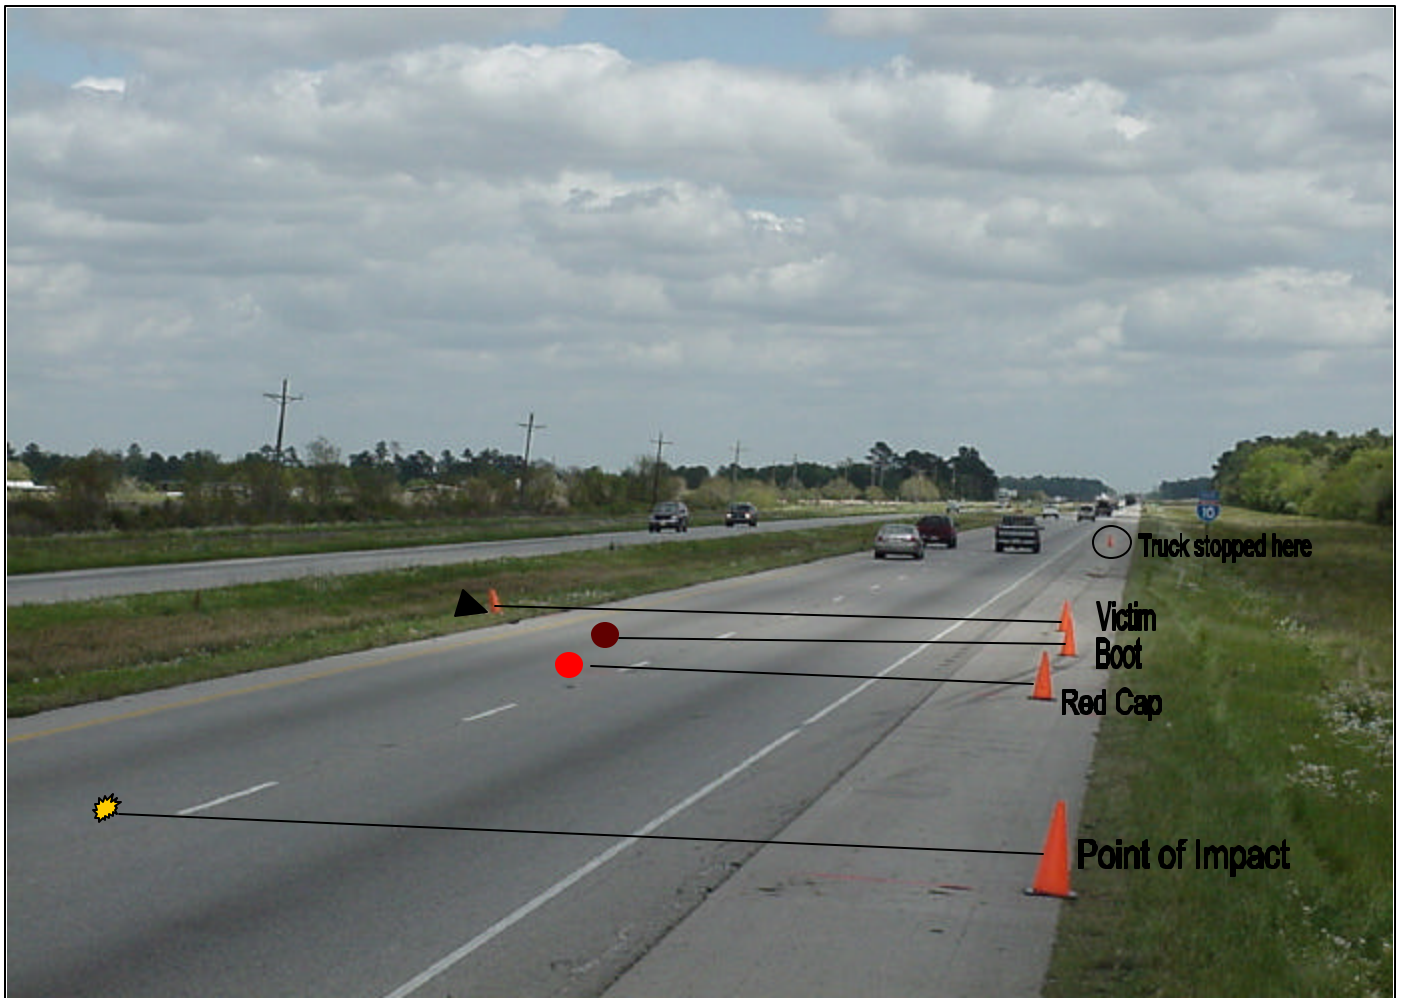
**Interstate 10 Eastbound Lanes, Mile Marker 833.69, Jefferson County, Texas**

Sheriff's deputy Lee and the tractor-trailer driver witnessed the impact. Firefighter Dearborne said he saw the silhouette of Lieutenant Mathew as he walked across the median and then saw him momentarily illuminated by the headlights of the oncoming truck. Dearborn heard, but did not witness the actual impact. Firefighter Michael Howard was driving westbound toward the scene and was crossing the Taylor Bayou Bridge approximately 3.3 miles east of the incident when he observed the oncoming tractor-trailer pull to the right and stop on the shoulder. Howard stated that fog was not present on the Interstate highway at that time.

The LODD incident occurred at approximately 3:00 a.m. with patchy, heavy fog in the area, but visibility was not impaired. The incident occurred on a straight, level section of interstate highway. There was no construction in the area and there was no roadway lighting. The only illumination on the scene was provided by a full moon and the headlights of parked vehicles. The roadway was dry with no loose foreign material.
