# STATE FIRE MARSHAL'S OFFICE

## Firefighter Fatality Investigation

### **Volunteer Firefighter James McMorries**

Howardwick Volunteer Fire Department

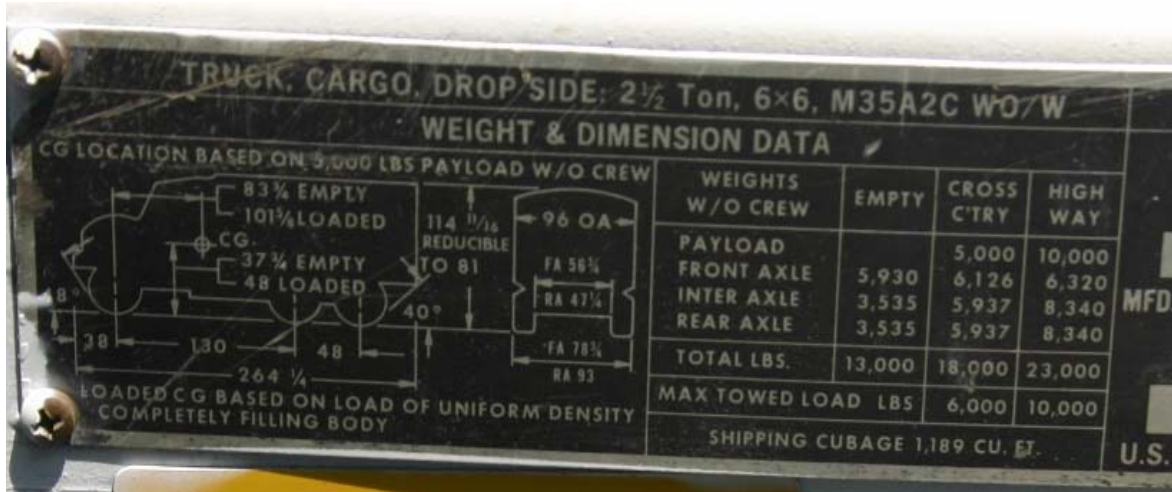
The overloaded vehicle with inadequate water tank baffles presented an extreme challenge to the driver to maintain control.

**Recommendation:** Any fire department acquiring a vehicle, chassis, or trailer not originally designed as firefighting apparatus should proceed with caution when converting equipment for use in firefighting. Fire departments should take into account factors such as the weight of tank water and equipment, center of gravity, load distribution, capacity of the drivetrain, tires, steering, and braking systems during fire apparatus construction.

**Recommendation:** All fire departments acquiring vehicles, chassis, or trailers should refer to all available manuals or documentation prior to commencing conversion or modification operations. Water tanks should be clearly marked with the tank capacity and full gross weight. Fire departments should install positive physical safeguards, such as overflow vents, to prevent vehicles from exceeding maximum permissible gross weight when fully loaded.
