STATE FIRE MARSHAL'S OFFICE

Line of Duty Death Investigation

Investigation Number 03-193-01

Firefighter Gary L. Staley

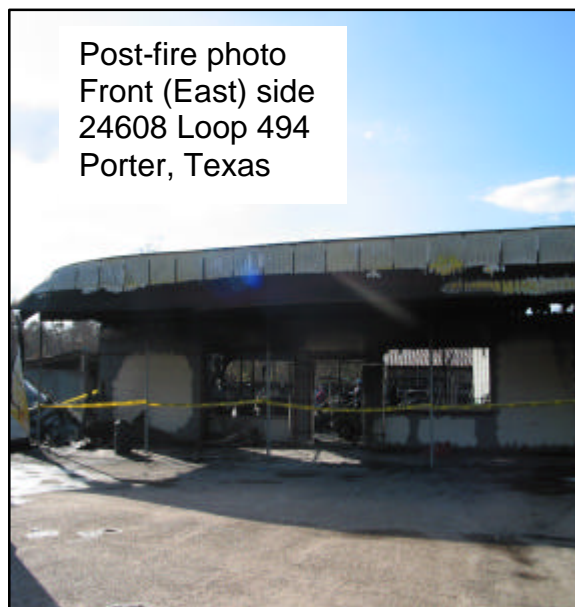
The business faces east and fronts onto Loop 494. The single-story building is of wood frame construction. Metal siding covers all areas except the concrete block façade on the front part of the building. The floor is a concrete slab. The roof in the front part of the building is a tar built-up roof with an overhanging canopy. The roof in the remainder of the building is corrugated metal installed over wood joists supported on metal columns. There is a rear overhanging roof protecting an open storage area enclosed with chain link fencing. There are several additions to the original building.

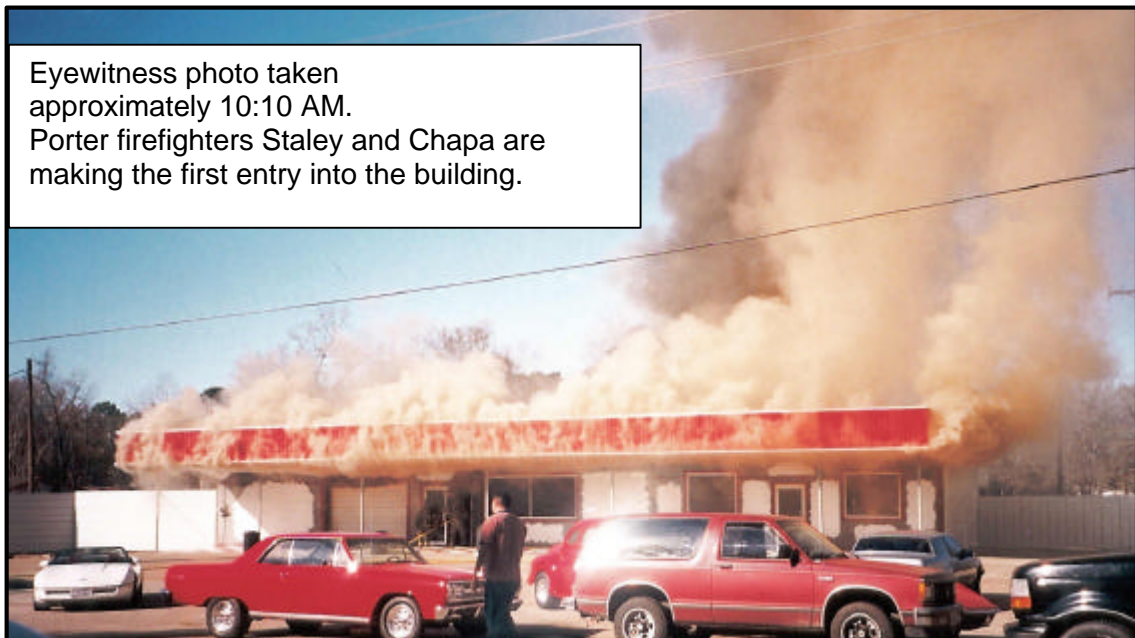
Firefighters Staley and Chapa entered the front door of the building, opened an adjacent overhead door, withdrew and operated their hose in the doorway pending arrival of additional personnel. Mixx did not enter, but assisted in feeding hose through the doorway and preventing the door from closing on the hose. No rapid intervention team (RIT) had been established at the time of initial entry.
