NATIONAL TRANSPORTATION SAFETY BOARD

MARINE INCIDENT SUMMARY REPORT

NEAR GROUNDING OF THE LIBERIAN TANK SHIP *PATRIOT*
BAY OF CAMPECHE, MEXICO
OCTOBER 15, 1995

Vessel: Tank ship *Patriot*, Liberian registry, LR9006904, 798 feet long, 53,772 gross registered tons, built 1992

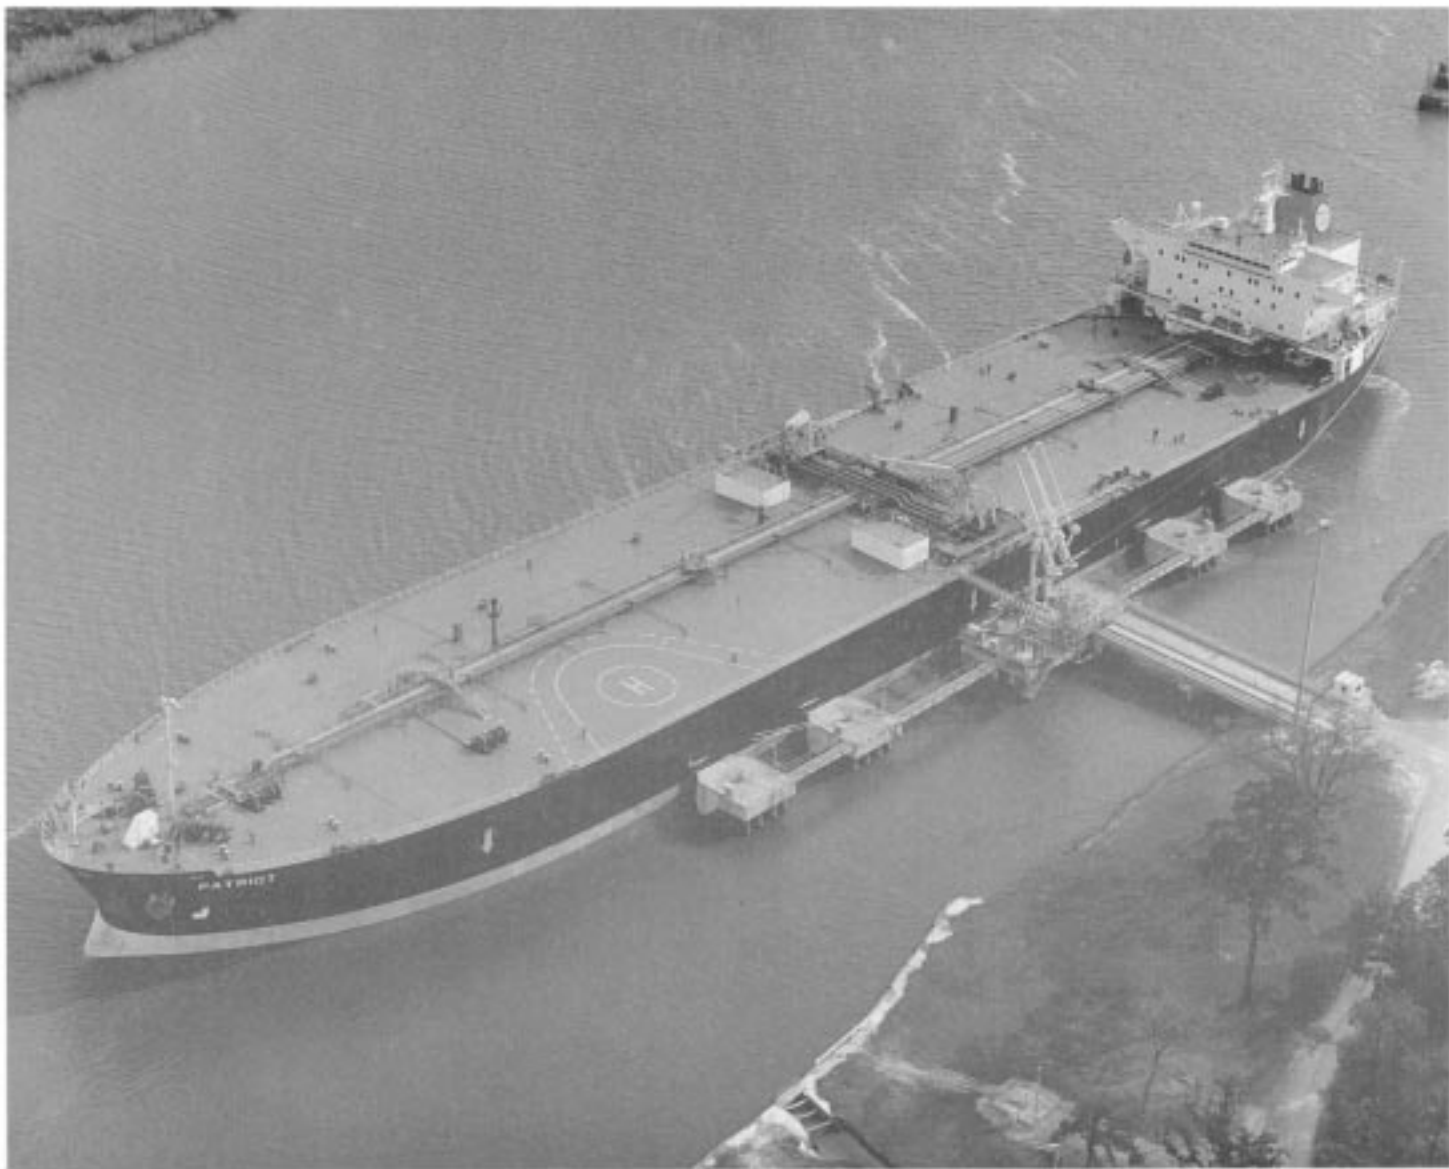
Figure 1 – Conoco Shipping Company tank ship *Patriot*

On October 15, 1995, the Liberian-registered motor vessel *Patriot*, a 95,000 deadweight-ton¹ tank ship (see figures 1 and 2), came within 10 miles (2-3 hours) of grounding on the north side of the Yucatan Peninsula near Campeche, Mexico, while navigating in rough seas and high winds associated with Hurricane Roxanne. Had the grounding occurred, it could have resulted in significant damage to the ship's structure, injuries or deaths among the 27 crewmembers, and damage to the environment. The vessel was en route from Galveston, Texas, to Dos Bocas, Mexico, when the near-grounding incident occurred.

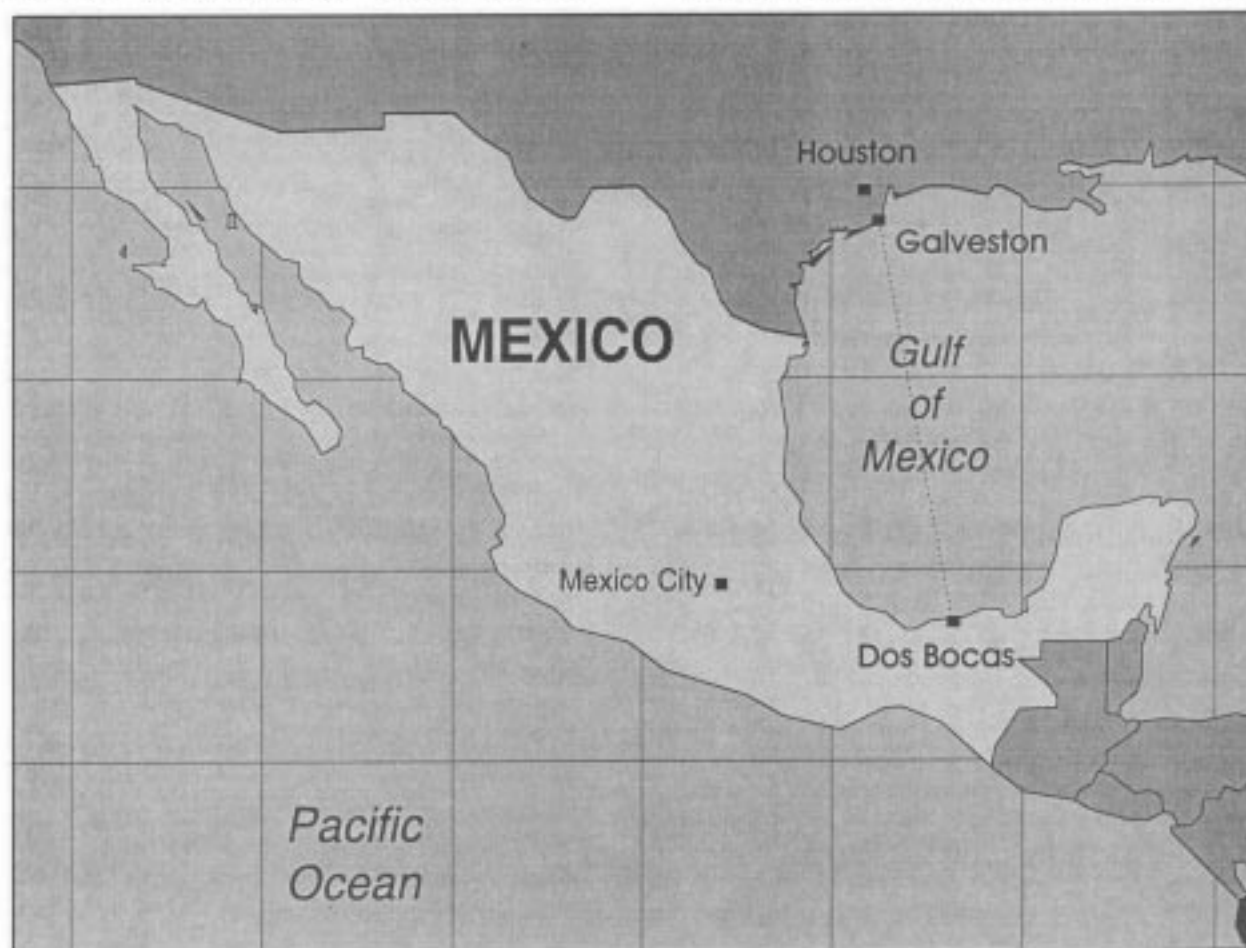
Figure 3 – Route of Conoco Shipping Company tank ship *Patriot*

At 2000 on October 9, 1995, the *Patriot*, operating in ballast (without cargo), departed Galveston (see figure 3) under orders to arrive at the Port of Dos Bocas on or before midnight on October 11, 1995, and there to load 500,000 barrels of crude oil. Shortly after departing Galveston, the *Patriot* received a National Weather Service (NWS) forecast²

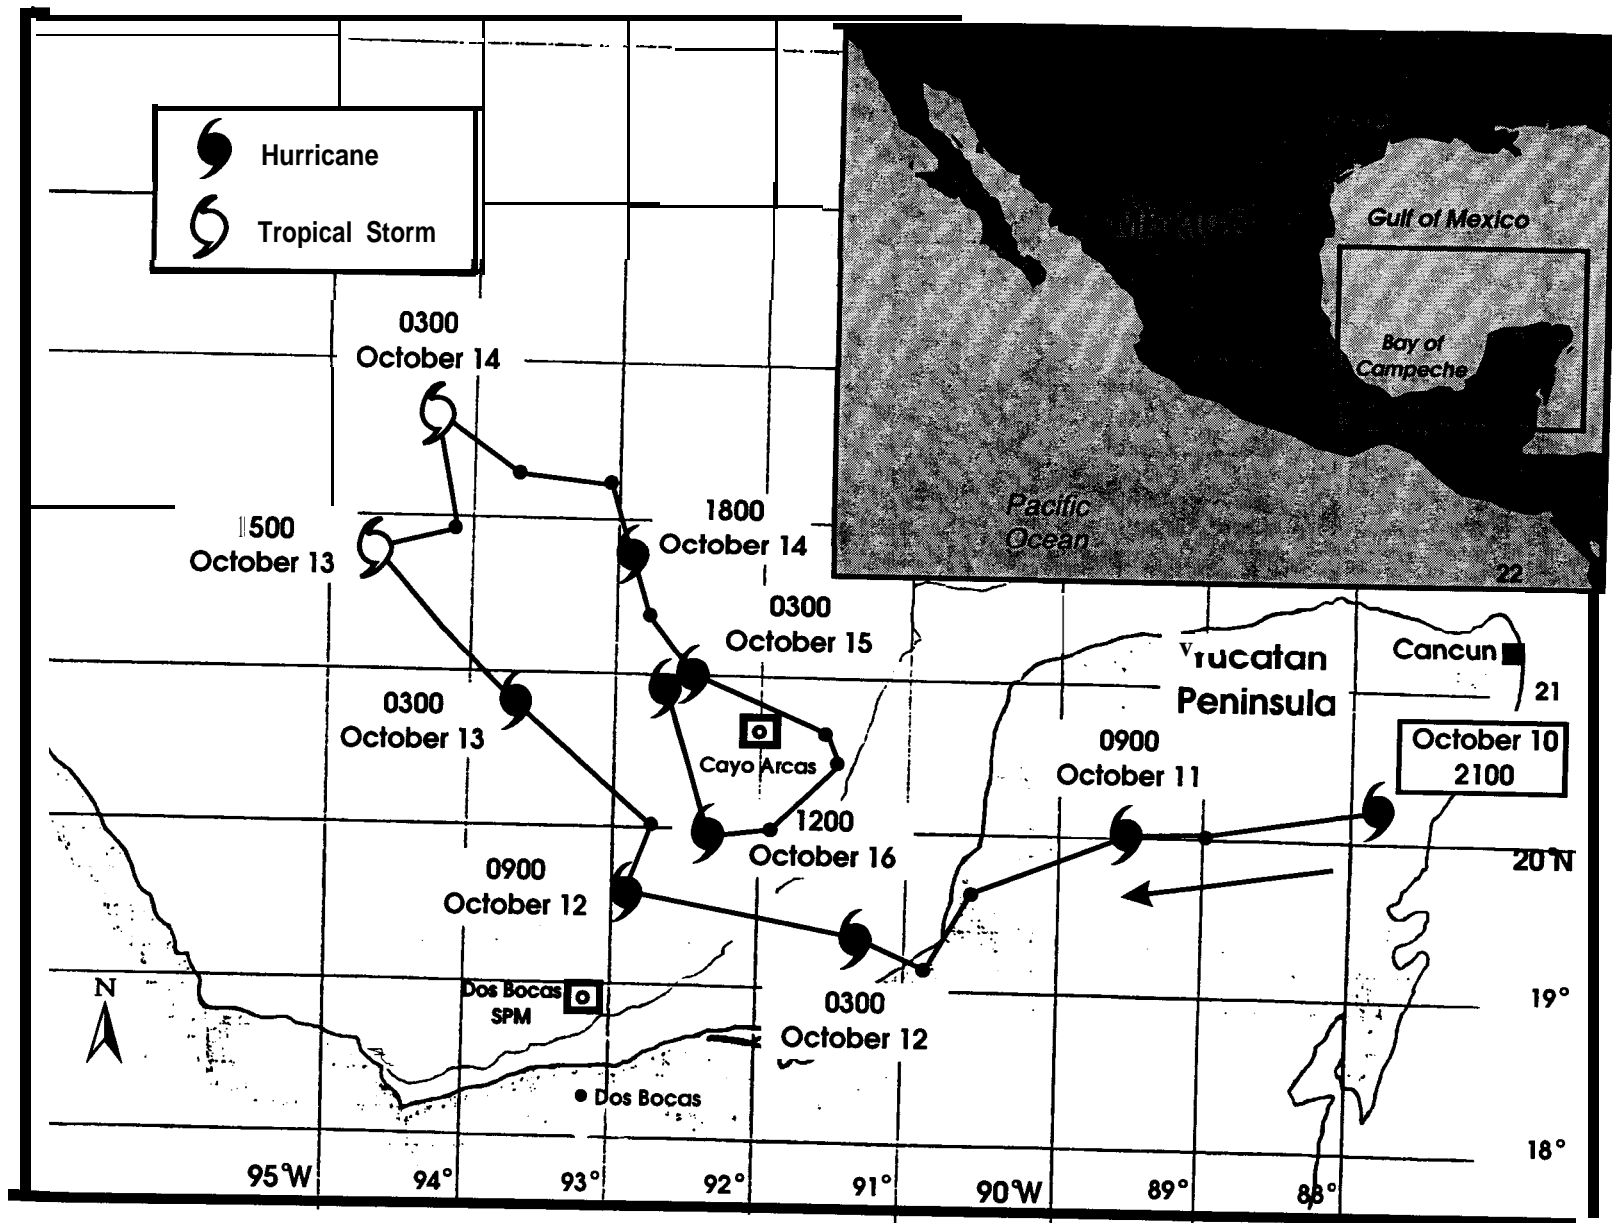
Figure 4- Approximate track of Hurricane Roxanne October 10-16,1995

Yucatan Peninsula's east coast. At 2100 on October 10, Roxanne, now classified as a hurricane, made landfall about 100 miles south of Cancun, Mexico. (See figure 4.) During the next 9 hours, the storm moved in a westerly direction across the Yucatan Peninsula toward Dos Bocas at a speed of about 10 knots.

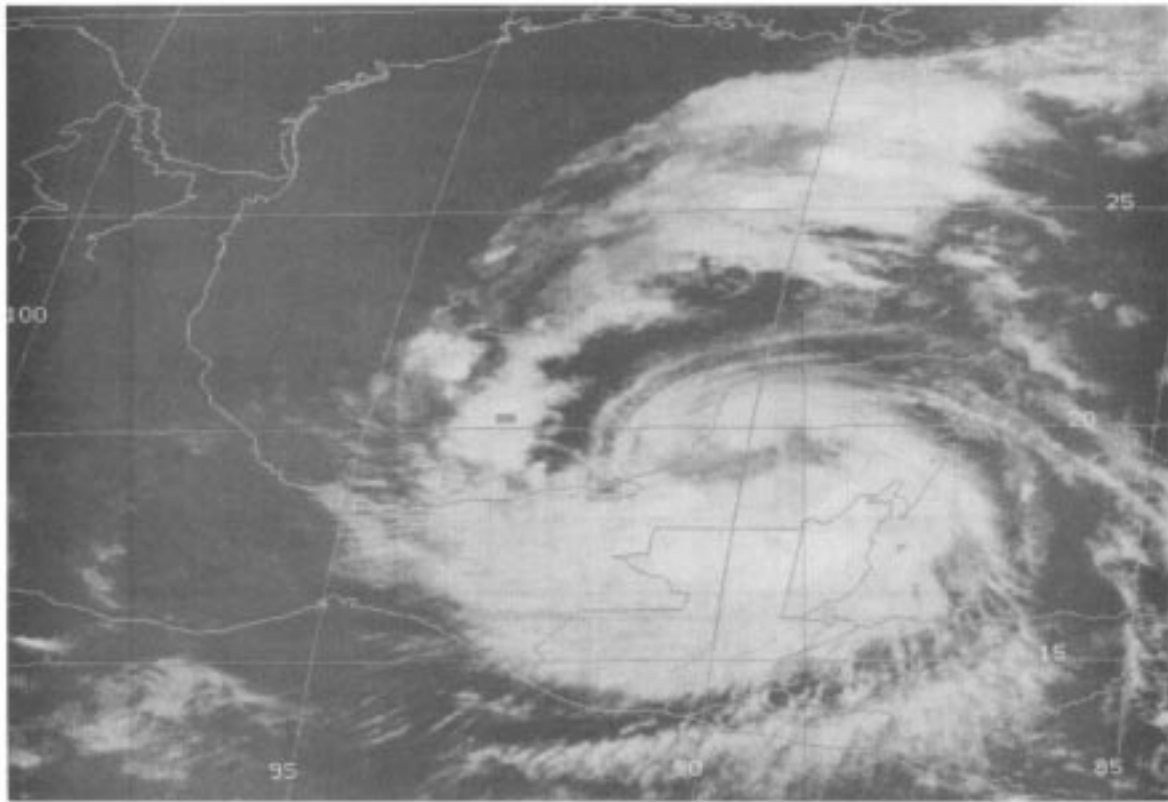
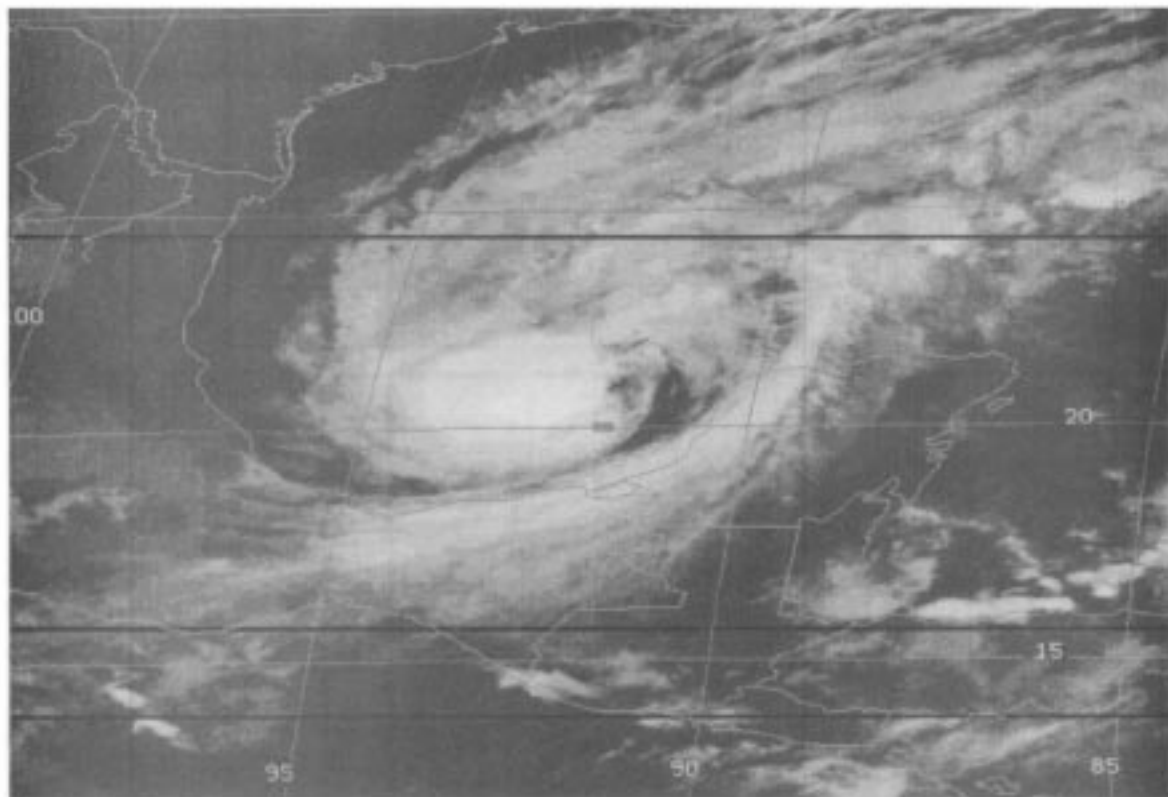
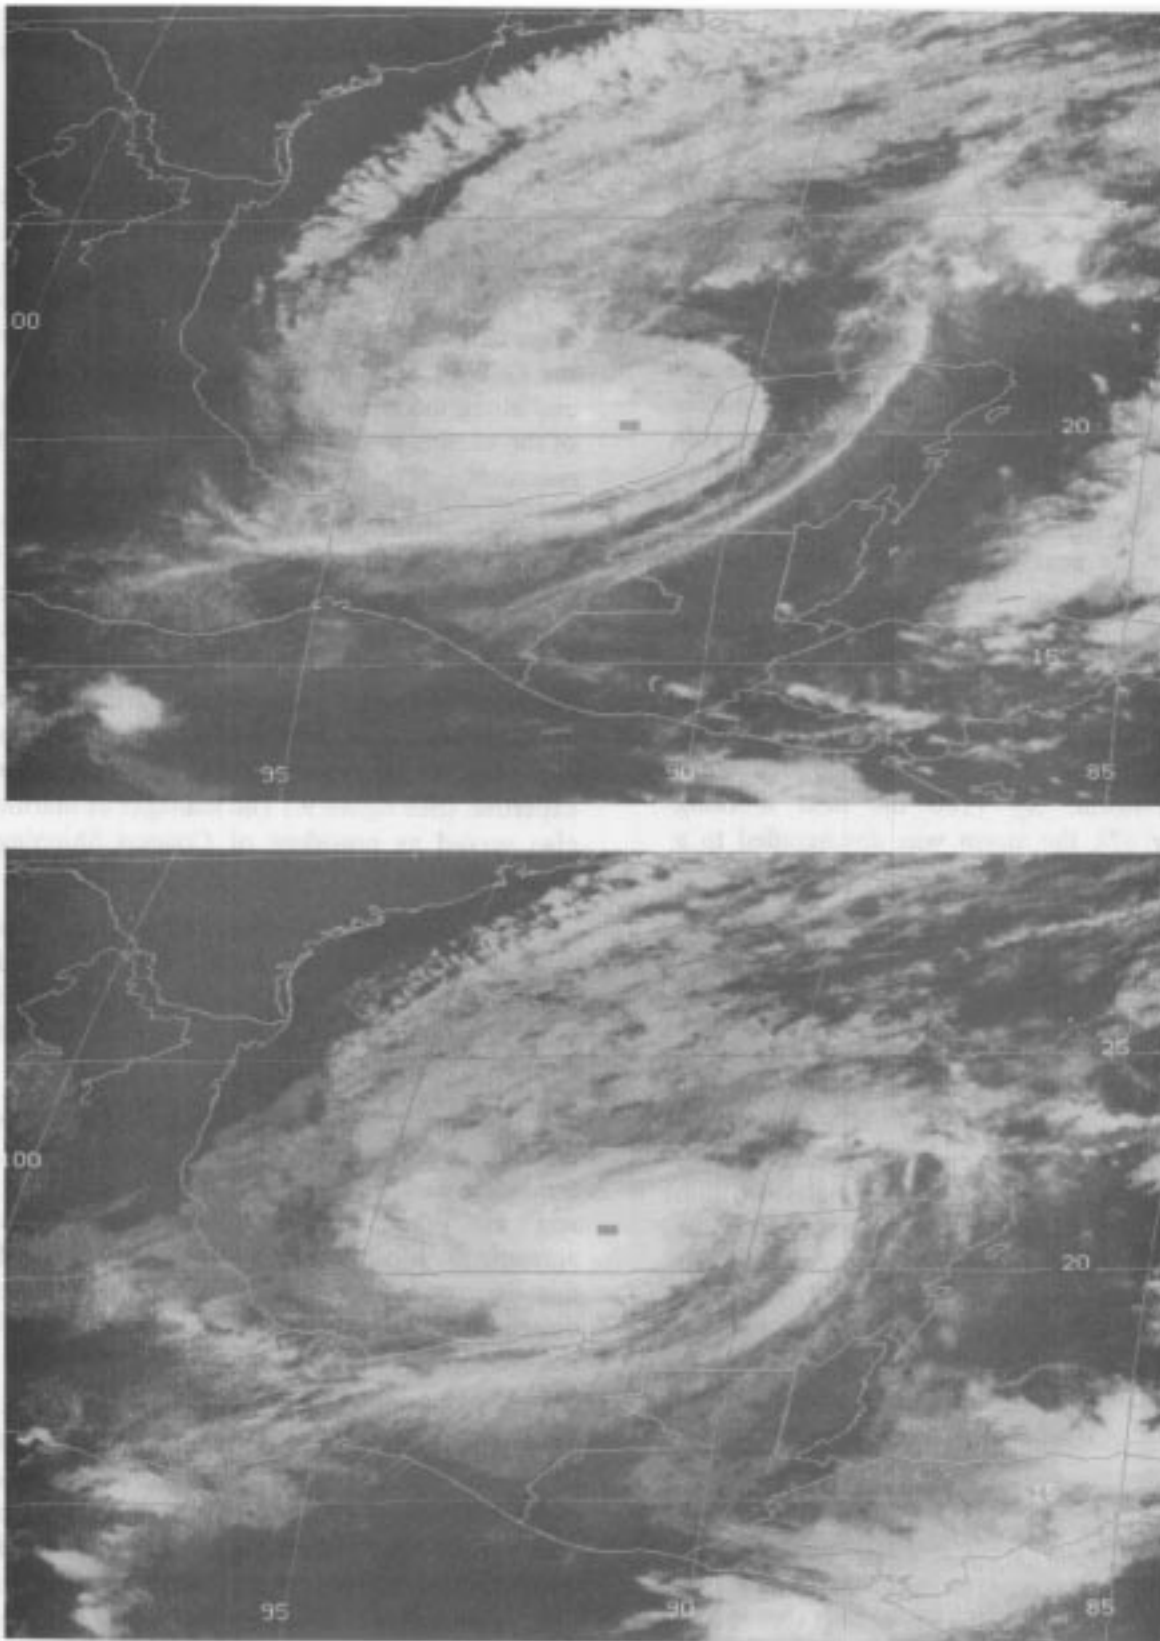
because the *Patriot* was essentially hemmed in between the storm and the shore with no easy avenue of escape (see figures 7 and 8), the master turned the vessel into the wind and waited for conditions to improve. During the early morning of October 15, watchstanders reported winds in excess of 130 knots and rough seas that caused the vessel to roll and pitch heavily. At 0421, the main engine once again went into an overspeed condition and shut down. Although the engine was quickly restarted, engine speed had to be limited to about 50 rpm.

Figure 8A -- Enhanced satellite images indicating relative positions of *Patriot* (small dark rectangle) and Hurricane Roxanne at 1216 on October 11 (top) and 0616 on October 15 (bottom).

Figure 8B -- Enhanced satellite images indicating relative positions of *Patriot* (small dark rectangle) and Hurricane Roxanne at 1217 on October 15 (top) and 0046 on October 16 (bottom).

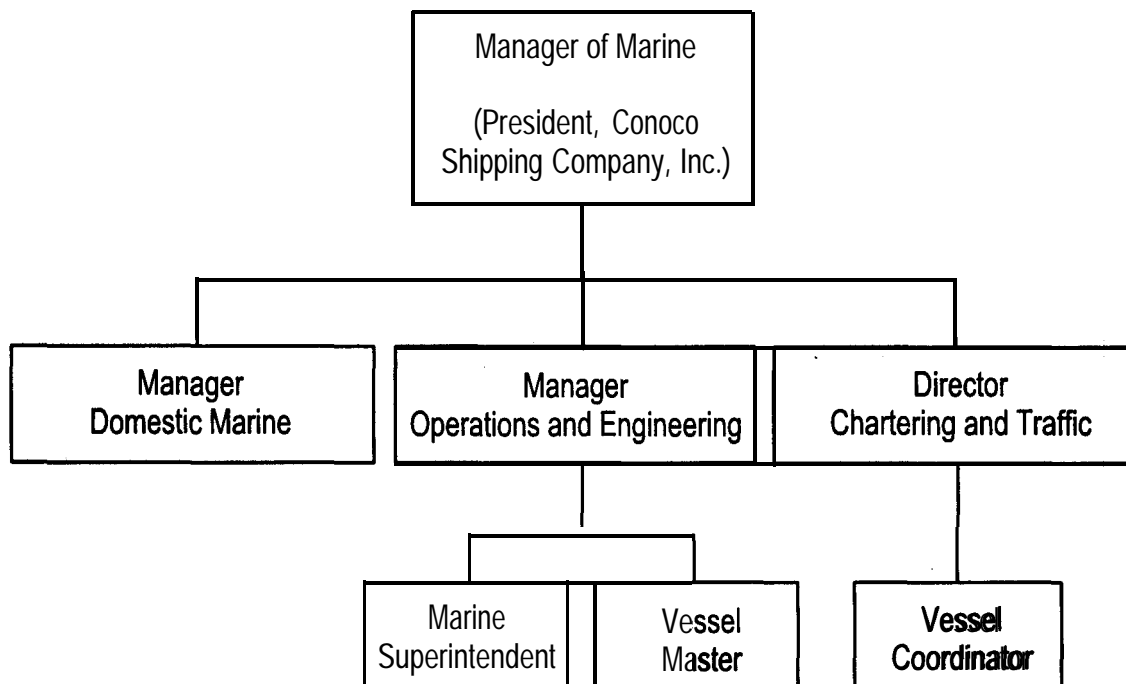
Figure 9-- Selected organizational elements of Conoco Shipping Company, Inc.

Organizational Structure -- At the time of this incident, the three main operating units of Conoco Shipping Company were the Domestic Marine Department, the Chartering and Traffic Department, and the Operations and Engineering Department, all answering to the manager of marine, who was a licensed master with commercial experience and ship operations expertise. (See figure 9.) The manager of marine also served as president of Conoco Shipping Company.
