# NATIONAL TRANSPORTATION SAFETY BOARD

## MARINE ACCIDENT REPORT

**GROUNDING OF THE LIBERIAN PASSENGER SHIP *STAR PRINCESS* ON POUNDSTONE ROCK, LYNN CANAL, ALASKA, JUNE 23, 1995**

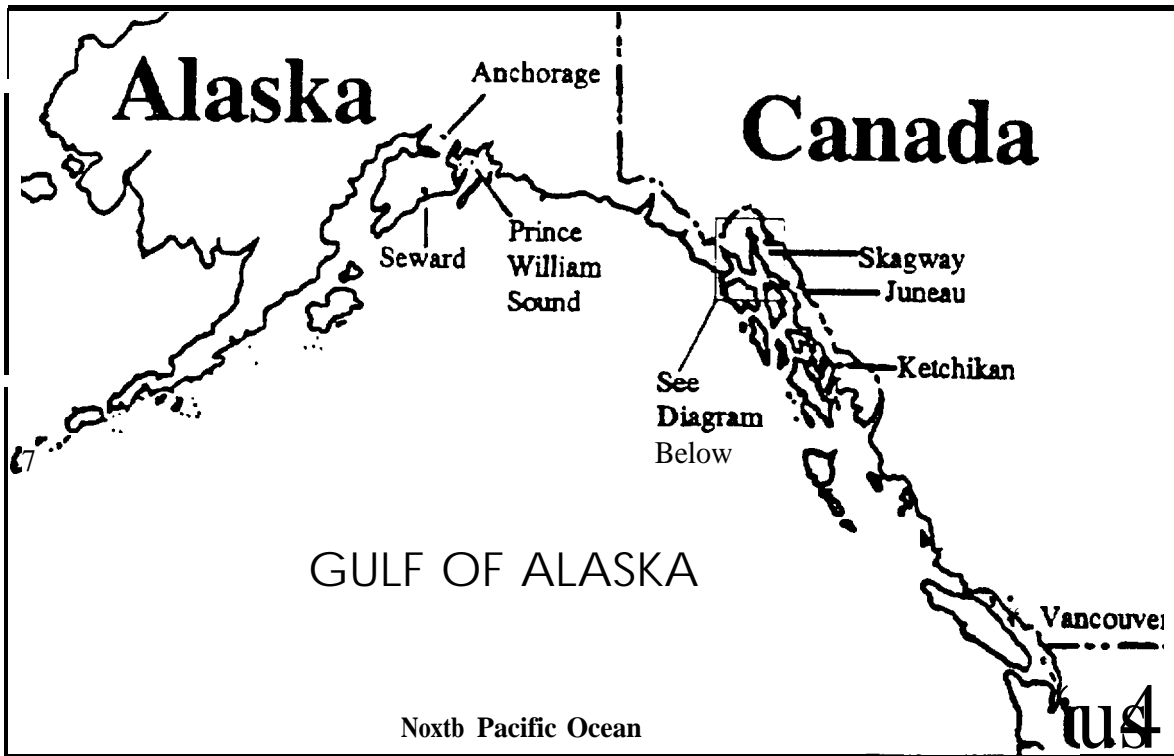
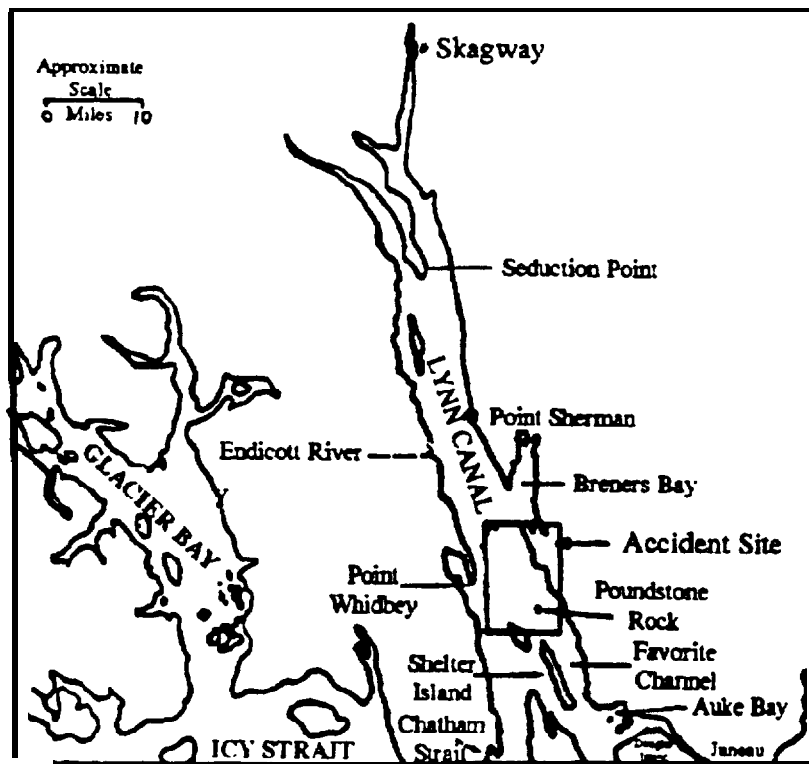
Figure 2. – Accident site

About 0010, on a true course (T) of 156°T and at a speed of about 10 knots, the *Star Princess* passed Point Sherman, which is about 36 miles south of Skagway in the Lynn Canal (see figure 2) and about 65 miles from Juneau. The second officer determined that the vessel was about 1 to 1 1/2 hours ahead of its scheduled 0515 to 0530 arrival time at the entrance to Juneau harbor.

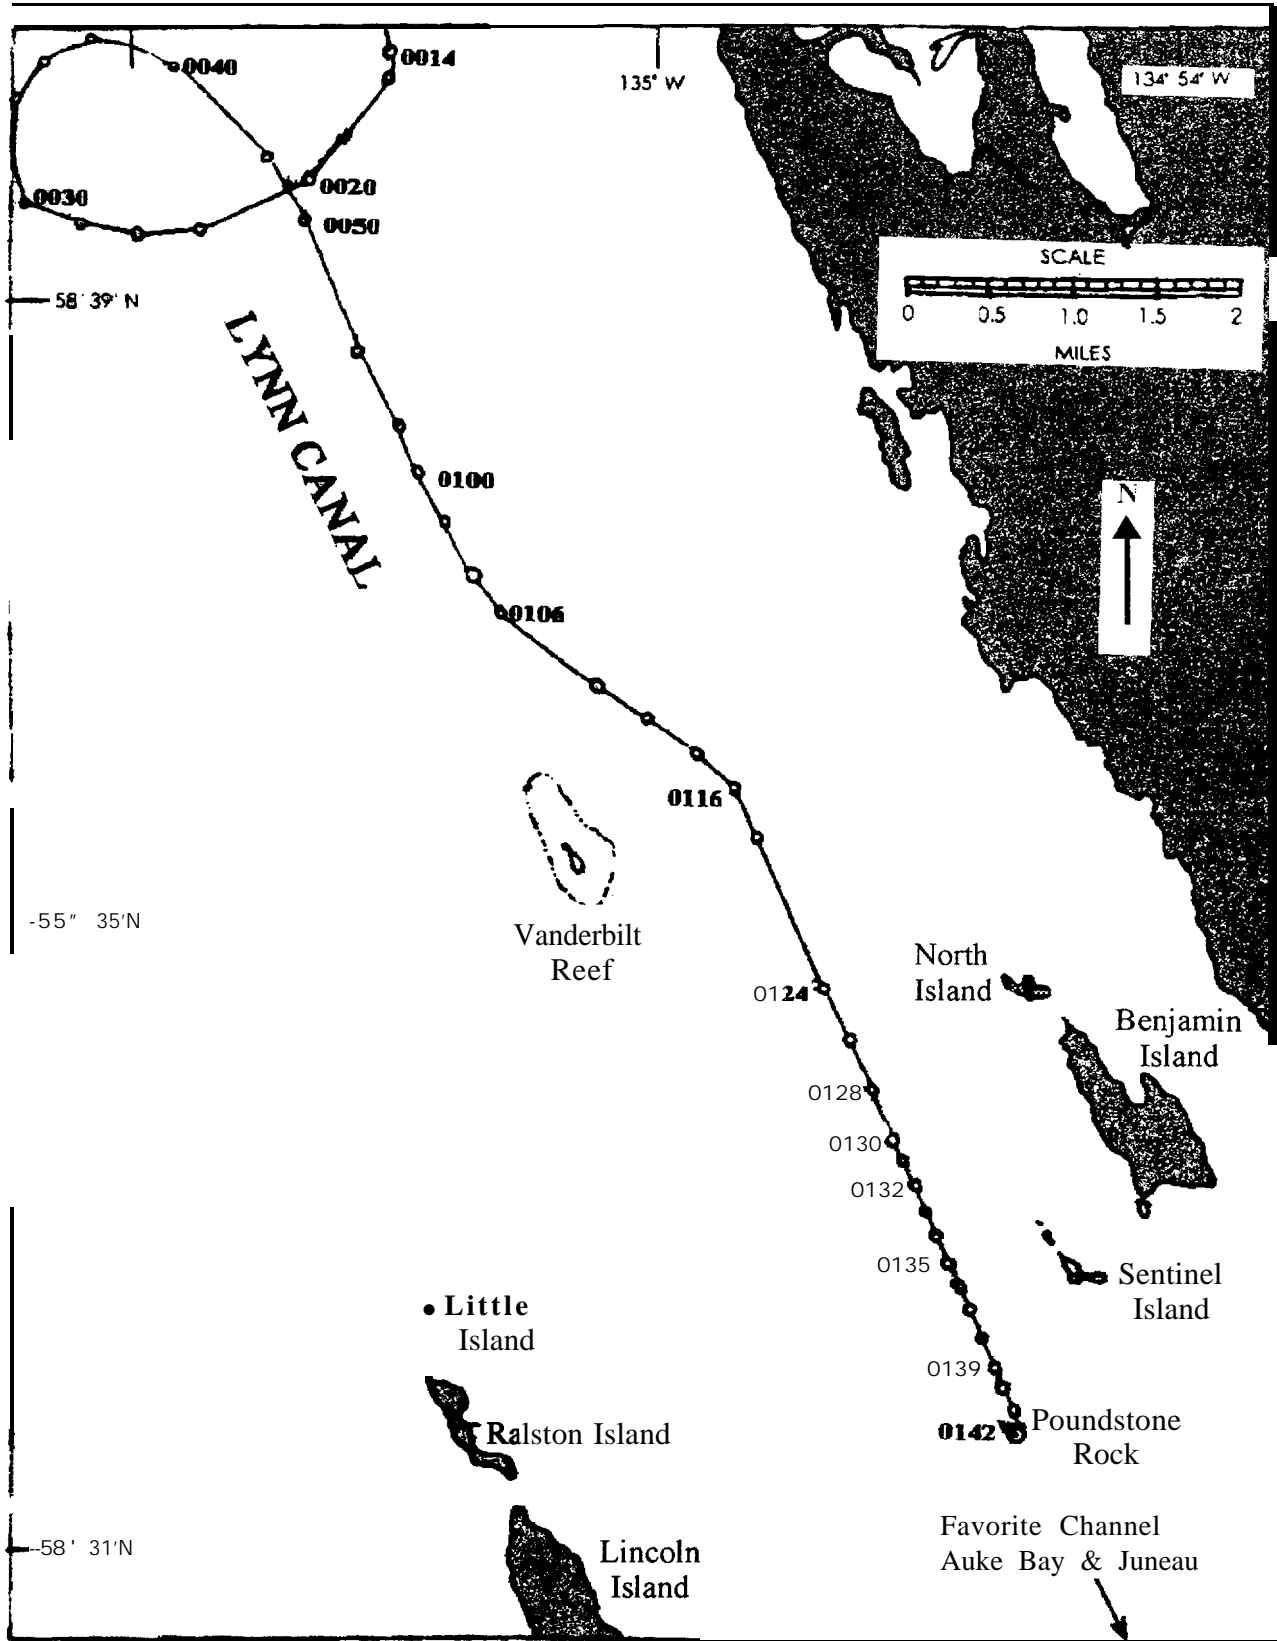
Figure 3. – Trackline of the *Star Princess*

In accordance with PCL requirements, after the accident the VER recording tapes were removed by the masters of both involved vessels and sent to London, England, for review.<sup>45</sup> Two Safety Board investigators went to England in December 1995 to observe the VER playbacks. The recorded radar, GPS, and gyro data for the June 23, 1995, periods from 0000 to 0145 (for the *Star Princess*) and from 0135 to 0145 (for the *Fair Princess*) as provided by the VERs were used to reconstruct the vessels' tracklines, as displayed in figures 3 and 6.

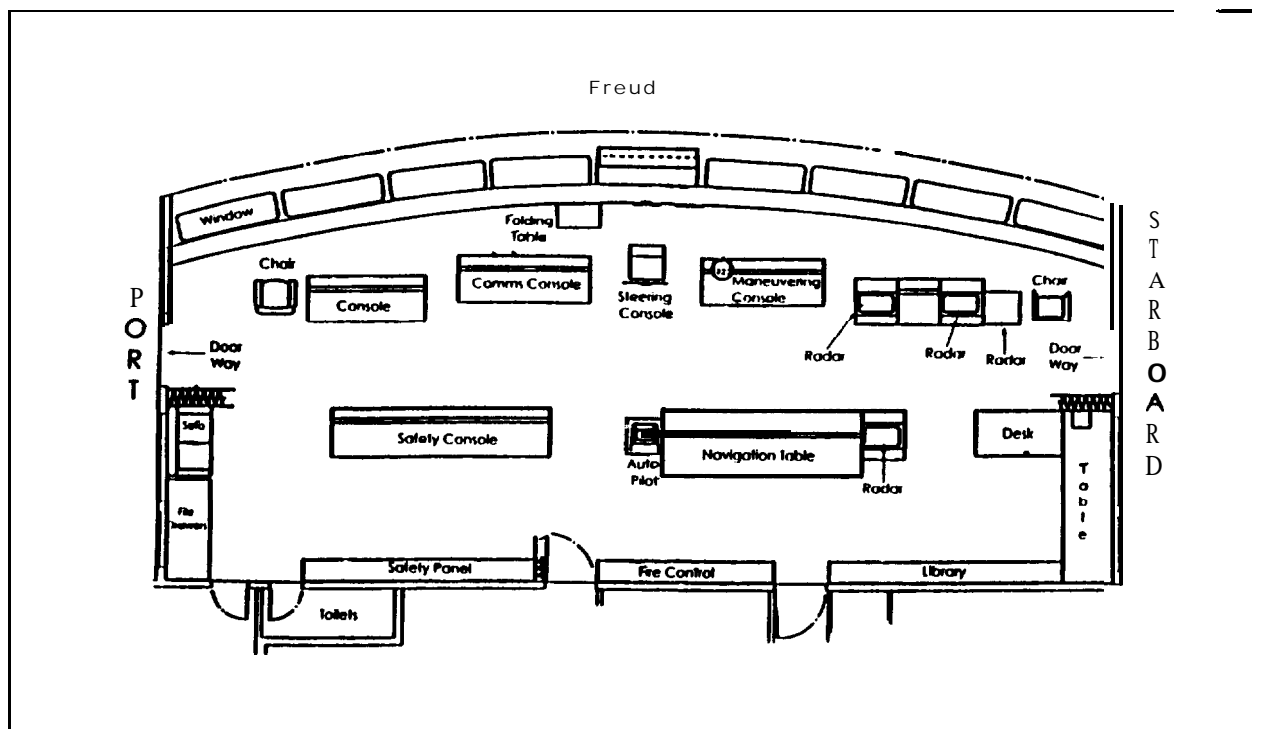
Figure 4. – *Star Princess* wheelhouse layout

The pilot testified that when he coned the vessel he usually referred to the automatic radar plotting aid (ARPA)<sup>8</sup> radar next to the chair on the starboard side of the wheelhouse (figure 4). He said he usually kept the radar (which had a 12-inch screen) on the 6-mile scale, with the center offset to provide a longer view forward. He said he used the radar to check his vessel's position, vessel traffic, and his own vessel's set and drift." He further testified that the navigation crew used the ARPA radar next to the navigation table aft of the far starboard chair. He stated that he and the bridge crew used two different radars so each would not interfere with the settings used by the other while navigating, taking fixes, or watching traffic.

The *Star Princess* had four radars (refer to figure 4, the wheelhouse layout). The radar the pilot used was beside the chair on the starboard side of the wheelhouse. The antenna for this radar was mounted on the ship's bow. (The bow-mounted antenna provided a better presentation of small craft vessels, buoys, and other objects that might be shadowed by the ship's bow and go undetected by a mast-mounted antenna.)

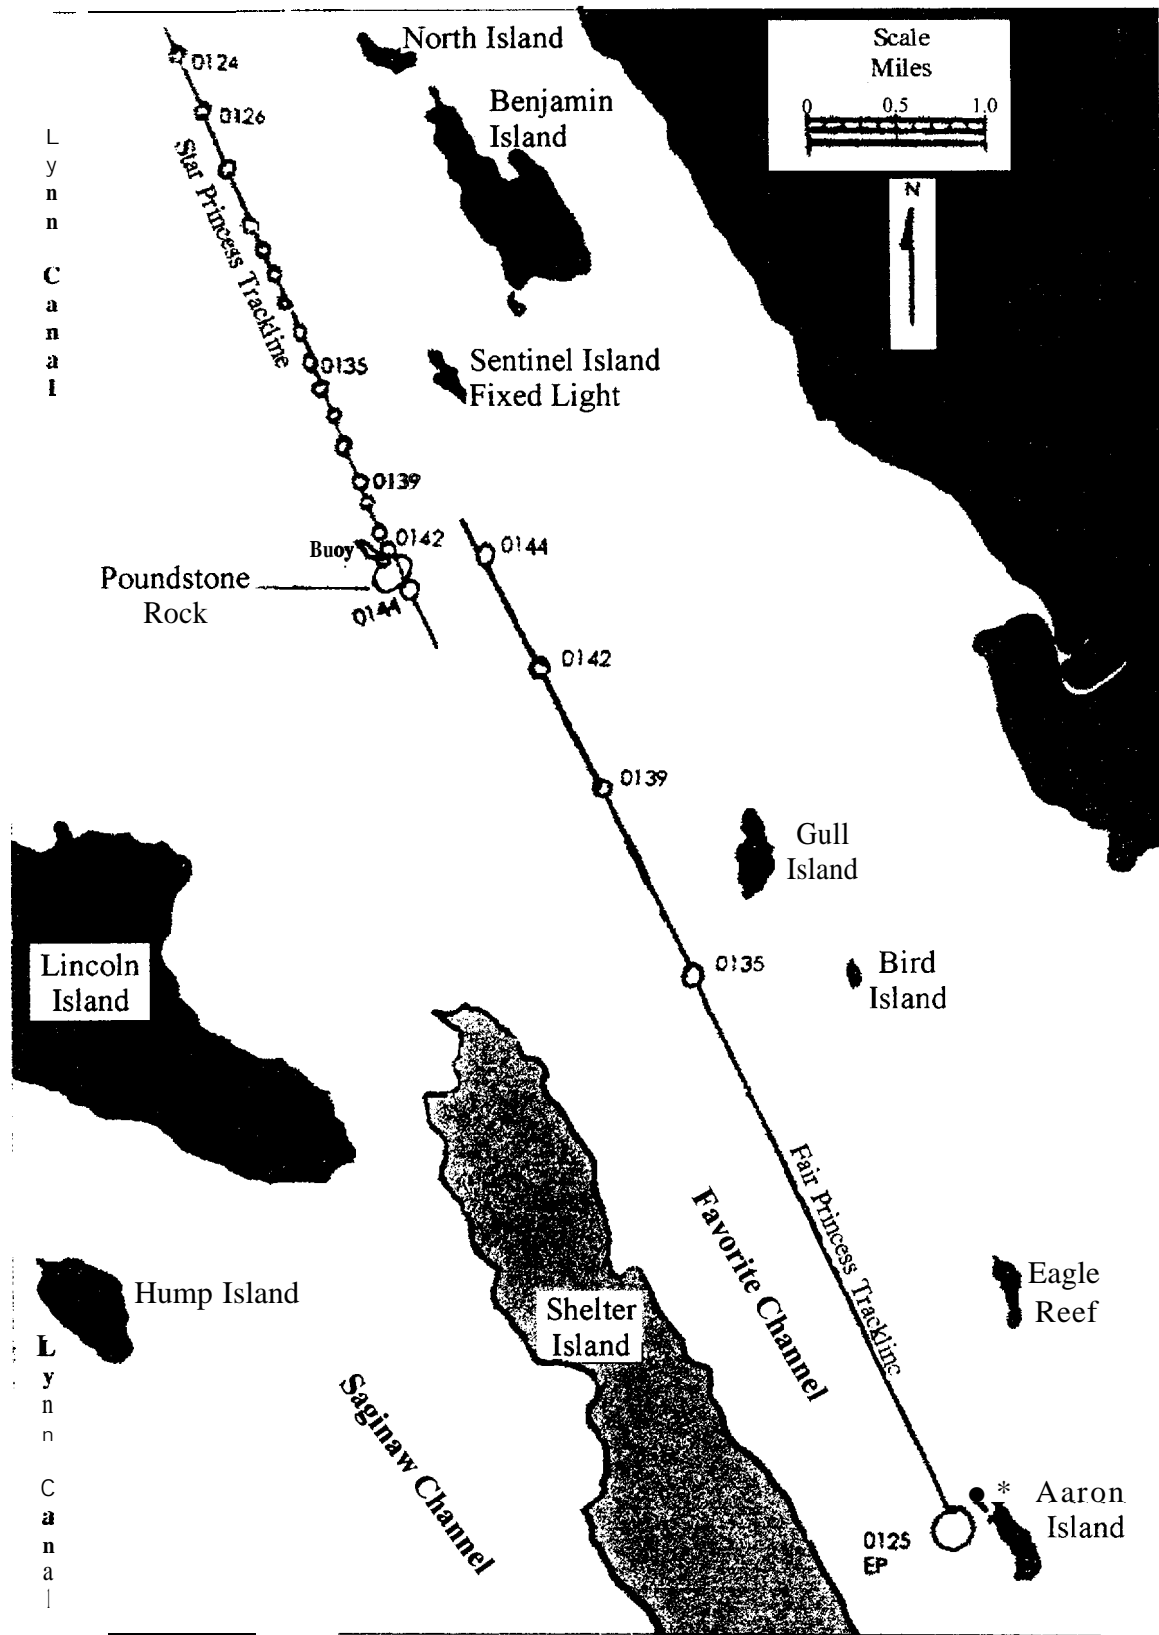
Figure 6. – Tracklines of the *Star Princess* and the *Fair Princess*

No radio contact was made by the *Star Princess* pilot or the bridge watch officers with, nor was any received from, the *Fair Princess*. Meanwhile, the *Fair Princess* was northbound, approaching the Poundstone Rock area from the Favorite Channel (between the east side of Shelter Island and the mainland). The pilot on the *Fair Princess* testified that he had been watching the *Star Princess* both visually and by radar (see figure 6).
