NATIONAL TRANSPORTATION SAFETY BOARD

MARINE ACCIDENT REPORT

**ALLISION OF THE LIBERIAN FREIGHTER
BRIGHT FIELD WITH THE POYDRAS STREET
WHARF, RIVERWALK MARKETPLACE, AND
NEW ORLEANS HILTON HOTEL IN
NEW ORLEANS, LOUISIANA
DECEMBER 14, 1996**

**Adopted: January 13, 1998
Notation 6885A**

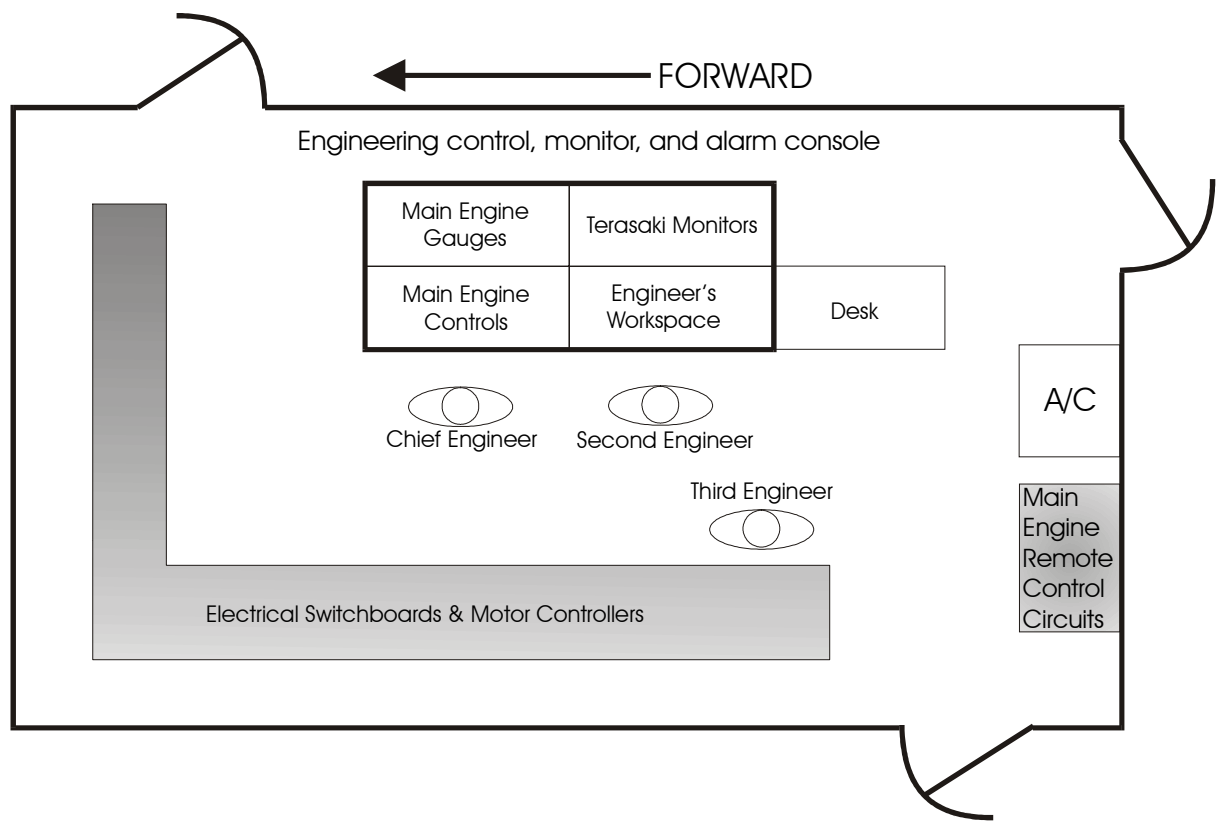
Figure 3 -- *Bright Field* engine control room layout showing reported positions of crewmembers when engine power reduction occurred.

The chief engineer on duty in the engine control room¹⁸ (figure 3) stated that, immediately before the engine lost power, an audible alarm sounded. He said he then looked at a computer screen in front of him and saw a visual alarm and an indication of a loss of pressure in the lubricating oil system. (See figure 4.) He said he looked at the analog main engine lubricating oil pressure gauge and saw that the system was rapidly “depressurizing” below normal levels. He said he then noticed that the main engine automatic slow down light was on, and he noticed that main engine noise was decreasing. He reported that he also observed that engine rpm had dropped from 72 to between 30 and 35. He said that, as he turned to the electrical switchboard behind him to determine why the No. 2 lubricating oil pump had not started automatically, the pump started. He said that, except for the low rpm, everything seemed to him to be back to normal almost immediately.

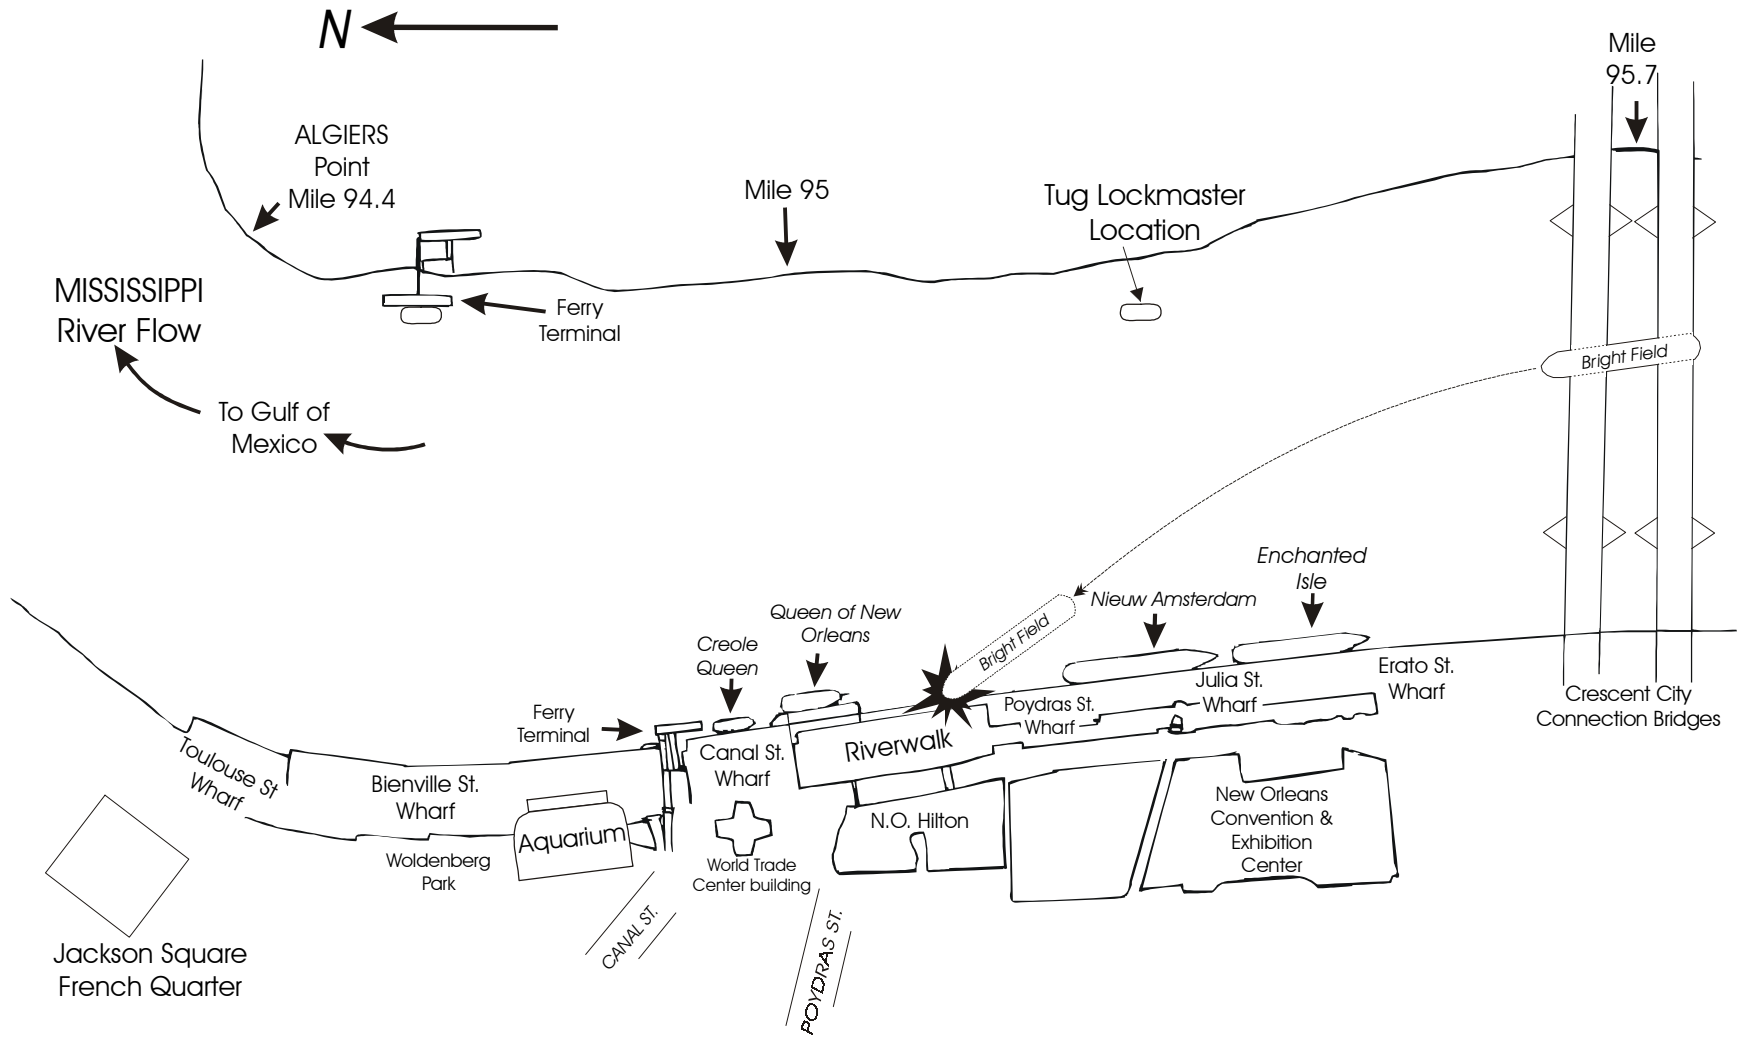
Figure 5 -- Path of Bright Field (not to scale)

About 1411, the port bow of the *Bright Field* struck the Poydras Street wharf at a location between the docked *Nieuw Amsterdam* and *Queen of New Orleans*. (See figure 5.) The vessel struck the wharf at what witnesses said was a 40- to 45-degree angle, went into the wharf up to the end of the forecastle deck (about 50 to 60 feet), and then made a sideways movement. The bow portion of the vessel scraped and collapsed portions of the buildings on the Poydras Street wharf, including a portion of the Riverwalk Marketplace shopping mall, a condominium parking garage, and part of the Hilton Riverside Hotel. The ship came to rest against the wharf with its stern about 200 feet from the stern of the *Nieuw Amsterdam* and its bow about 70 feet from the bow of the *Queen of New Orleans*. (See figure 6.) The pilot ordered the engine stopped, after which several tugboats arrived to hold the ship against the dock. About 3 minutes had elapsed from the time the pilot made his first emergency call to the Coast Guard light operator until the ship struck the wharf.
