Ramming of the Eads Bridge by  
Barges In Tow of the *M/V Anne Holly* With  
Subsequent Ramming and Near Breakaway  
of the *President Casino on the Admiral*  
St. Louis Harbor, Missouri  
April 4, 1998

**NTSB/MAR-00/01  
DCA98MM027  
PB2000-916401  
Notation 7009B  
Adopted September 8, 2000**

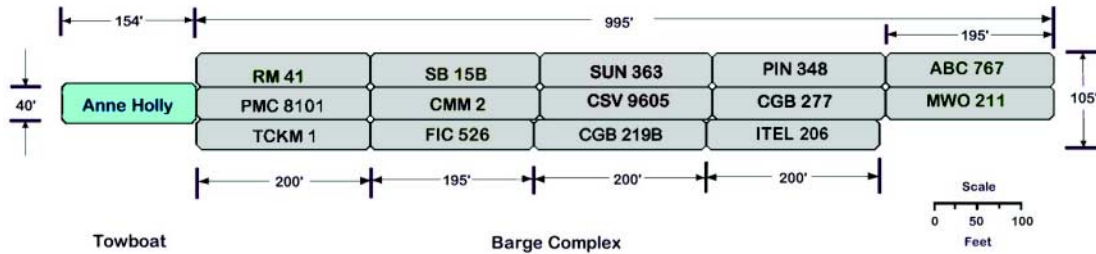
**Figure 2.** Schematic of the *Anne Holly* tow barges

The tow was five barges long in the port side or string, five barges long in the center string, and four barges long in the starboard string.<sup>5</sup> Except for the two empty barges on the forward end of the starboard string, all the barges contained dry cargo (mostly fertilizer) and carried 981 to 1,696 tons of cargo each. All 14 barges were 35 feet wide; 11 barges were 200 feet long, and the remaining 3 barges were 195 feet long. The complete tow, including the 154-foot-long towboat (secured at the after-center of the tow), was 1,149 feet long and 105 feet wide. (See figure 2.)

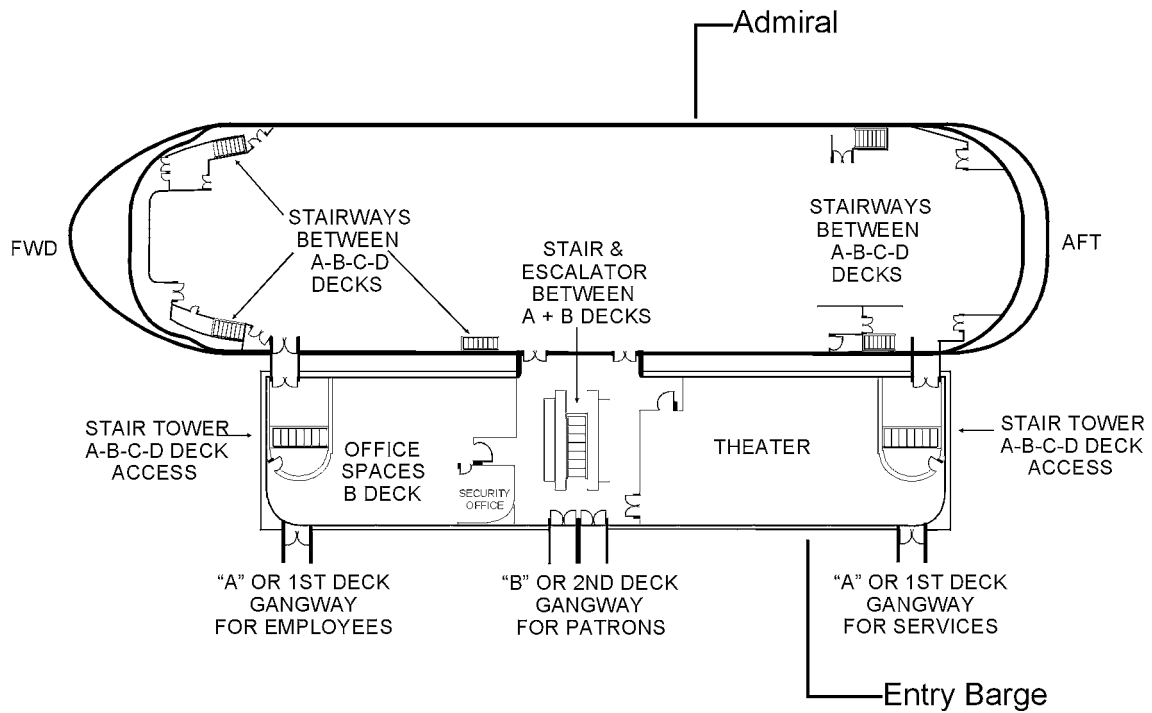
Figure 4. Schematic of the *Admiral* complex

Shortly thereafter, the three barges from the *Anne Holly* drifted toward the *Admiral* and severed or severely damaged mooring line numbers 8, 9, and 10 at the *Admiral*'s bow, before colliding with the *Admiral*. At least two of the three barges struck the *Admiral*, and two barges drifted downriver. The third barge drifted toward shore and struck the sidewalk protection guards and the north gangway between the shore and the entry barge. The impact to the *Admiral* caused wire rope numbers 1, 2, 3, 4, and 5 to break. (Figure 5 details the mooring arrangement. Figure 6 shows two views of the complex.)

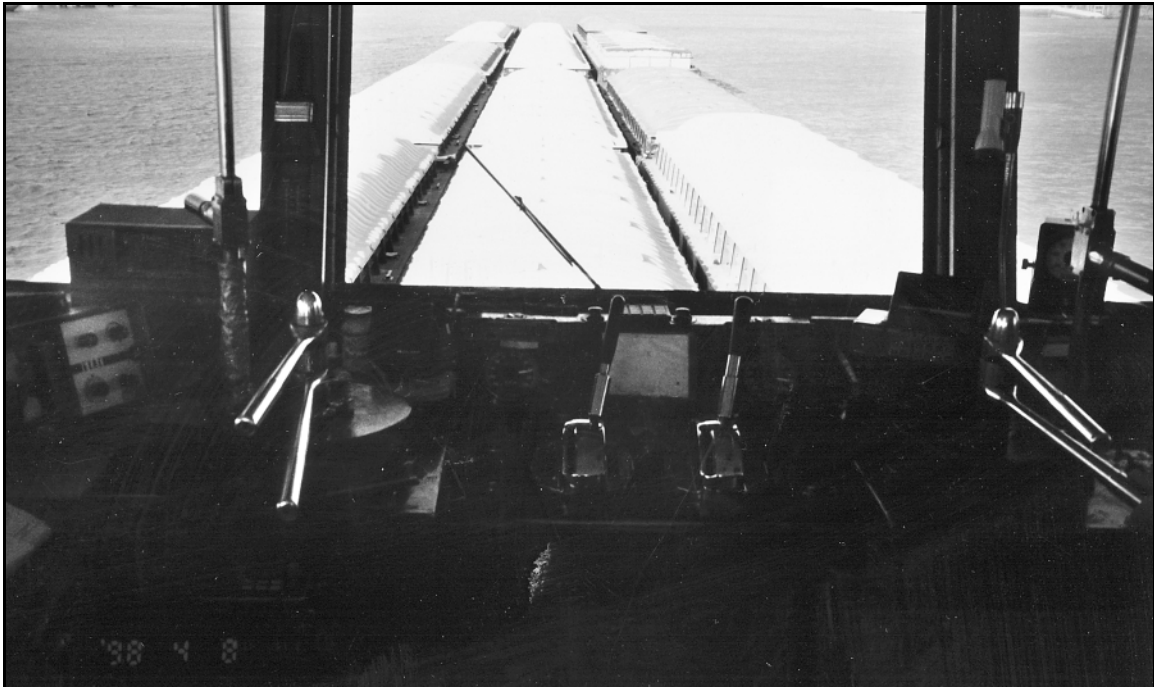
**Figure 7.** *Anne Holly* pilothouse interior

console was to the operator's right as he stood his watch at the control console. (See figure 7 for the *Anne Holly* pilothouse interior.)

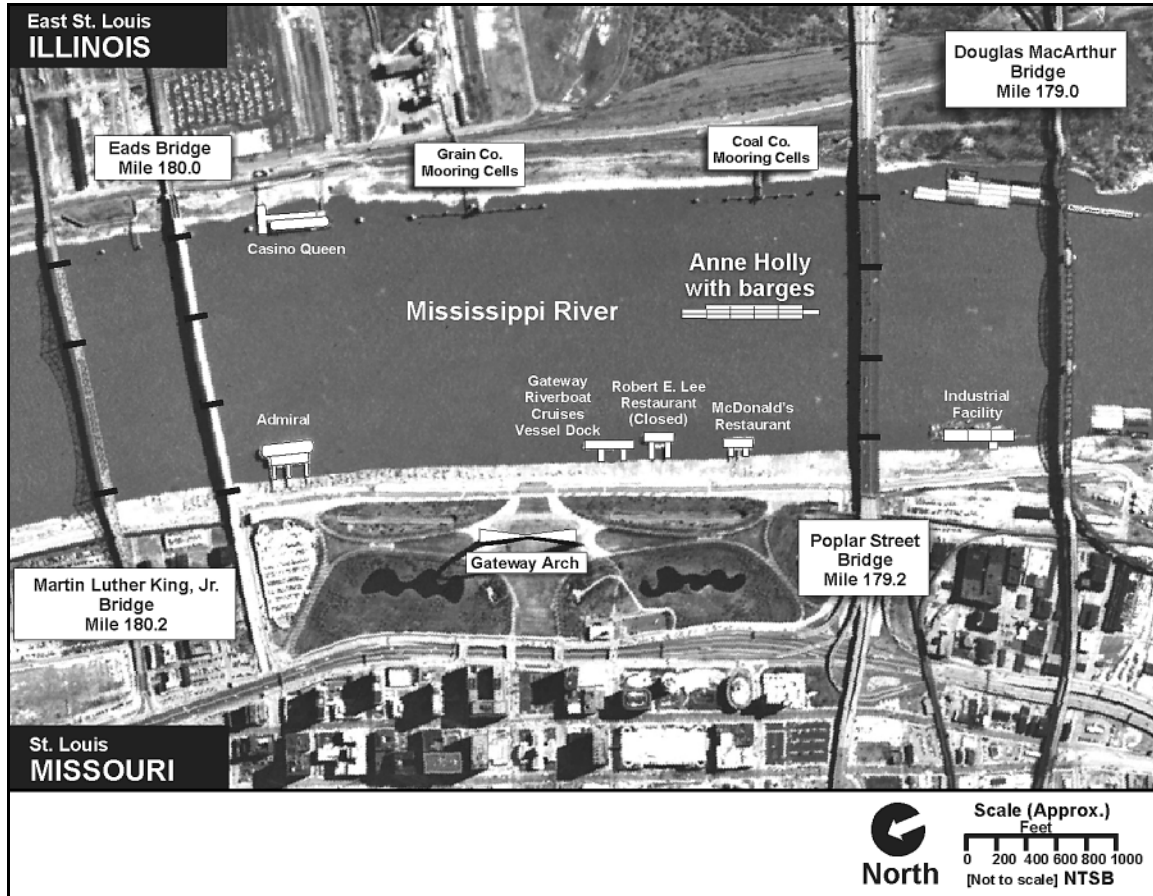
**Figure 9.** Schematic view of the accident area

Below the Poplar Street Bridge, on both sides of the river, are barge terminals, fleeting areas, and other industrial facilities. (See figure 9.)
