MARINE ACCIDENT REPORT

FIRE ON BOARD THE
U.S. PASSENGER FERRY *COLUMBIA*
CHATHAM STRAIT
NEAR JUNEAU, ALASKA
JUNE 6, 2000

**NTSB/MAR-01/02
PB2001-916403
Notation 7292A
Adopted September 18, 2001**

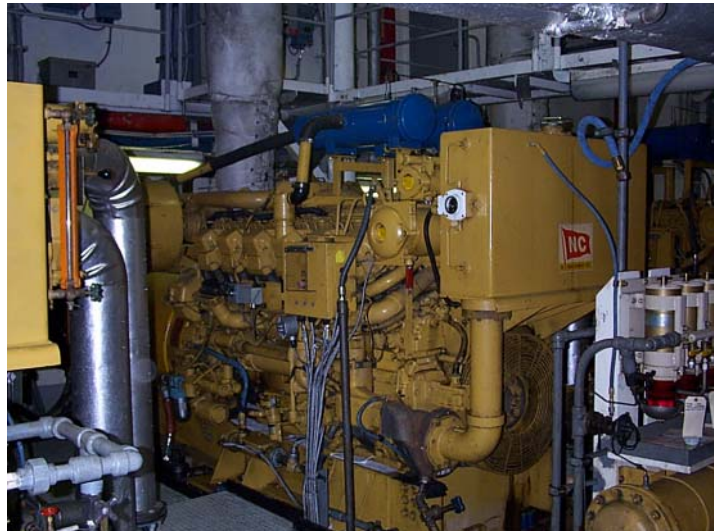
Figure 4. One of the three auxiliary diesel generators.

Meanwhile, the watch engineer was making an inspection round when he noticed the ship’s No. 2 auxiliary generator surging and moving erratically on its foundation. (See figure 4.) He stated that the generator “would go from a slower speed to a higher speed, and it was shaking and rattling.” He went to the control room to see if he could determine the cause of the erratic operation. On the way, he noticed that the lights were flickering. Upon opening the door to the control room, he “saw fire coming out of the first panel [unit] closest to the starboard door...heard a large [sic] popping sound”; he also saw what appeared to be the panels coming off the side of the breaker board. He closed the fire screen door to the control room and went to the auxiliary engineroom, where he shut down the ship’s No. 2 auxiliary generator and began to stage firefighting equipment at the starboard fire screen door of the control room.

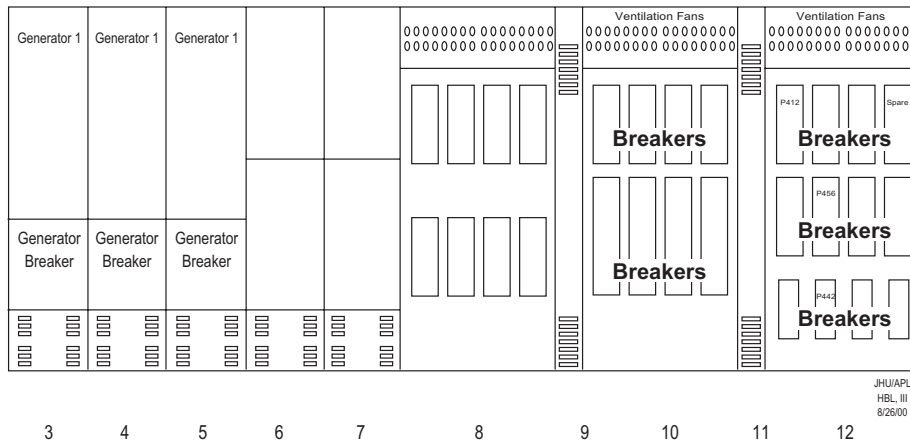
Figure 5. Outline view of main switchboard showing arrangement of units 3 through 12.

The main switchboard, located in the control room, consisted of 12 units. (See figure 5.) The starboard-most unit was identified as unit 12 and consisted of three rows of circuit breakers. Each row had four circuit breaker locations. Of the 12 locations, only 10 had circuit breakers. Units 8 and 10 of the main switchboard each had two rows of circuit breaker locations. Units 8 and 10 had 8 circuit breakers installed. Units 9 and 11 were ventilation spaces and had no circuit breakers. The three main generator circuit breakers were in units 2, 3, and 4.
