Fire Aboard Construction Barge *Athena 106*  
West Cote Blanche Bay, Louisiana  
October 12, 2006

ACCIDENT REPORT

NTSB/MAR-07/01  
PB2007-916401

# Marine Accident Report

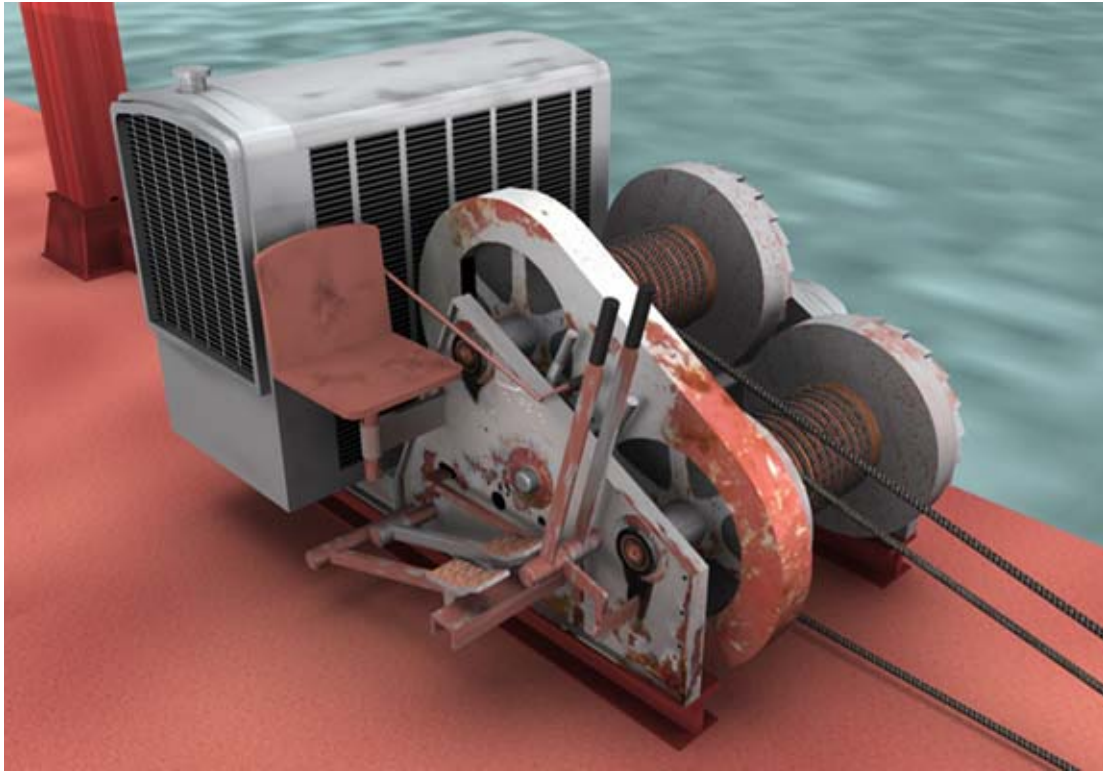
The spud winch operator's first duties of the day included checking the diesel and oil levels on the barge crane, checking the barge's air compressor, and checking the oil level in the spud winch gearcase as well as the general condition of the winch. Both spuds were raised and lowered by a single winch equipped with two steel cables, each wound around a drum and attached to one of the spuds (figure 3).<sup>4</sup> The spud winch operator said that he would periodically adjust the winch's foot brakes, which were used to control the speed of the winch drums as they raised or lowered the spuds. He said that on the day of the accident, the foot brakes "felt fine" and did not need adjusting. He stated that he also checked the condition of the spud-lifting cables daily. Both spud winch cables had been

**Figure 3.** Computer-generated image of a spud winch unit. The spud-lifting cables are wound on the drums to the left of the operator's seat. The winch's foot brakes are below and forward of the seat.

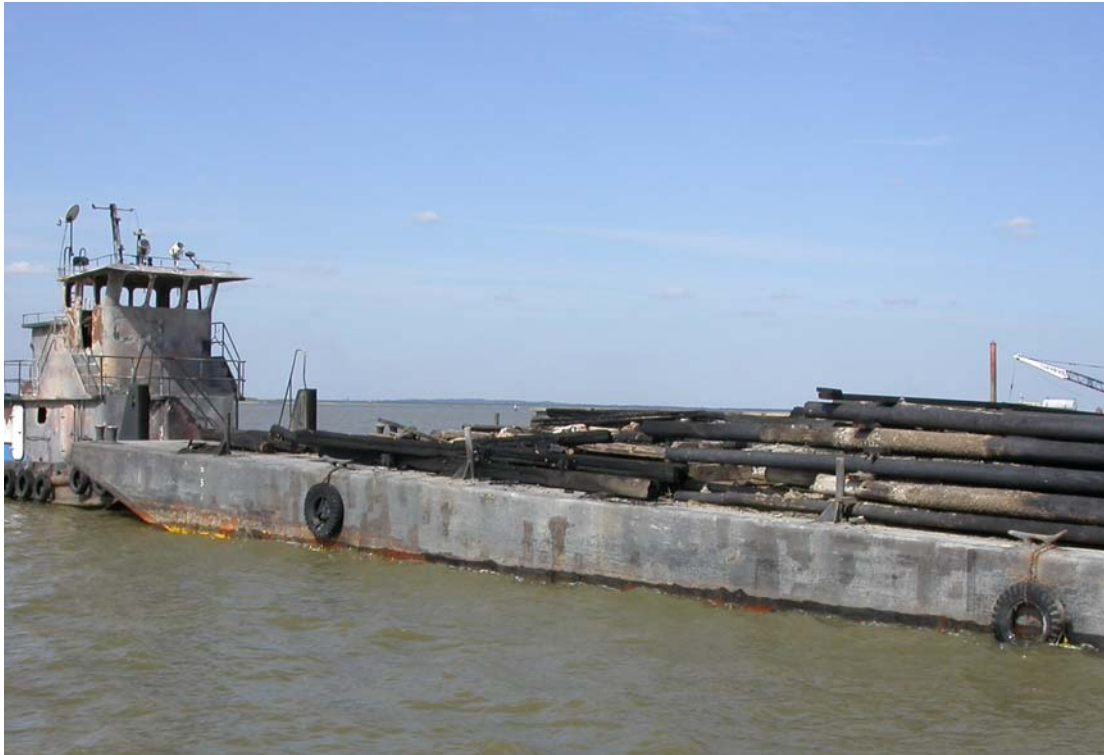
After completing the morning checks, the *Athena 106* crew began extracting pilings. The *IBR 234* was secured alongside the *Athena 106* to store the extracted pilings (figure 4). The barge also housed new pilings that would be driven later.

**Figure 4.** Barge *IBR 234* loaded with pilings (being pushed by the *Miss Megan*).

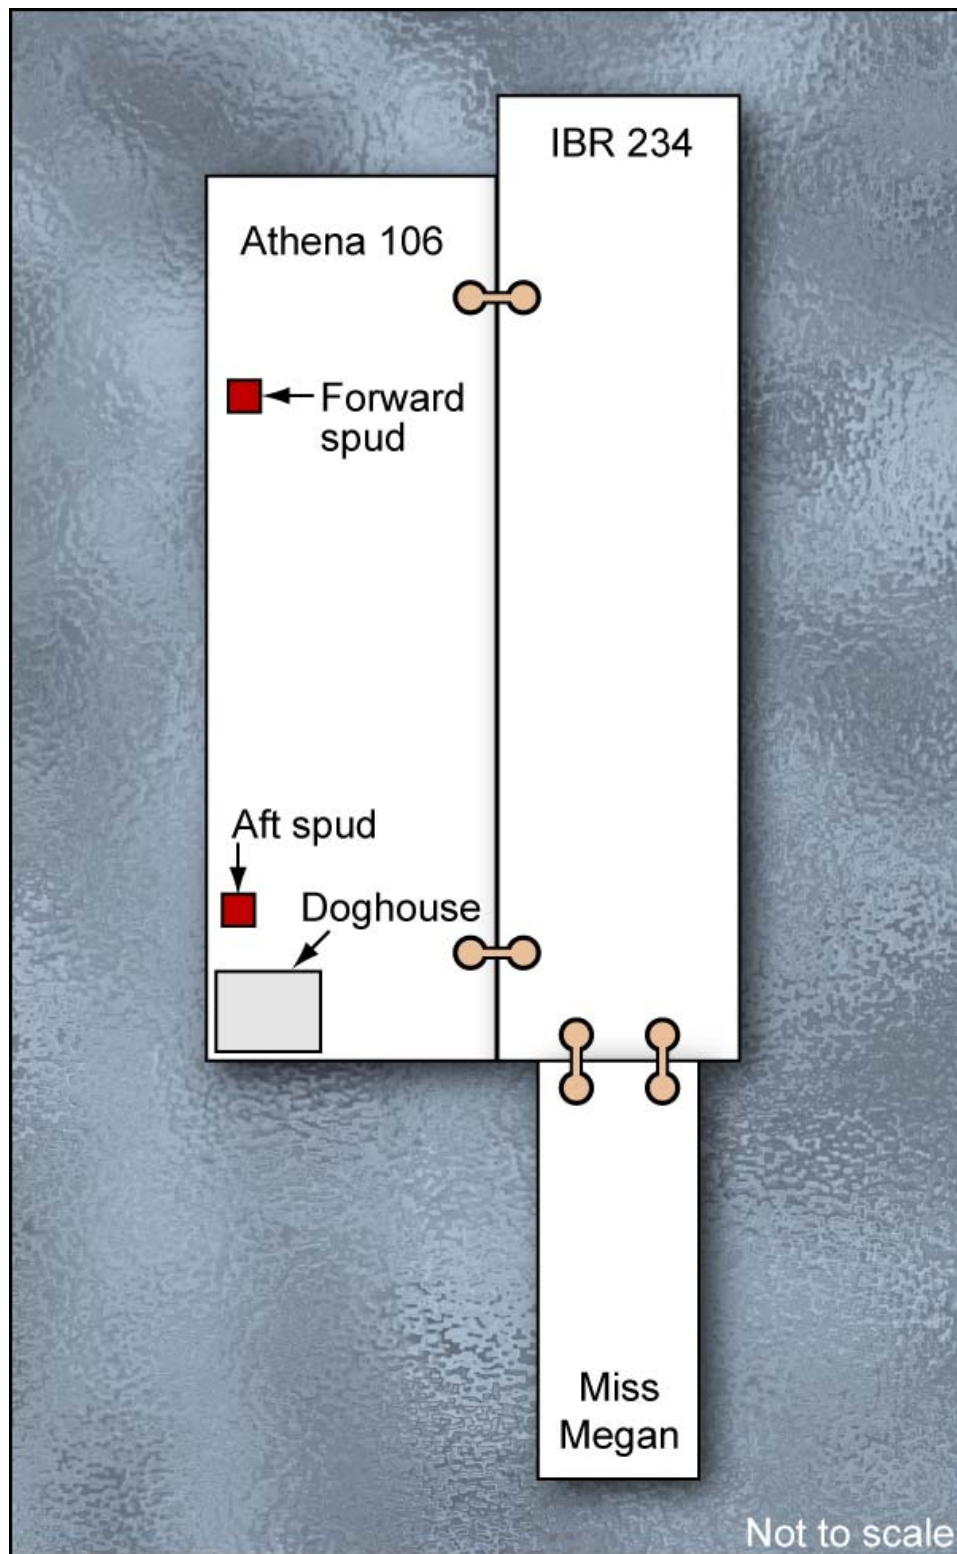
The extraction work continued until about 1130, when the towboat *Miss Megan* arrived and was secured to the aft end of the *IBR 234* in preparation for propelling the two barges to their next work location (figure 5). While the towboat master and deckhand made fast to the barges, the barge crew stopped its work of extracting pilings.

**Figure 5.** Towing arrangement of the *Miss Megan* and the two barges. The barges were tied together, with the *Miss Megan* secured to the aft end of the *IBR 234* and pushing both barges.

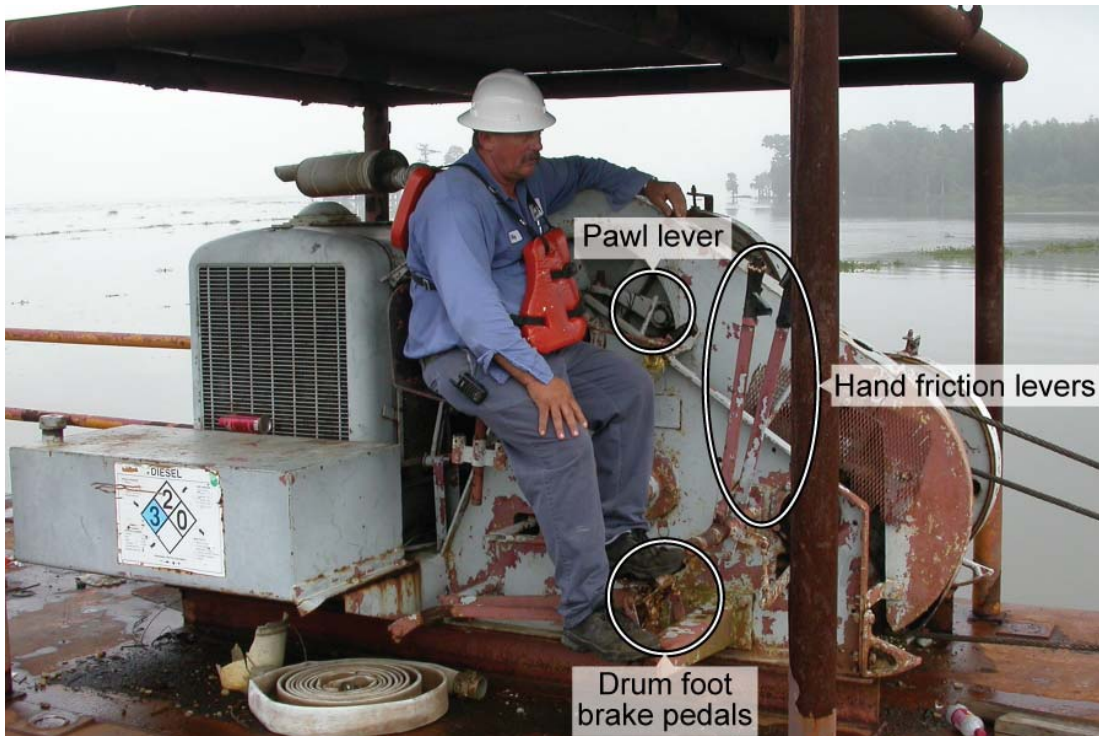
The spud winch operator could control the drums independently, working from a seat mounted on the inboard side of the winch, facing the forward end of the barge (figure 8). Each winch drum had two brake bands, one on the outside and one on the inside nearest the operator. Both bands were controlled from the operator's seat, the outer band by a foot lever and the inner band by a hand control lever. Thus, the operator had two foot brake pedals and two hand levers that acted as friction brakes to control the speed of the winch drums as they lowered or raised the spuds. The operator's winch controls also included (1) a single-lever throttle to control the diesel engine's speed, (2) a lever for engaging or disengaging the diesel engine's clutch from the winch drum driveshaft (used only while lifting the spud; lowering the spud was accomplished by gravity), and (3) a lever for each drum to engage or disengage the drum pawls into a notched ring on the drum's outer edge and prevent its cable from paying out accidentally.

**Figure 8.** Operator in position at the spud winch on another Athena barge, not the *Athena 106*, used in the salvage operation after the accident. Highlighted are the foot brake pedals and hand levers that controlled the speed of the winch drums as they lowered or raised the spuds, and one of the levers that engaged or disengaged the drum pawls into a notched ring on the drums' outer edge to prevent the cables from paying out. Note the operator's work vest, the flotation device worn by barge workers on the job.

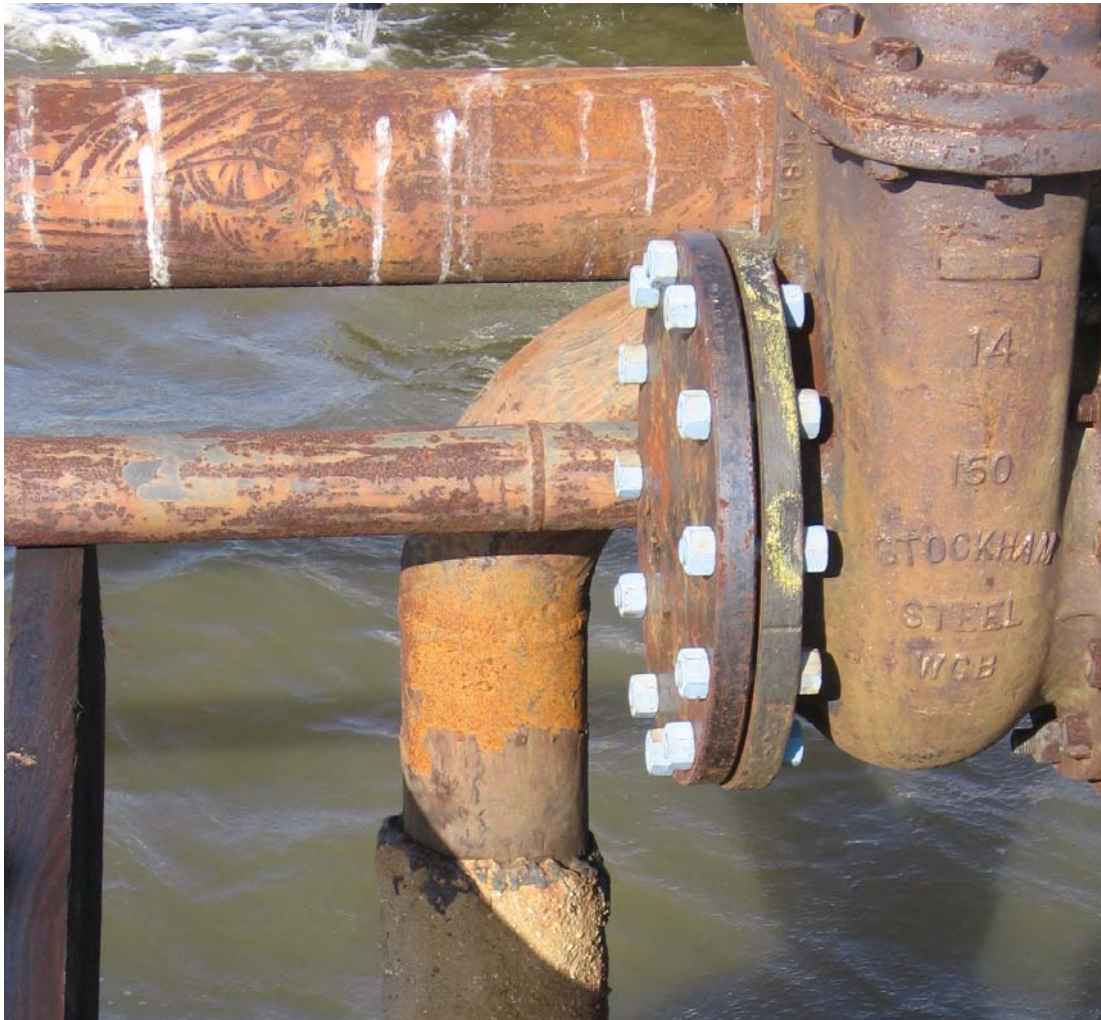
At the point where it was struck, the gas sales pipeline ran roughly east to west under the bay (figure 1). West of where it was struck, the pipeline made a 90-degree turn north. At the east end, the pipeline began at the Gulfport sales platform (figure 14). The sales platform was in Gulfport’s West Cote Blanche Bay production field (state lease 340). At the west end, the pipeline terminated at Chevron’s bay junction platform, where it tied into Chevron’s Vermilion Bay gas sales pipeline. A check valve downstream of the tie-in prevented backflow from the downstream gas-gathering system.

**Figure 14.** Beginning of the gas sales pipeline (vertical pipe entering water) at the Gulfport sales platform in the West Cote Blanche Bay oil field. The pipeline was ruptured by the *Athena 106*'s aft spud in an east-west section near the Gulfport platform. The pipe's concrete coating is visible above the waterline.
