NATIONAL TRANSPORTATION SAFETY BOARD

HIGHWAY ACCIDENT REPORT

**COLLISION OF AMTRAK TRAIN NO. 88 WITH
ROUNTREE TRANSPORT AND RIGGING VEHICLE
ON CSX TRANSPORTATION, INC., RAILROAD
NEAR INTERCESSION CITY, FLORIDA
NOVEMBER 30, 1993**

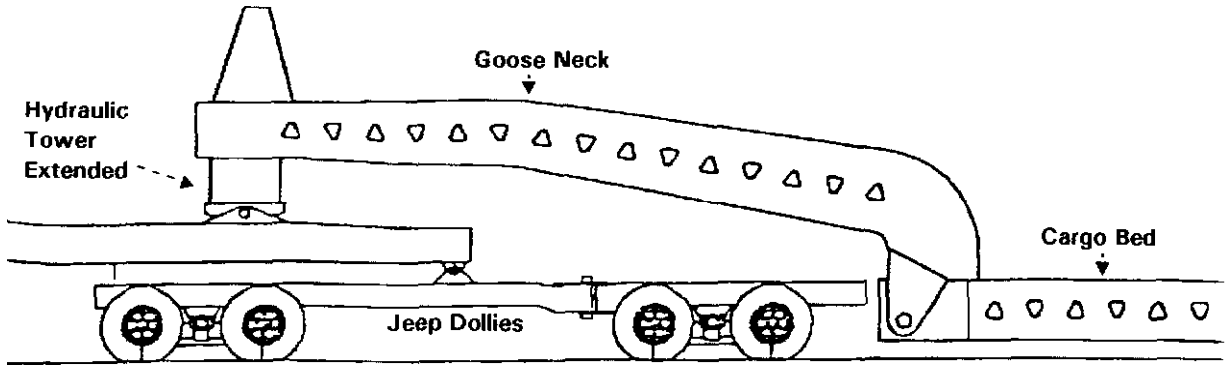
Peterbilt Tractor and Modular Transport Trailer

Normal travel configuration: Hydraulic tower is in the extended position; no shims are used at goose neck/bed connection.

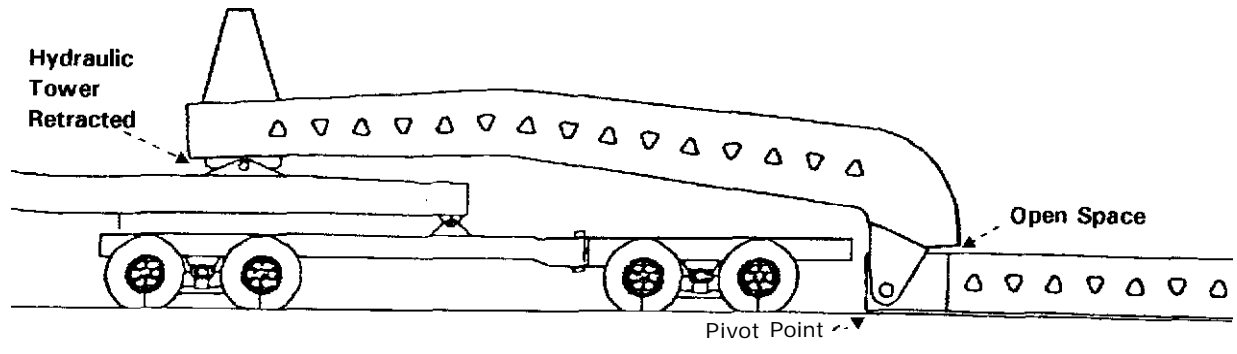
Set-down mode: Hydraulic tower is in the retracted position. The goose neck pivots, leaving an opening for the placement of shims.

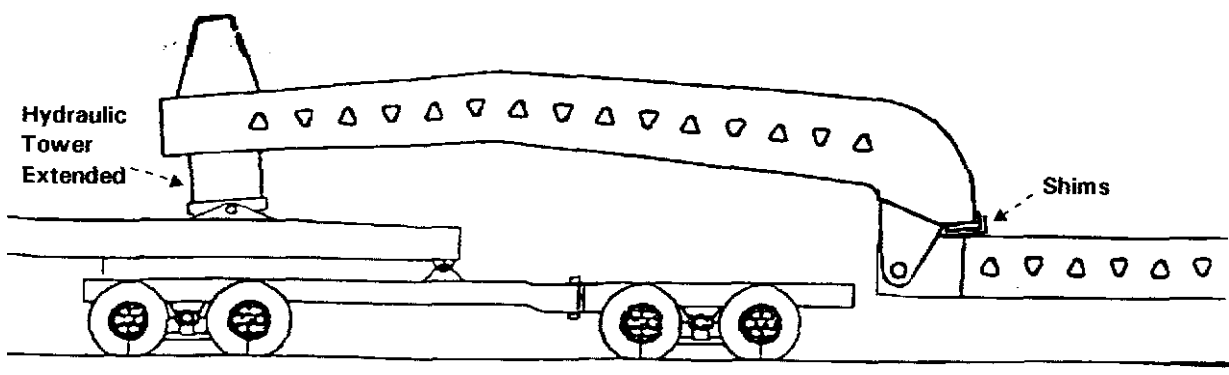
Modified travel configuration: Hydraulic tower is in extended position. The shims change the position of the goose neck, which provides increased ground clearance.
