# 15-Passenger Van Single-Vehicle Rollover Accidents, Henrietta, Texas, May 8, 2001, and Randleman, North Carolina, July 1, 2001

**Highway Accident Report**  
**NTSB/HAR-03/03**

**15-Passenger Van Single-Vehicle  
Rollover Accidents,  
Henrietta, Texas, May 8, 2001,  
and Randleman, North Carolina,  
July 1, 2001**

**NTSB/HAR-03/03  
PB2003-916203  
Notation 7567  
Adopted July 15, 2003**

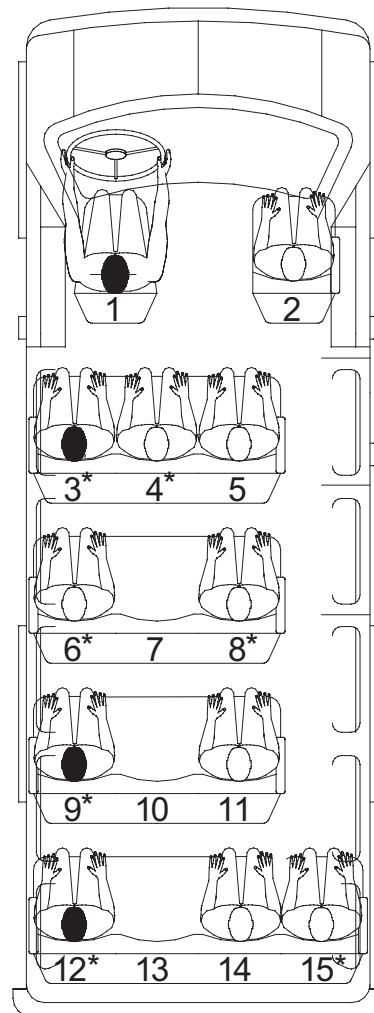
1 through 7, fractured left clavicle, fractured left ribs 1 through 8, abraded contusions to the right hand and abrasions and lacerations of the left forearm and elbow. The fatally injured passenger in seat 3 (see figure 3) was ejected and sustained a large gaping laceration of the scalp; C1 and C2 vertebrae fractures with partial dislocation into the spinal canal and laceration of the spinal cord; spleen laceration; liver pulpification; laceration of the inferior vena cava; fractured right ribs 1 through 9; fractured left ribs 1 through 11; fractured right clavical, pelvis, left femur, left radius, and ulna; multiple abrasions; contusions; and lacerations. The fatally injured passenger in seat 9 was ejected and sustained a deep laceration to the right femoral region extending into the anterior right thigh and a large scalp laceration.<sup>4</sup> The fatally injured passenger in seat 12 was ejected and sustained a C2 vertebra fracture with partial dislocation into the spinal canal and transection of the spinal cord and medulla, liver lacerations, fractured right posterior pelvis, dislocation of the left femur head, and multiple contusions and abrasions.

**Figure 3.** Henrietta seating chart. (\*ejected; shading indicates fatal injuries)

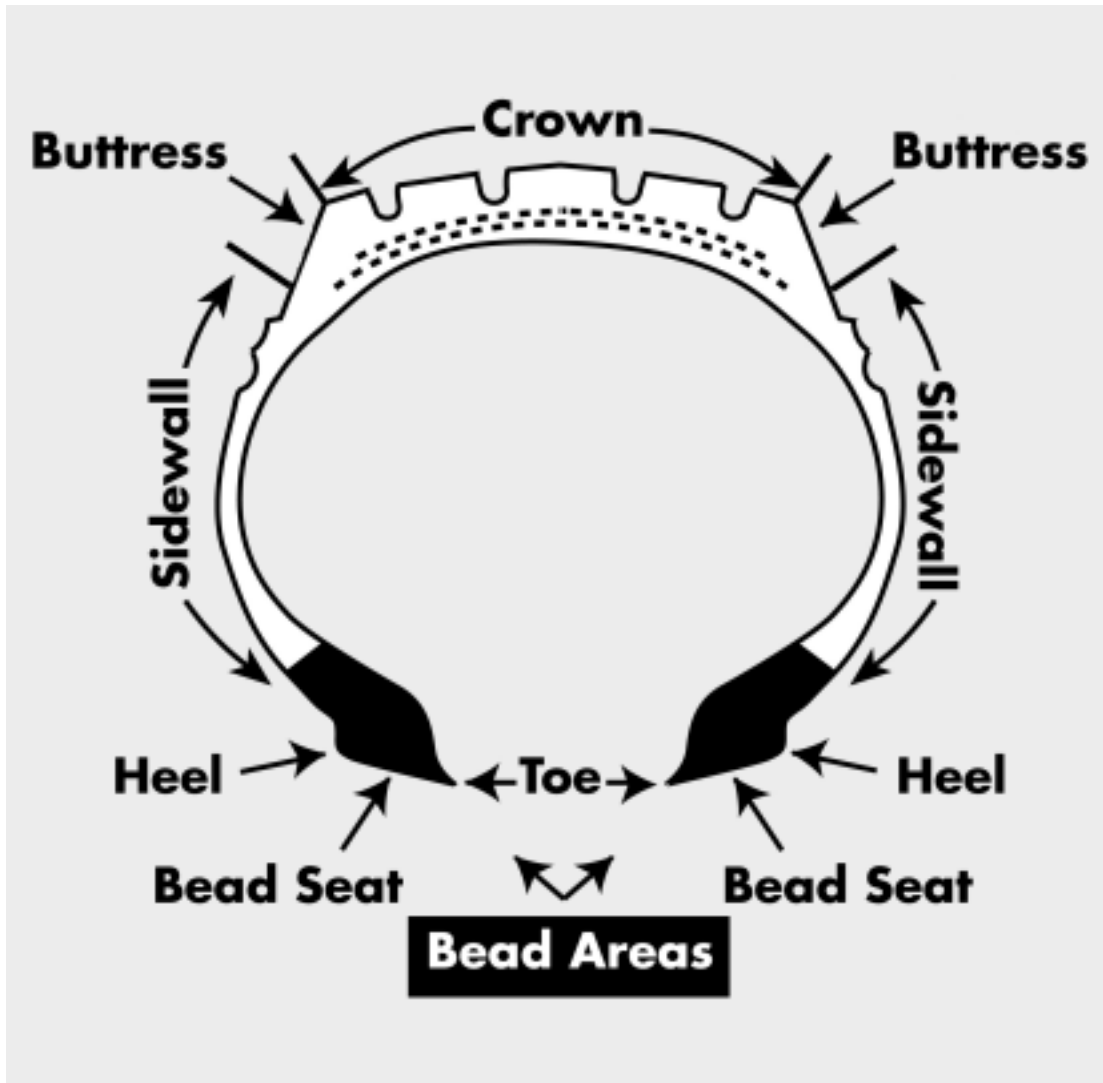
**Figure 4.** External tire diagram. Source: Michelin.

The left front tire exhibited extensive circumferential sidewall (see figure 4) and tread groove cracking (see figure 5). According to the manufacturer, the cracking was due to weather and is commonly referred to as weather checking, that is, surface cracks in the exterior tire rubber. Written in yellow crayon on the sidewall were the words "RE-

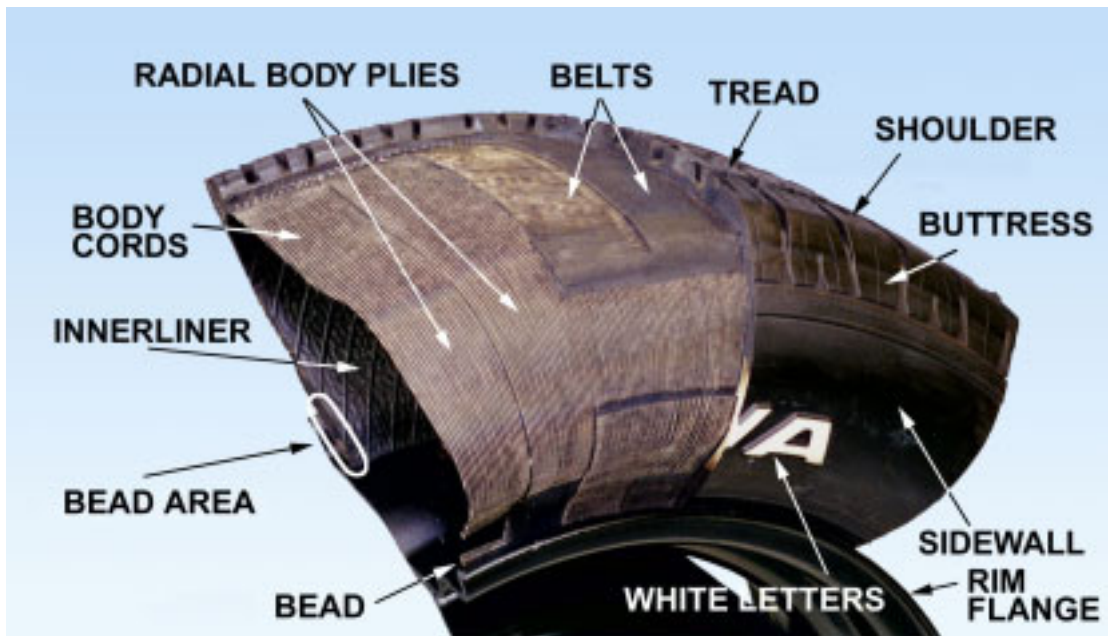
Figure 7. Inner tire diagram. Source: Michelin.

The left rear tire (see figure 6) sustained extensive damage to the inner and outer sidewalls and tread, exposing the body plies<sup>10</sup> and inner liner (see figure 7). The tire exhibited extensive circumferential cracking and deterioration of the sidewall and bead areas, which the manufacturer attributed to weather. Radial splits and abrasions were noted on the sidewalls, as was severe weather checking. The tread and belt components were partially detached from the tire. Where the bottom belt remained attached, it was separated from the body ply along the interior edge. A nail found embedded in the detached tread and top belt piece had not penetrated all components. Another puncture hole, extending through all components, was found. The inner liner was split radially.

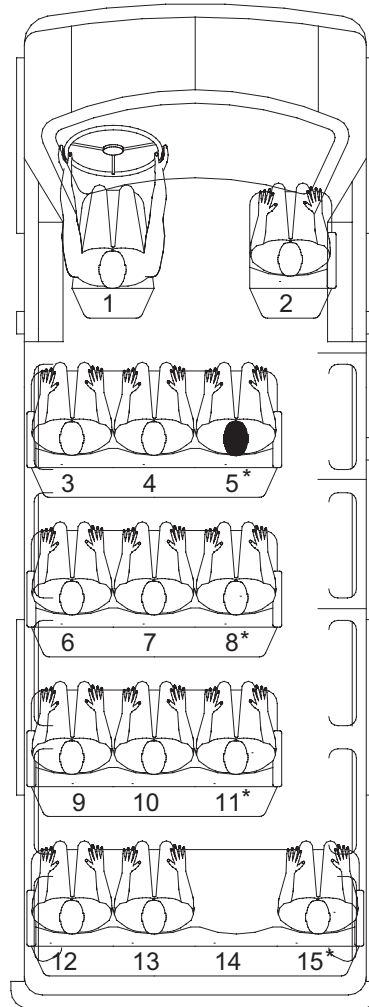
One passenger, who was in seat 5 (see figure 15) before being ejected, died in the hospital 4 days after the accident. She sustained a left front parietal<sup>14</sup> skin subdural hematoma, right temporal and parietal fractures, a diastic lambdoid<sup>15</sup> fracture, left temporal fracture, left basilar skull fracture, left petrous<sup>16</sup> fracture, left occipital fracture, and left orbital roof fracture.

**Figure 15.** Randleman seating chart. (\*ejected; shading indicates fatal injury)

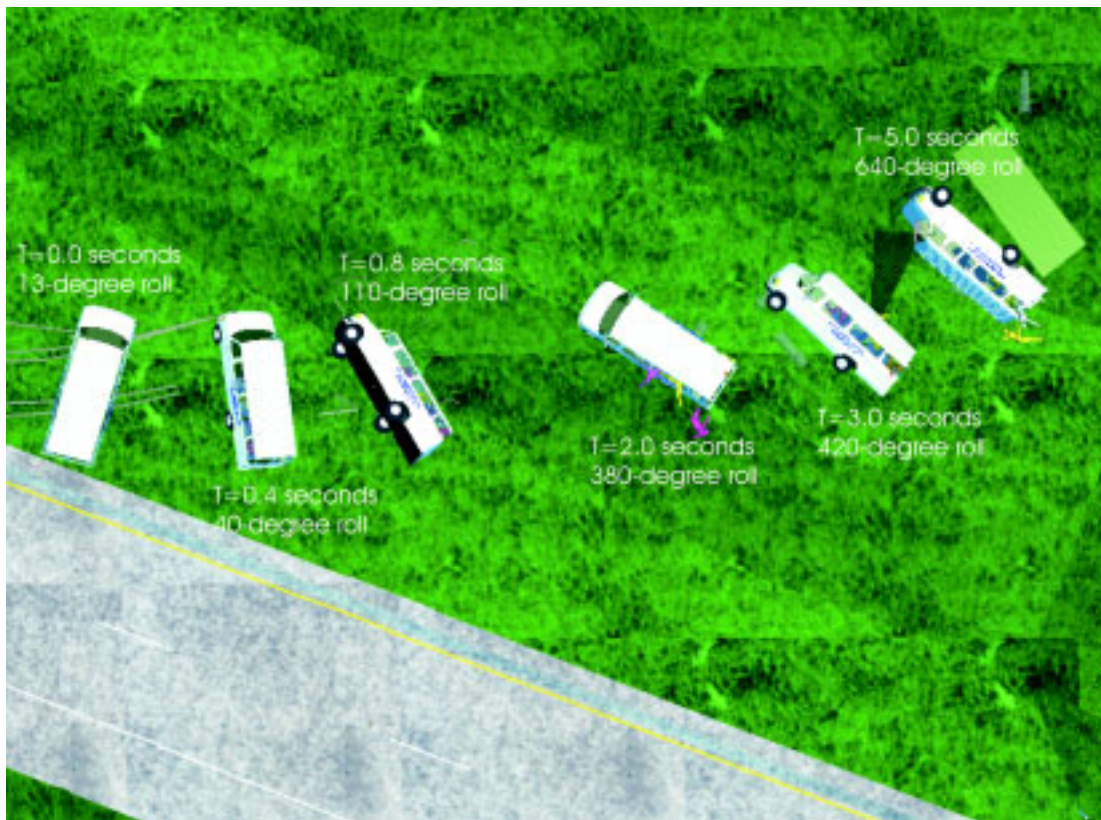
The results of the vehicle dynamics simulation indicated that the initial speed of the van before the tire blowout was 67 mph. After the blowout, steering input to the right and then back to the left was required to match the physical evidence on the roadway. The steering toward the left and the resulting yaw would have caused the vehicle to depart the roadway at an angle of approximately 100° counterclockwise to the initial direction of travel prior to the tire failure. Simulations of the overturn sequence indicated that the vehicle completed at least two rolls before reaching final rest. For a depiction of the van at various stages of the overturn, see figure 20.

**Figure 20.** Potential path of the van during the overturn; the time is based on the beginning of the rollover.
