Motorcoach Fire on Interstate 45  
During Hurricane Rita Evacuation  
Near Wilmer, Texas  
September 23, 2005

**ACCIDENT REPORT**

NTSB/HAR-07/01  
PB2007-916202

**Motorcoach Fire on Interstate 45  
During Hurricane Rita Evacuation  
Near Wilmer, Texas  
September 23, 2005**

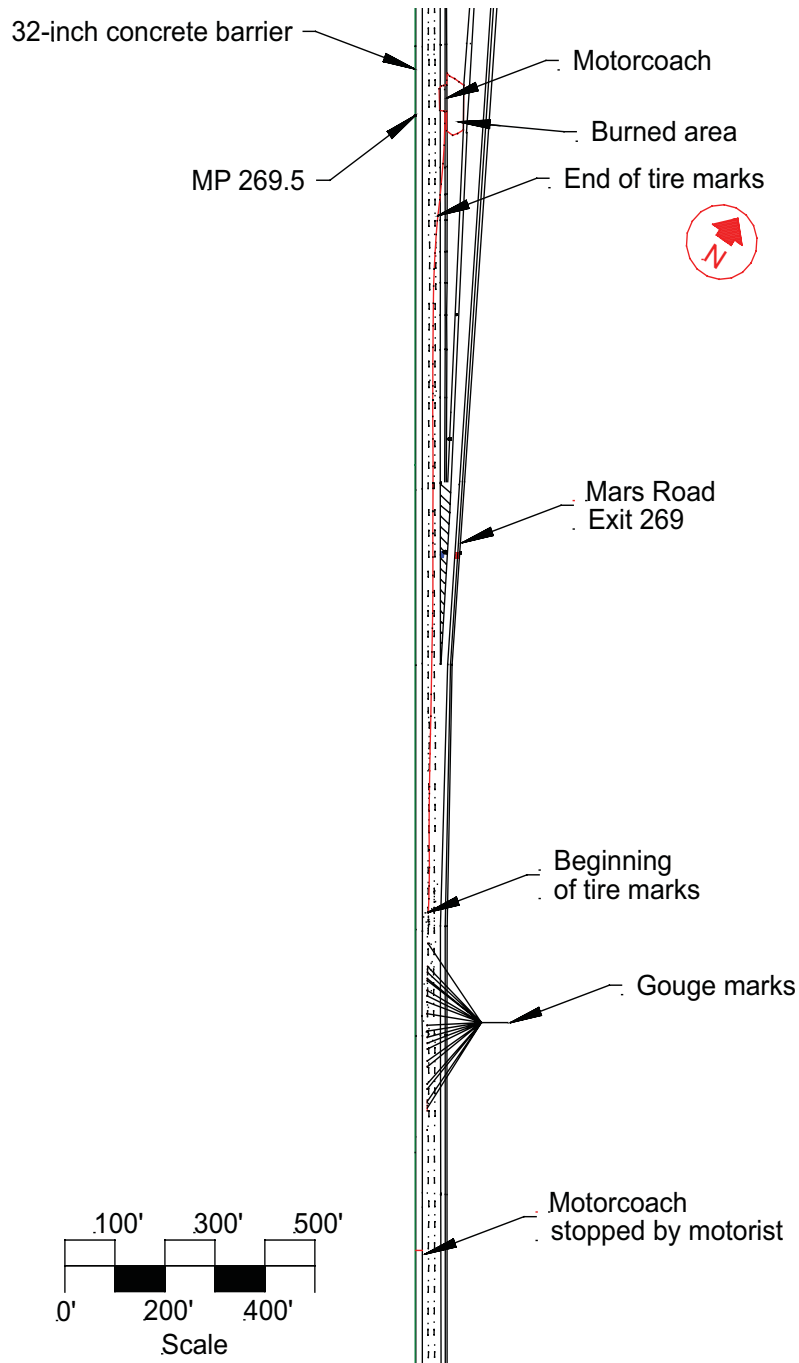
Figure 2. Accident scene diagram.

Board investigators that he was unsure whether the motorcoach driver understood him because the driver never responded verbally. The motorist then returned to his vehicle and drove away. The supervising nurse reported hearing the motorist approach the motorcoach driver and report a problem with the right-rear wheel. The driver began to move the motorcoach across the crowded lanes of travel and pulled off onto the right shoulder north of the Mars Road exit, at milepost (MP) 269.5. (See figure 2.)

The driver, nurse supervisor, and another nurse exited the motorcoach and observed the right-rear wheel well on fire. As the driver began trying to extinguish the flames with his shirt and by throwing dirt and grass, the nurses immediately went back into the vehicle and urged the passengers to quickly exit. As the nursing staff was evacuating the nonambulatory passengers, the driver had reentered the motorcoach and attempted to unlatch the fire extinguisher from its bracket under the right (passenger)-side second row seat. He was unable to unlatch it and reported opening a roof hatch vent instead; he tried opening a few windows on the driver's side but said that they would not stay open.

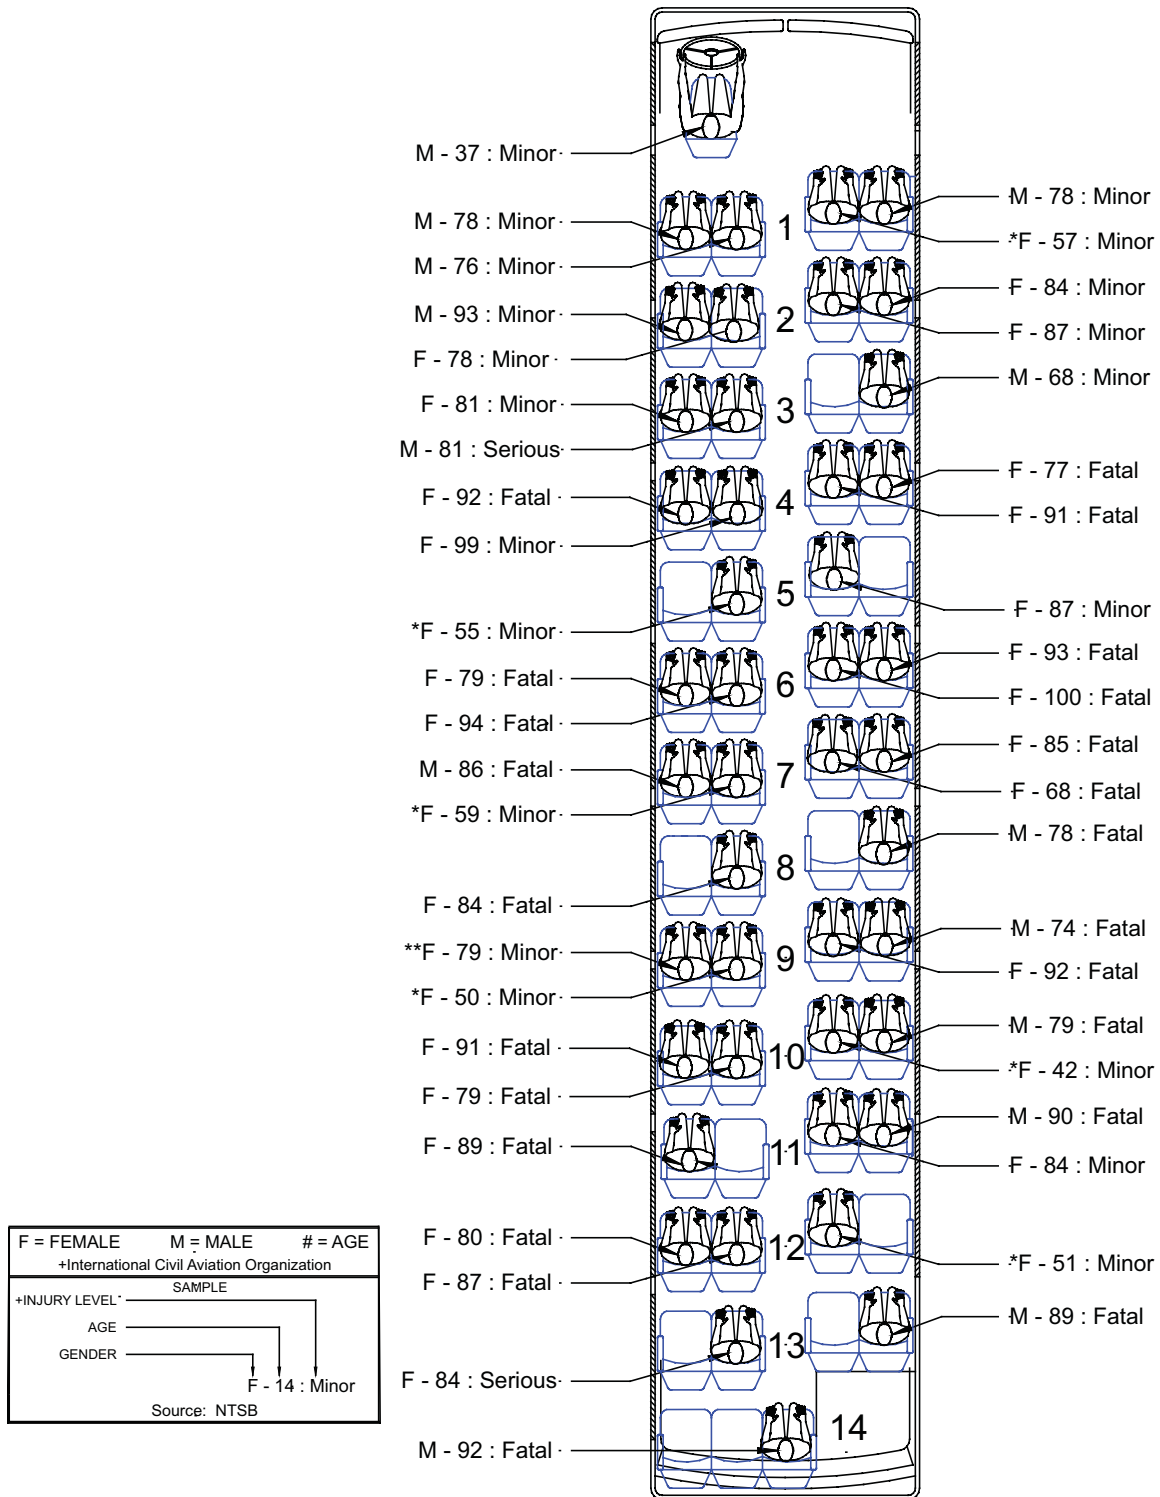
Figure 8. Passenger seating chart and postfire injury information.

The 23 passengers who died in the fire ranged from 68 to 100 years old. Eighteen individuals were found still seated, and 5 were found in the center aisle. One of these passengers had reportedly been seated in row 10 and was found near the front of the motorcoach in the aisle adjacent to row 1. (See figure 8.<sup>10</sup>)

<sup>10</sup> The seating chart shown in figure 8 is based on interviews with nursing staff and patients; it may not depict the exact seating locations immediately prior to the fire.

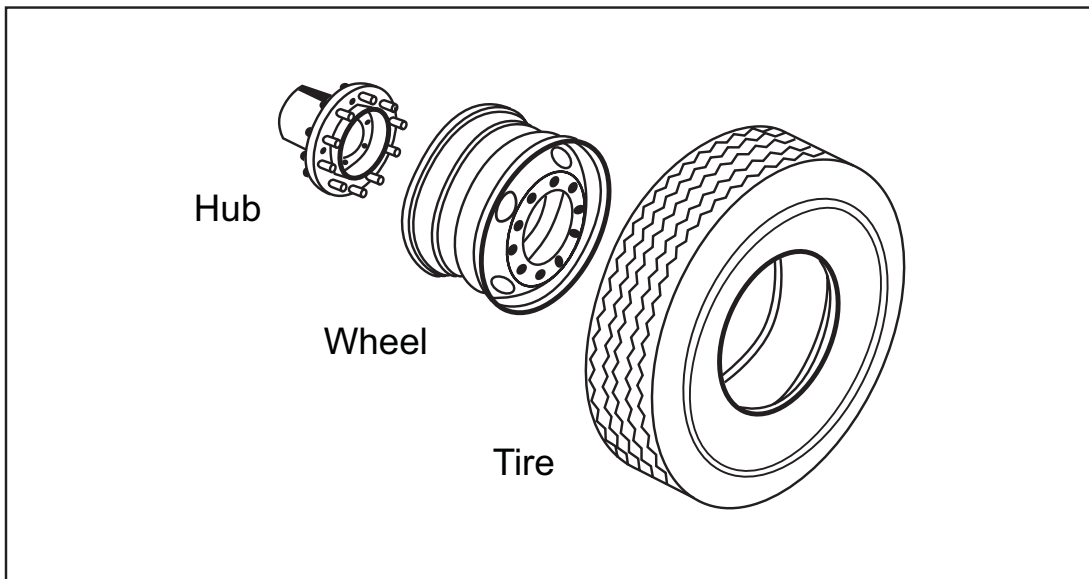
**Figure 10.** Simplified hub and wheel diagram.

The third axle is mounted to the frame of the motorcoach by means of an adjustable air suspension system. This auxiliary weight-bearing axle is commonly referred to as the tag axle. A hub affixed to both the left and right sides of the outer axle assembly serves as the interface, allowing the wheels to rotate. (See figure 10.) In vehicles equipped with a disc brake rotor, such as the accident motorcoach, the brake rotor is also mounted on the hub. At the Safety Board public hearing on this accident, on August 8–9, 2006, in Washington, D.C. (see appendix A),<sup>29</sup> a chief engineer with Timken Company (a bearing manufacturer) explained that a vehicle's wheel bearings have three functions: to allow rotation with minimum friction (between wheel assembly parts), to carry the vehicle load

or transfer the load (the weight of the motorcoach), and to concentrically position and align rotating and stationary components within the hub and wheel assembly. The wheel bearing rollers are evenly spaced and held within a circular wheel bearing cage, both of which are located inside a wheel bearing cup. The inner wheel bearing cup is fixed on the axle spindle (see figure 11), and the outer bearing cup is pressed into the hub. The inner cup remains stationary while the outer cup rotates with the hub and wheel.

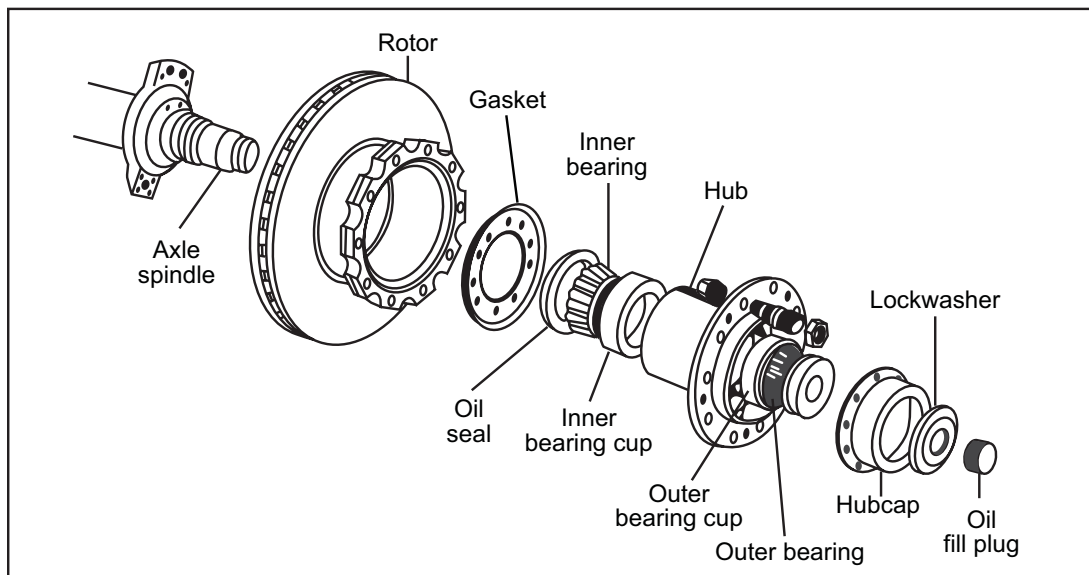
**Figure 11.** Hub and wheel bearing diagram.

The accident motorcoach had oil bath bearings; in this type of wheel bearing configuration, the individual bearing components are partially immersed in an oil lubricant (rather than being “packed” with grease) contained in a sealed reservoir within the wheel and hub. Oil is distributed to the bearings and throughout the reservoir cavity only when the vehicle is in motion. This distribution of oil provides both lubrication and cooling to the bearing rollers. A wheel bearing seal keeps the lubricant inside the bearing and the contamination outside.
