HETA 2000-0268-2812
Southwest Airlines San Antonio Reservations Center
San Antonio, Texas

Evaluation of Indoor Air Quality at the San Antonio Reservations Center

Health Hazard Evaluation Report 2000-0268-2812
Southwest Airlines San Antonio Reservations Center
San Antonio, Texas
November 2000

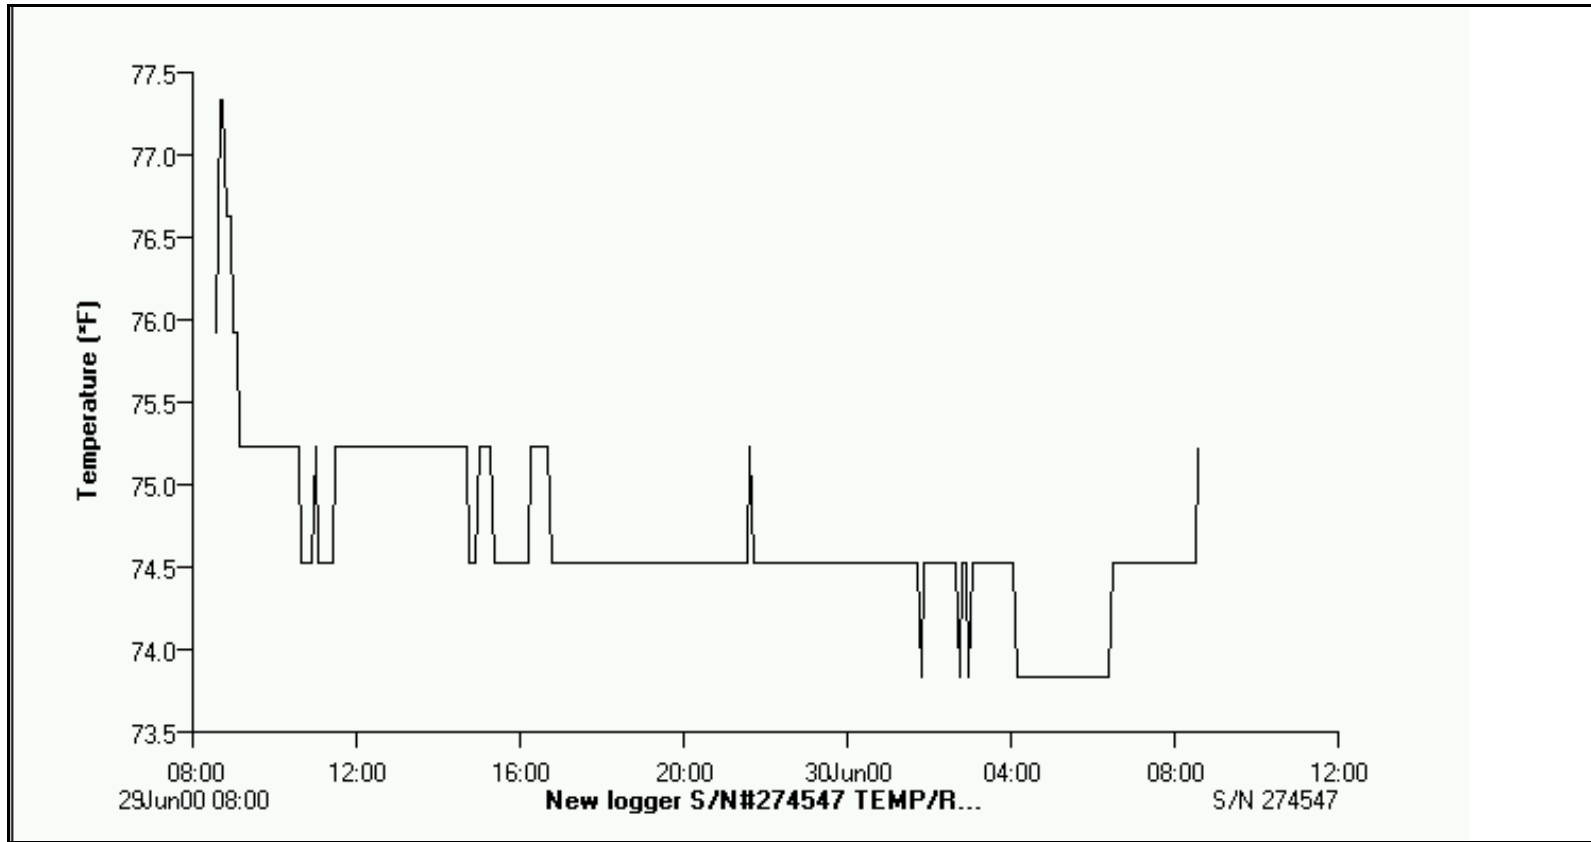
Figure 2
Temperature Variations in Quadrant A
HETA 2000-0268
Southwest Airlines San Antonio Reservations Center, San Antonio, TX
June 29-30, 2000

Figures 2-11 graphically illustrate the temperature variations at 5-minute intervals over a 24-hour period at different locations in the reservations center and outdoors. The locations are as follows: (1) quadrant A; (2) quadrant B; (3) quadrant C; (4) quadrant D; (5) console area; (6) front reception area; (7) break room; (8) first aid room; (9) Q & A office; (10) union shop steward's office; and (11) outdoors. The temperature varied from less than 1°- 3°F in the four quadrants. Quadrant B had the coolest temperature (72.5°F), measured from approximately 8:30 p.m. to 8:30 a.m. This corresponds to the times that the quadrant is unoccupied (8:30 p.m. to 8:00 a.m.). Figure 8 shows the most variation in temperature (approximately 73° to 77°F) in comparison with the other locations. This data logger was placed in the break room on top of a drink machine by the television. Although the temperature range only spanned approximately 4°F, the temperatures peaked at the upper and lower extremes in a continuous pattern from approximately 8:45 a.m. on June 29, 2000, through 8:51 a.m. on June 30, 2000. The offices around the perimeter of the quadrants exhibited more variable temperature patterns than those measured within the quadrants. The first aid and Q&A office (see figure 9 and 10) showed warmer temperature trends when compared with the remaining locations (up to 80°F), however the temperatures dropped and were within ASHRAE's recommended comfort range between 8:00 a.m. and 4:00 p.m. Temperatures logged in the shop steward's office (see figure 11) also showed more variation than within the quadrants, but the temperature range was approximately 4°F cooler than the other offices. All of the offices are serviced by one AHU. The instrument placed outdoors was directly in the sun in the afternoon, most likely causing the very high temperature readings (see figure 12).
