Section 11 Environmental Effects Associated with the Breach of the Upper Reservoir at the Taum Sauk Project

11.1 General Description of the Hydro Project and Project Area

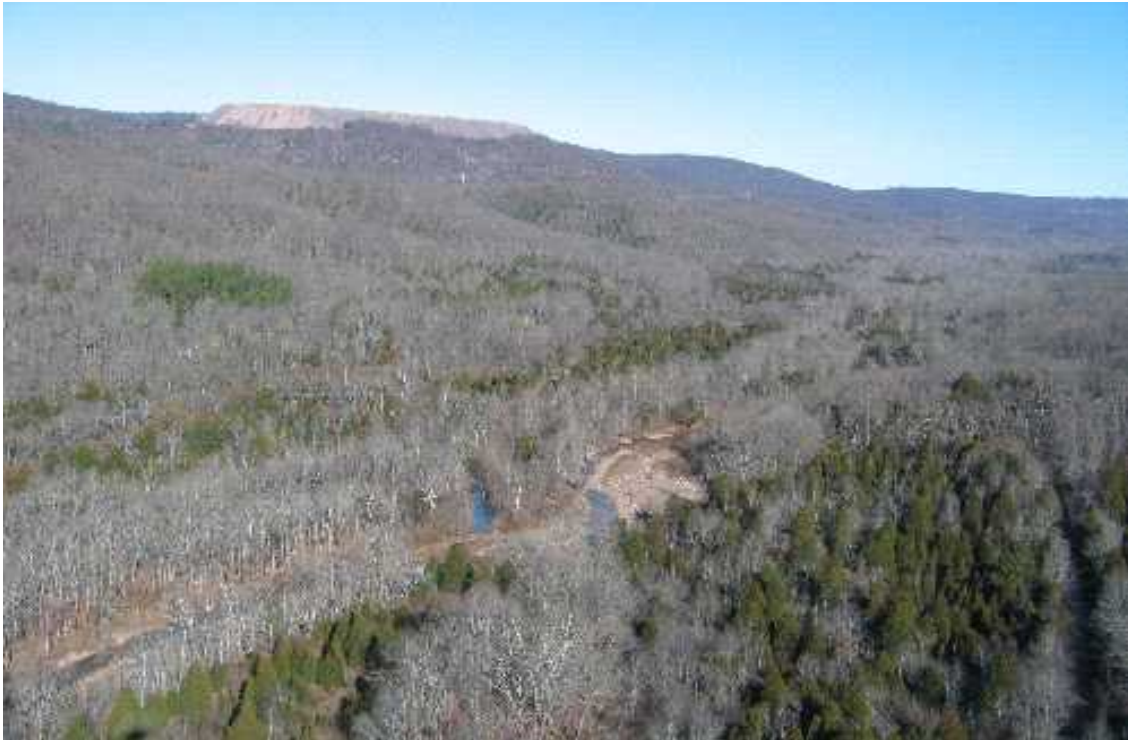
Figure 11.10 - Forested area surrounding Proffit Mountain (opposite side of breach) with upper reservoir in the background. December 2005. (Source: Missouri Department of Conservation)

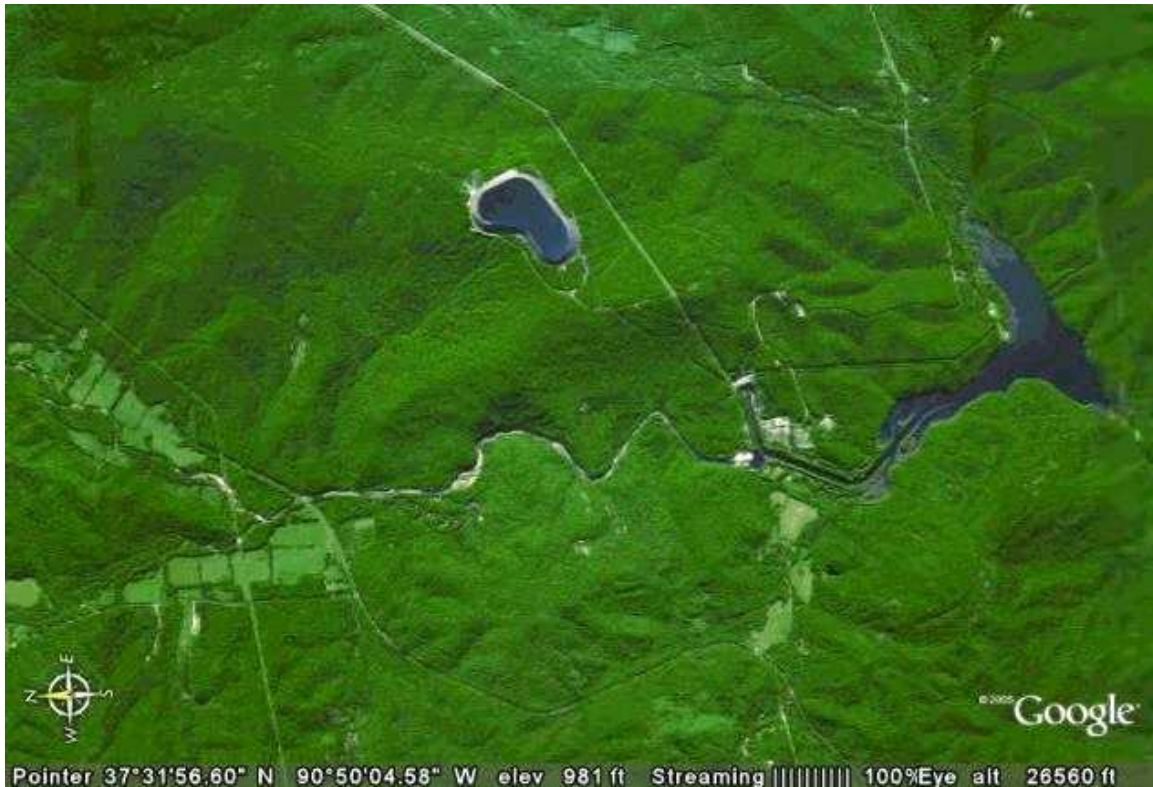
Prior to the December 14 event, Proffit Mountain was heavily forested as seen in the satellite photograph (Figure 11.13). From the base of the upper reservoir in the northwest corner, where the breach occurred, to the valley floor and state park, over 250 acres of forest vegetation was denuded. Compounding the problem of deforestation is the fact that all soil in a 200 yard swath down Proffit Mountain was removed down to bedrock. Therefore, the ability to reforest this area is highly

problematic. It is expected that due to the absence of topsoil, this area will remain deforested.

Figure 11.13 - Pre-event satellite photograph of the forested area surrounding Proffit Mountain. (Source: Google Earth, 2005)

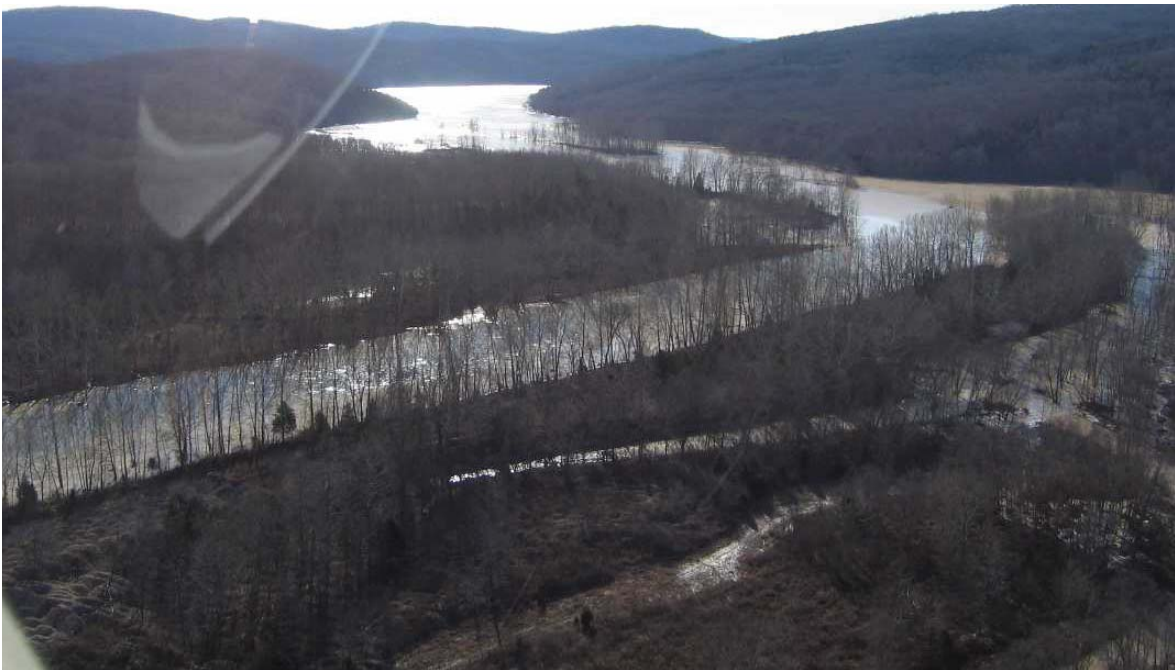
Figure 11.15 - East Fork Black River leading into Taum Sauk lower reservoir. December 2005. (Source: MDC)
